CRJ Constructions Pty Ltd
23 Horatio St
MUDGEES NSW 2850
AUSTRALIA

Re: 31 Court St Mudgee NSW 2850

Thank you for the opportunity to inspect 31 Court St Mudgee in April 2021.

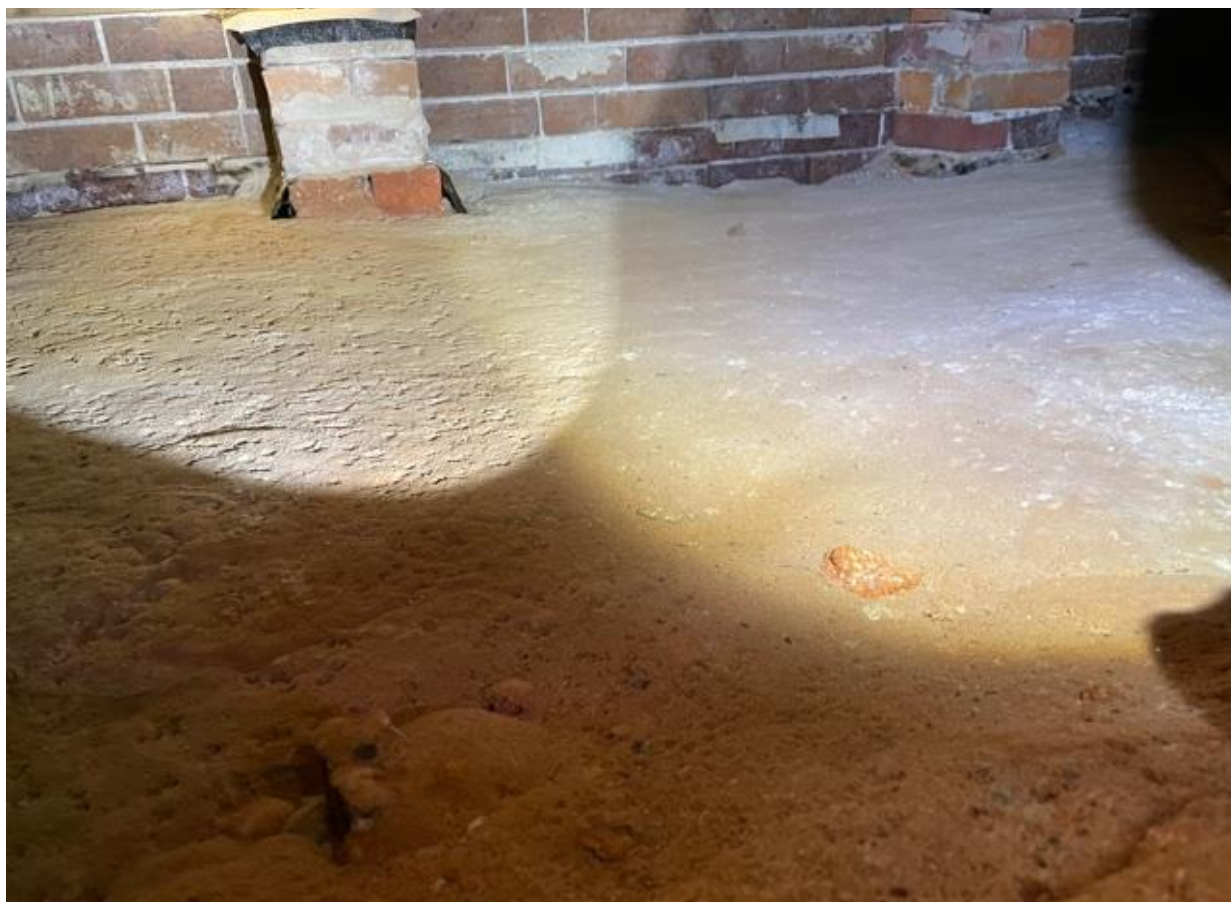
Photo 9745

Picture 9745 shows soft fluffy salt just lying on top of soil.

Recommend to demolish house and remove all debris off site. The surrounding top soil containing salt and contaminants will have to be removed moving forward as the salt will now attack any other future builds here. Recommend to get soil test to determine depth of soil fill to be removed.

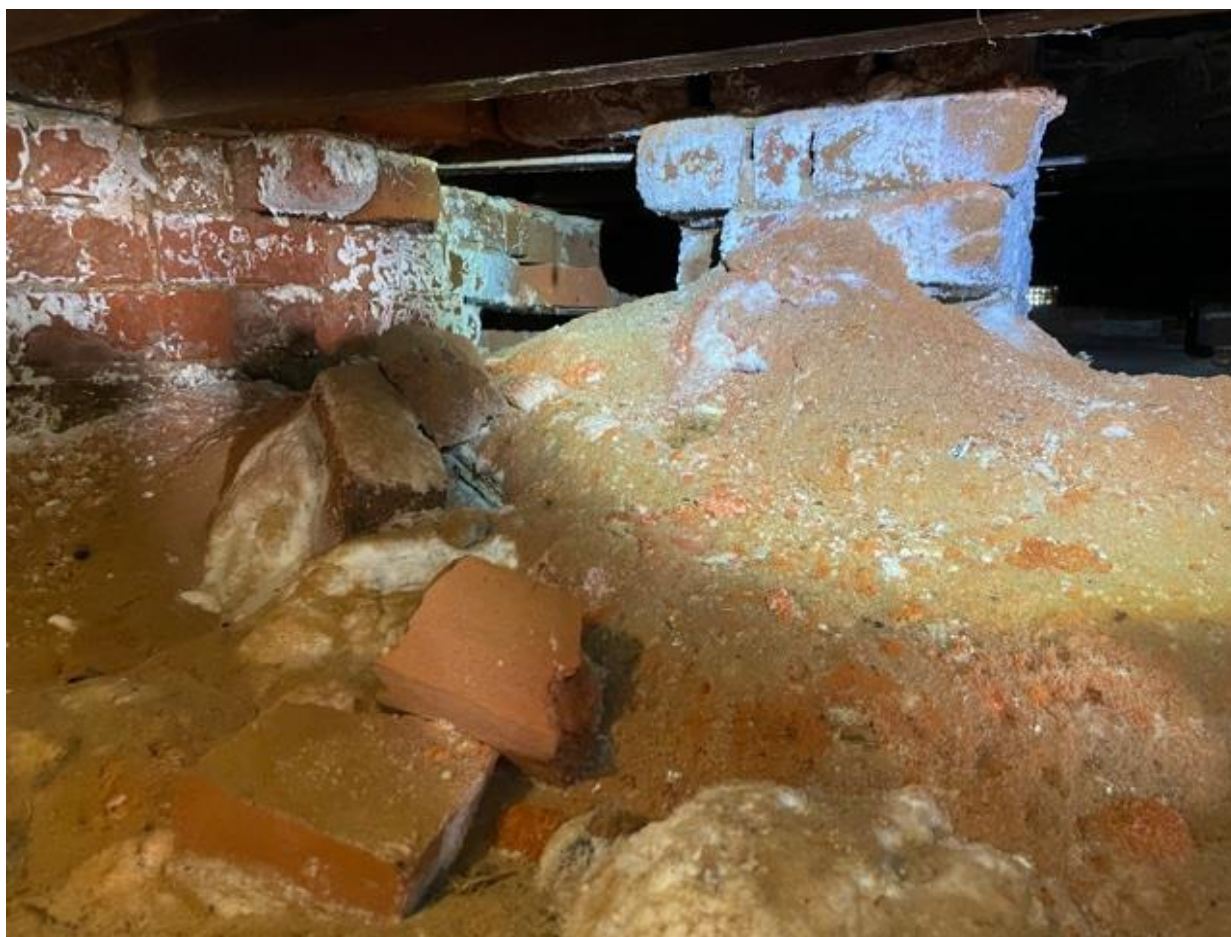
Photo 9737

Picture 9737 shows areas where there are almost no footings left from salt attack.

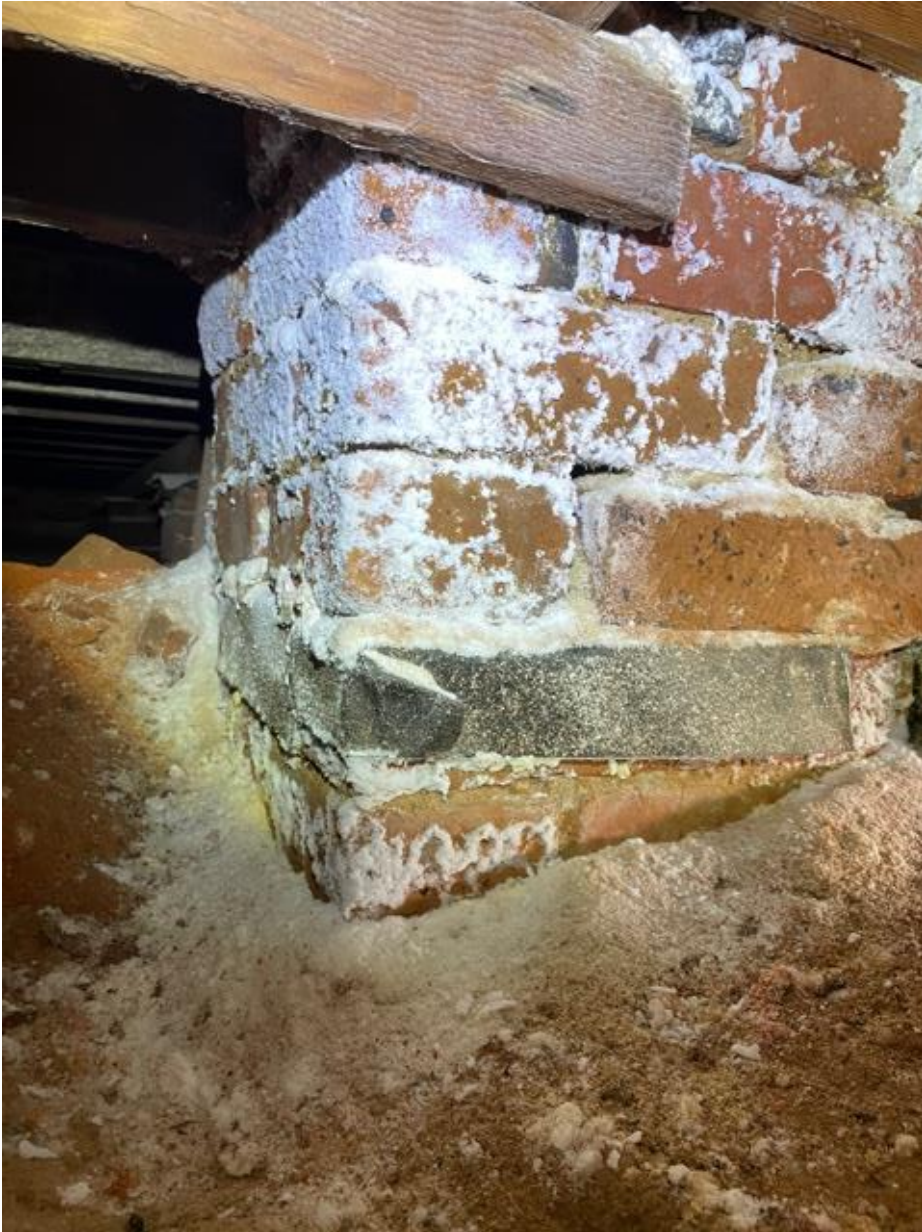
Photo 9738

Picture 9738 & 9740 shows salt attack on piers and bricks are now soft and are being eaten away.

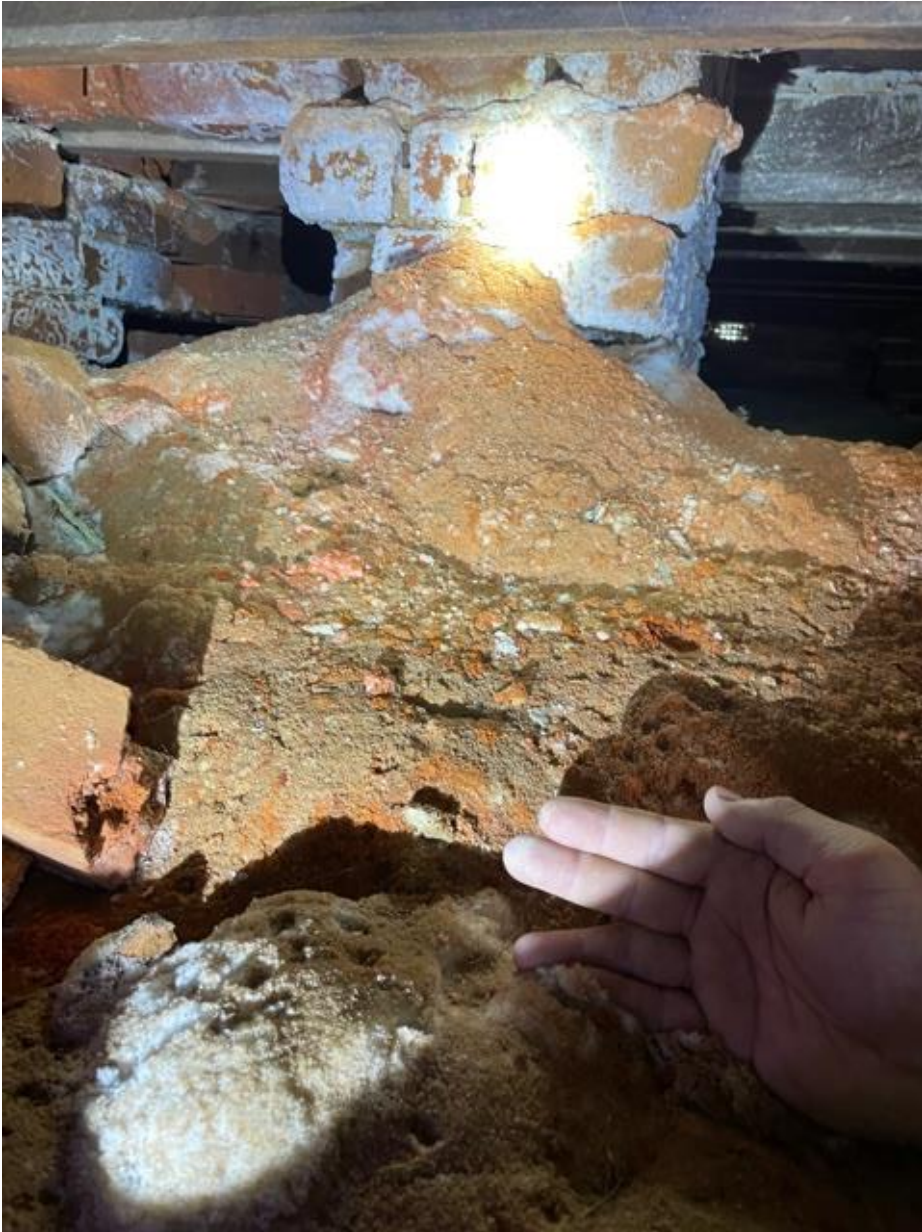
Photo 9741

Picture 9741 shows my hand in front of what's left of footing that have been completely eaten away. From ground level to timber bearers is 620mm. Footing almost completely eaten away as in a pile of soft dust.

These photos are showing areas where the damage has not been bad enough to cover. Behind timber borders walls are disintegrating and are falling beneath house as shown in photo 9741.

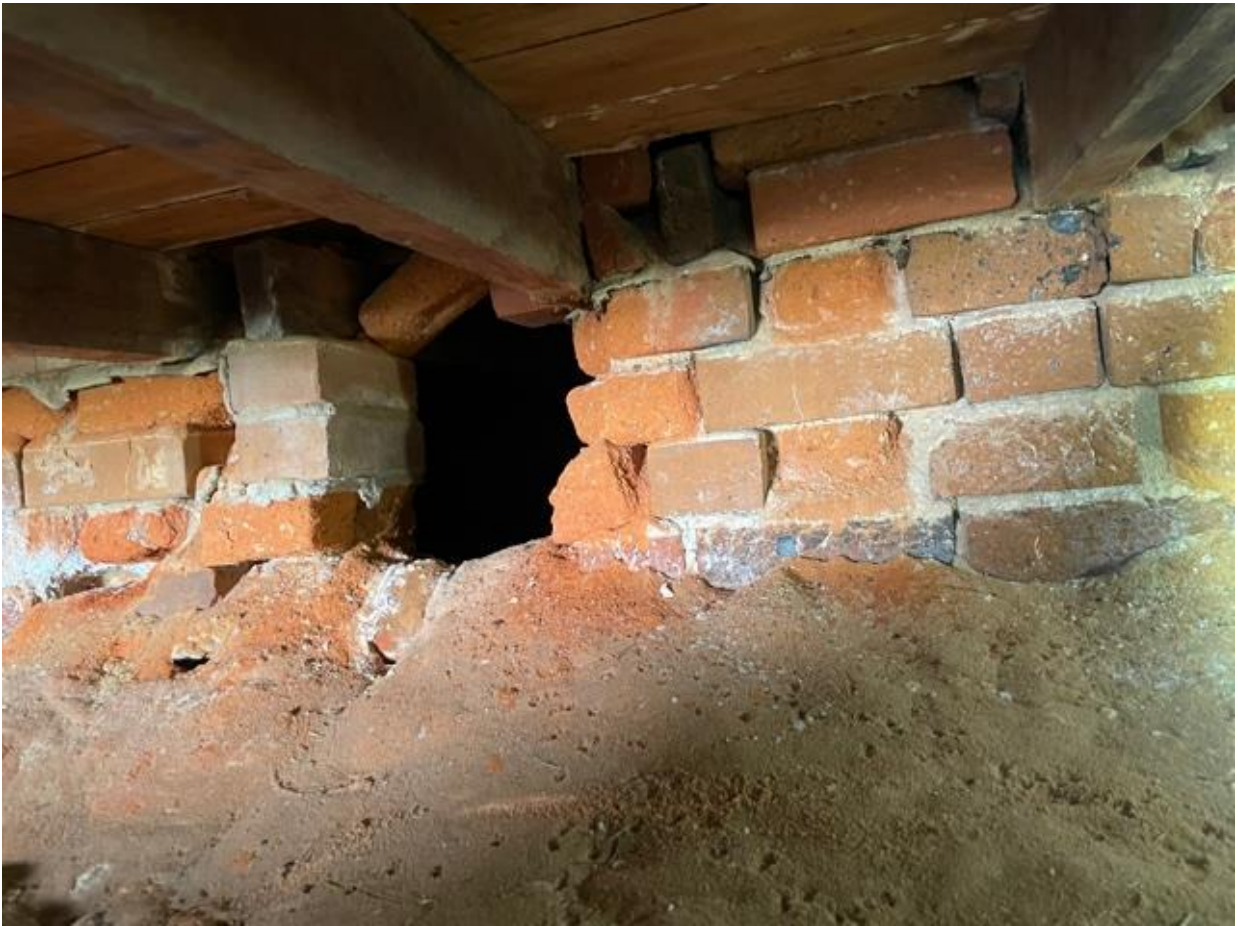
Photo 9742

Picture 9742 shows the same but now showing that bearers are now not being supported hanging in mid-air.

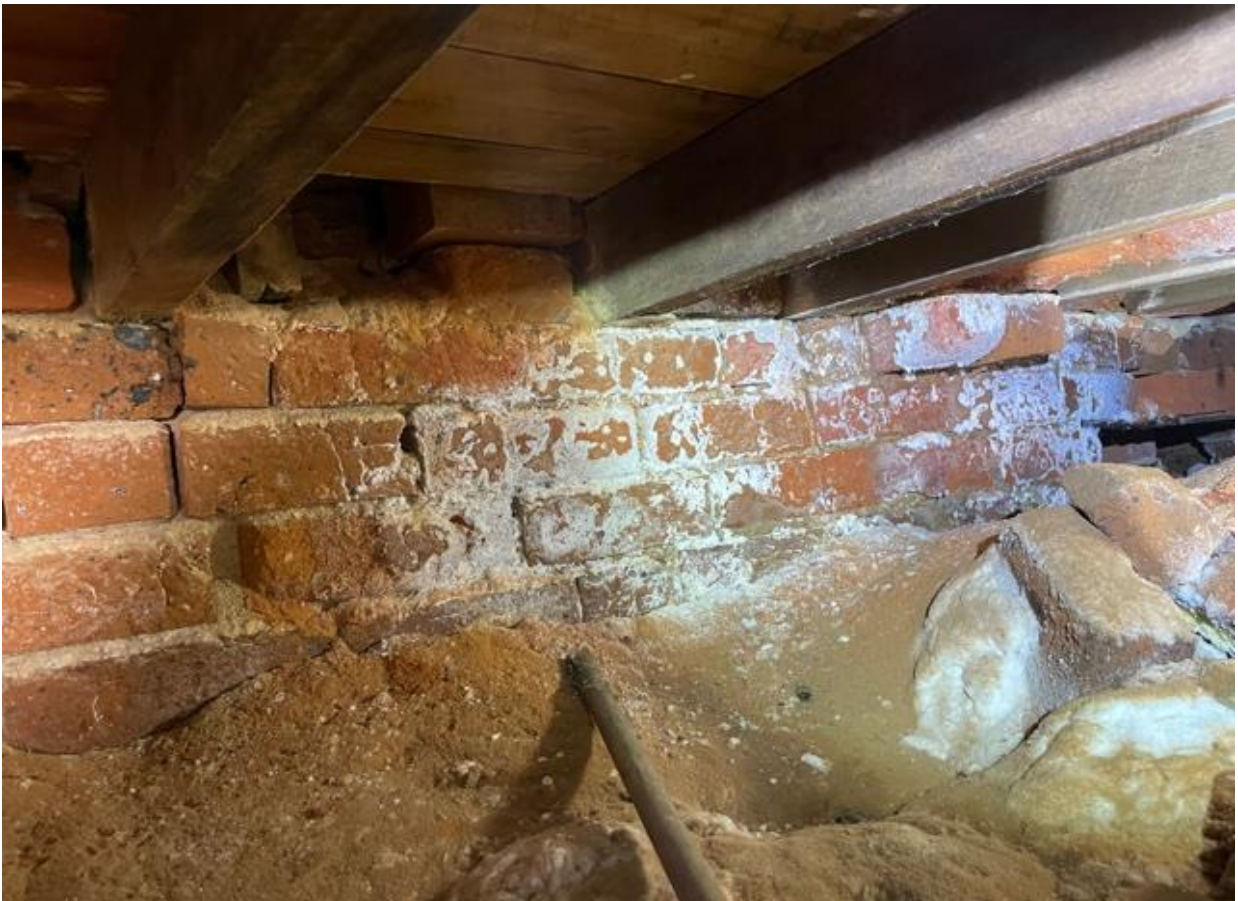
Photo 9743

Pictures 9743 & 9744 shows other footings. In areas there are large gaps with bricks hanging. Just remember in these old buildings these footings are the walls above. They go from ground level through to supporting roof structure. There is no building integrity left in these walls.

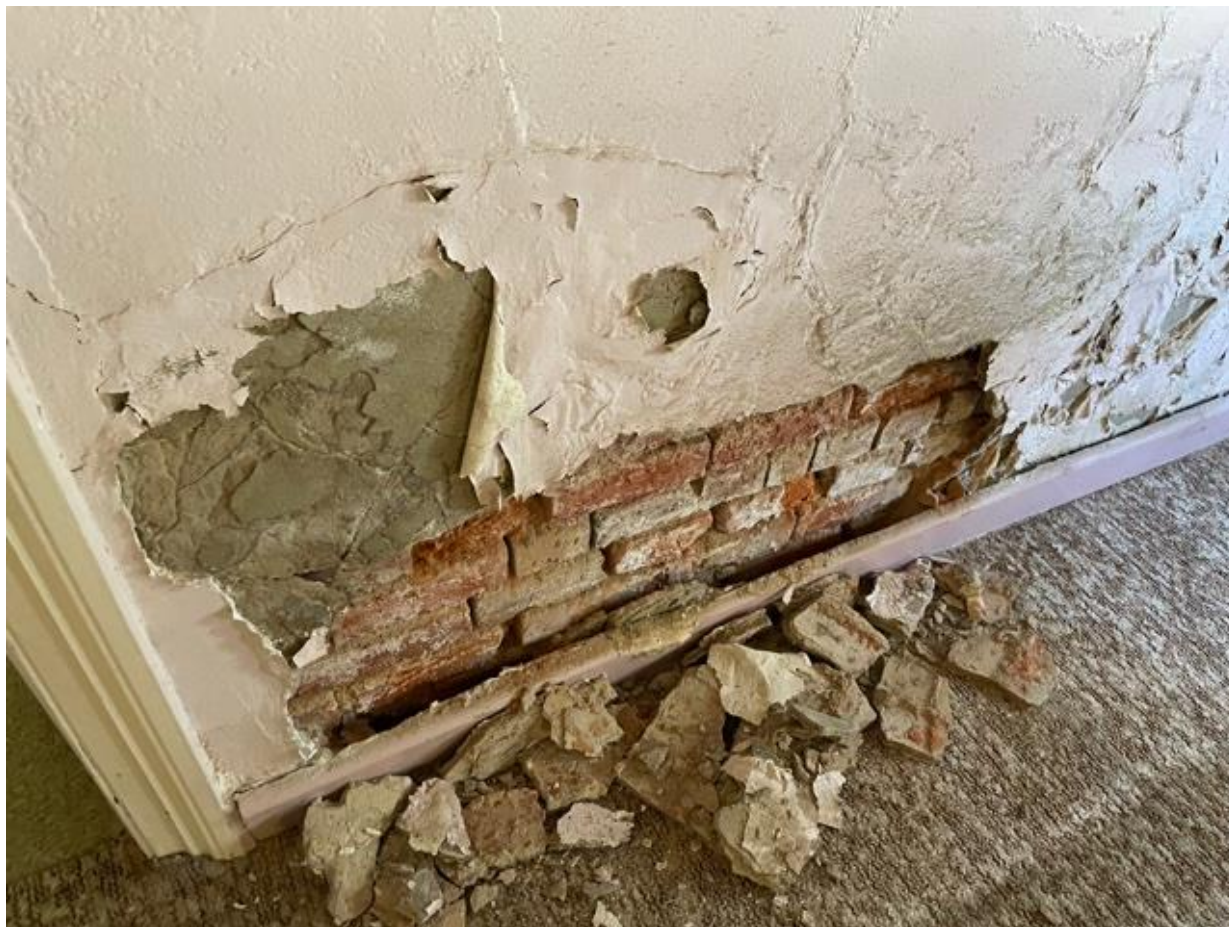
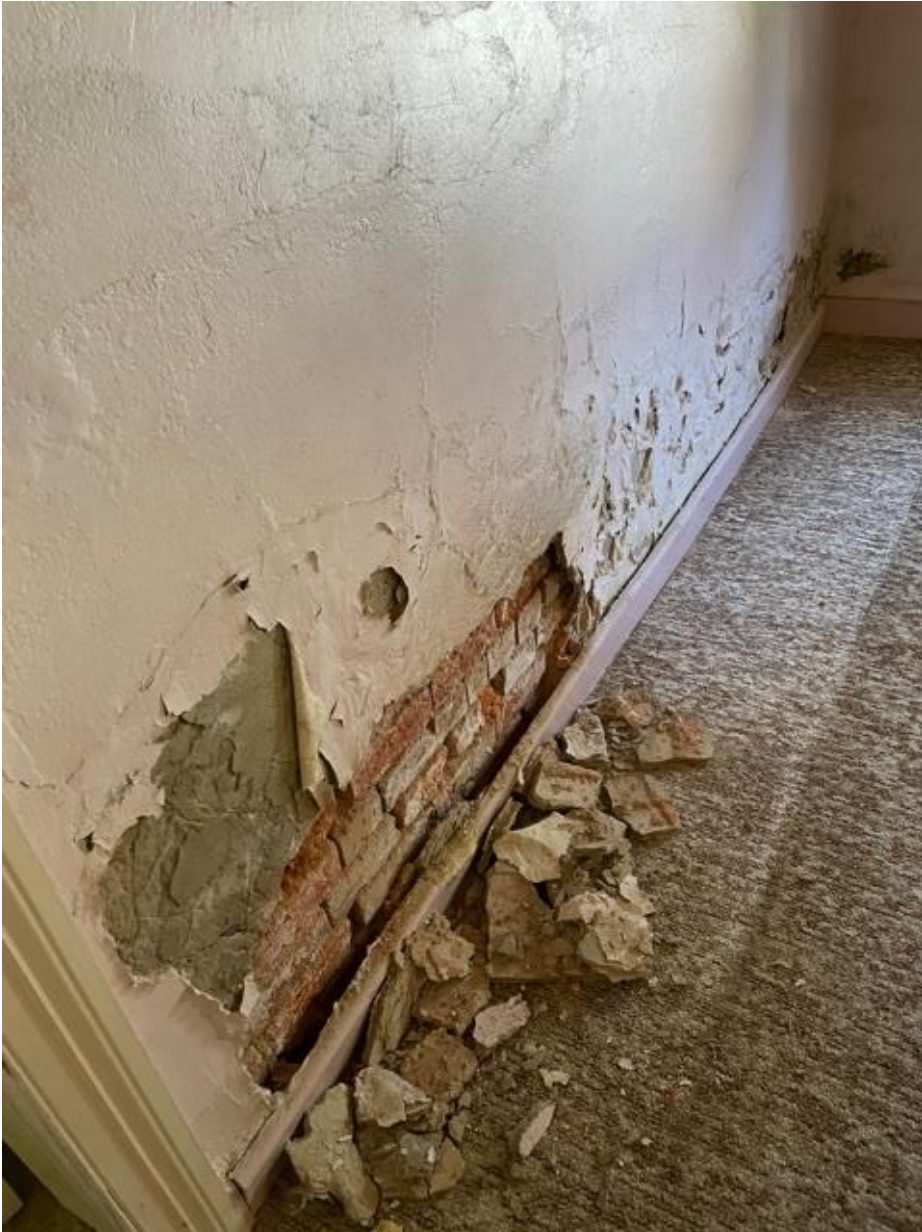
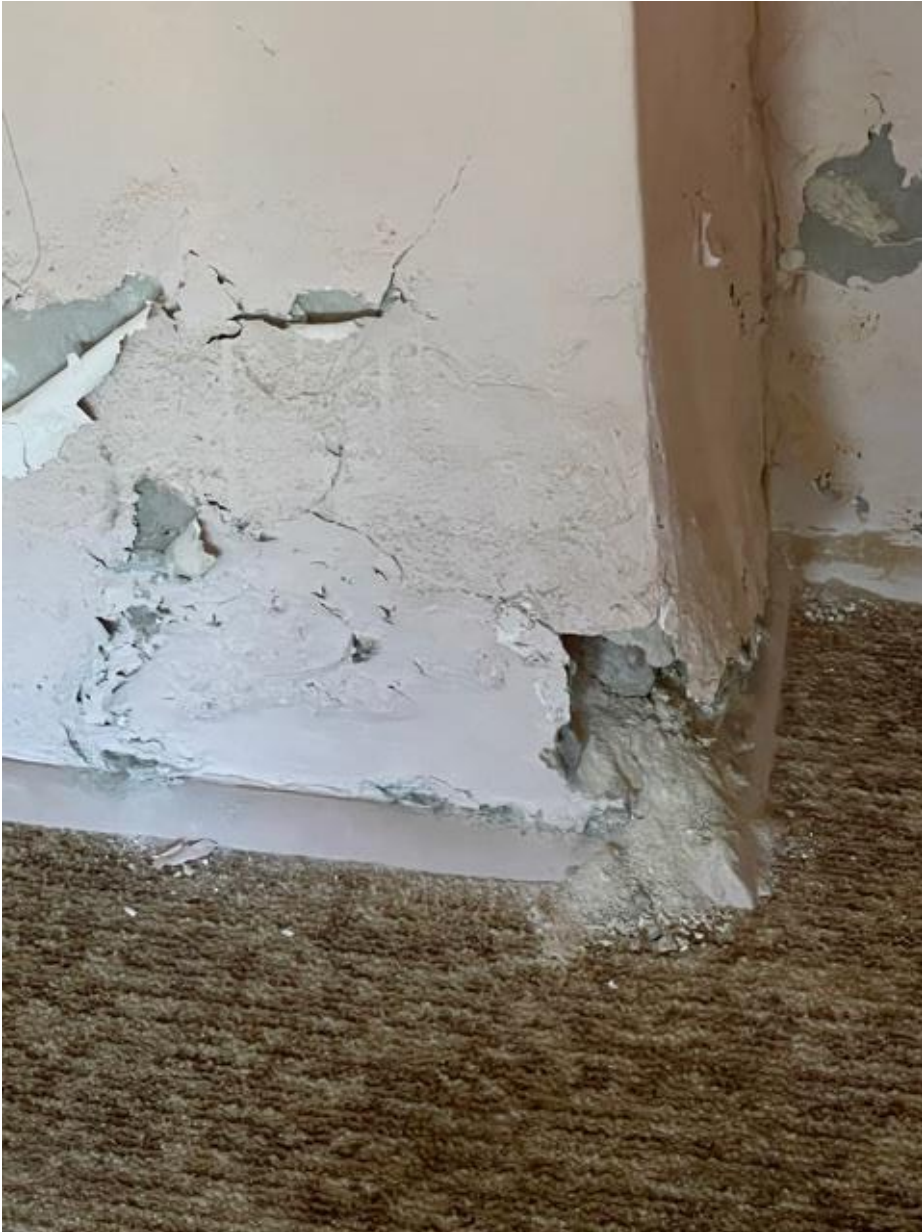
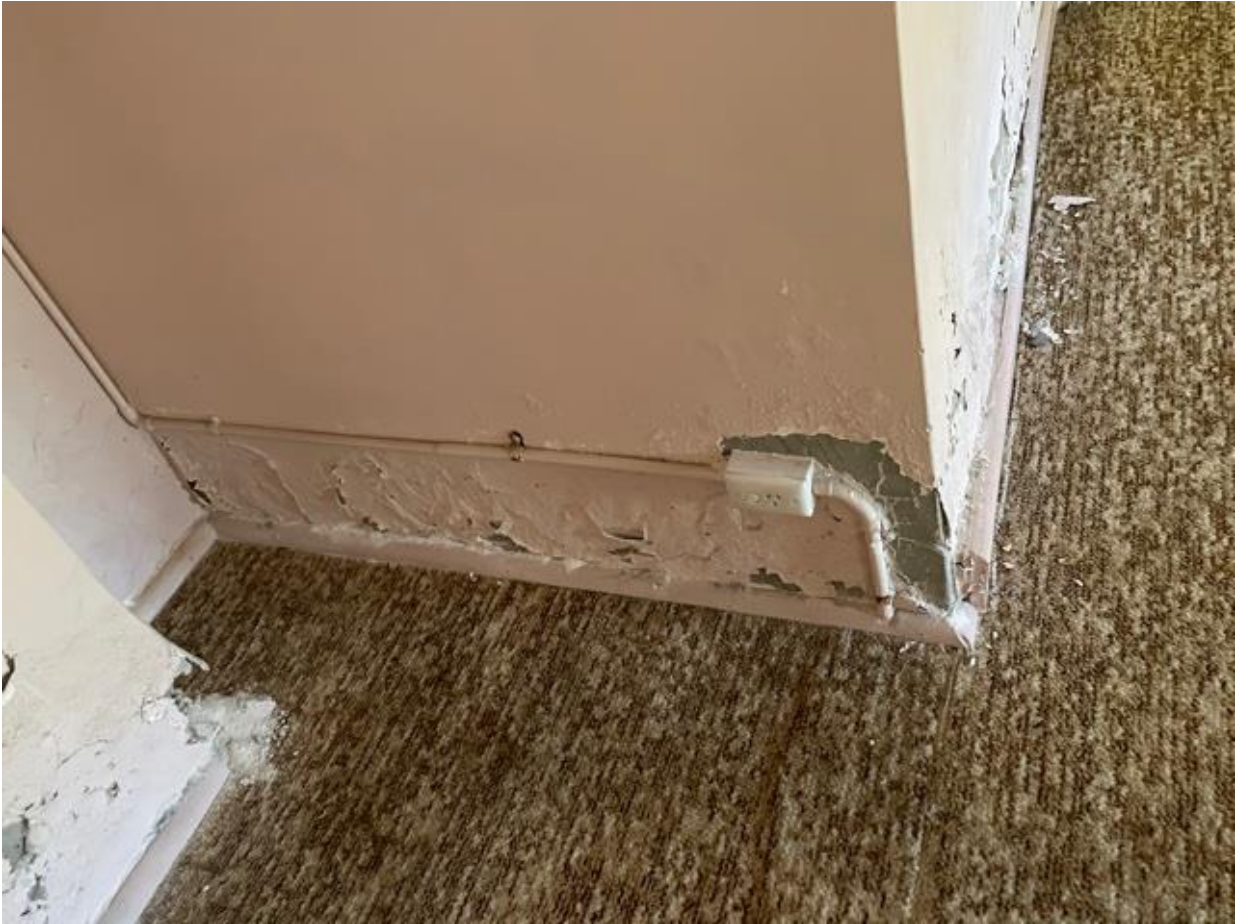
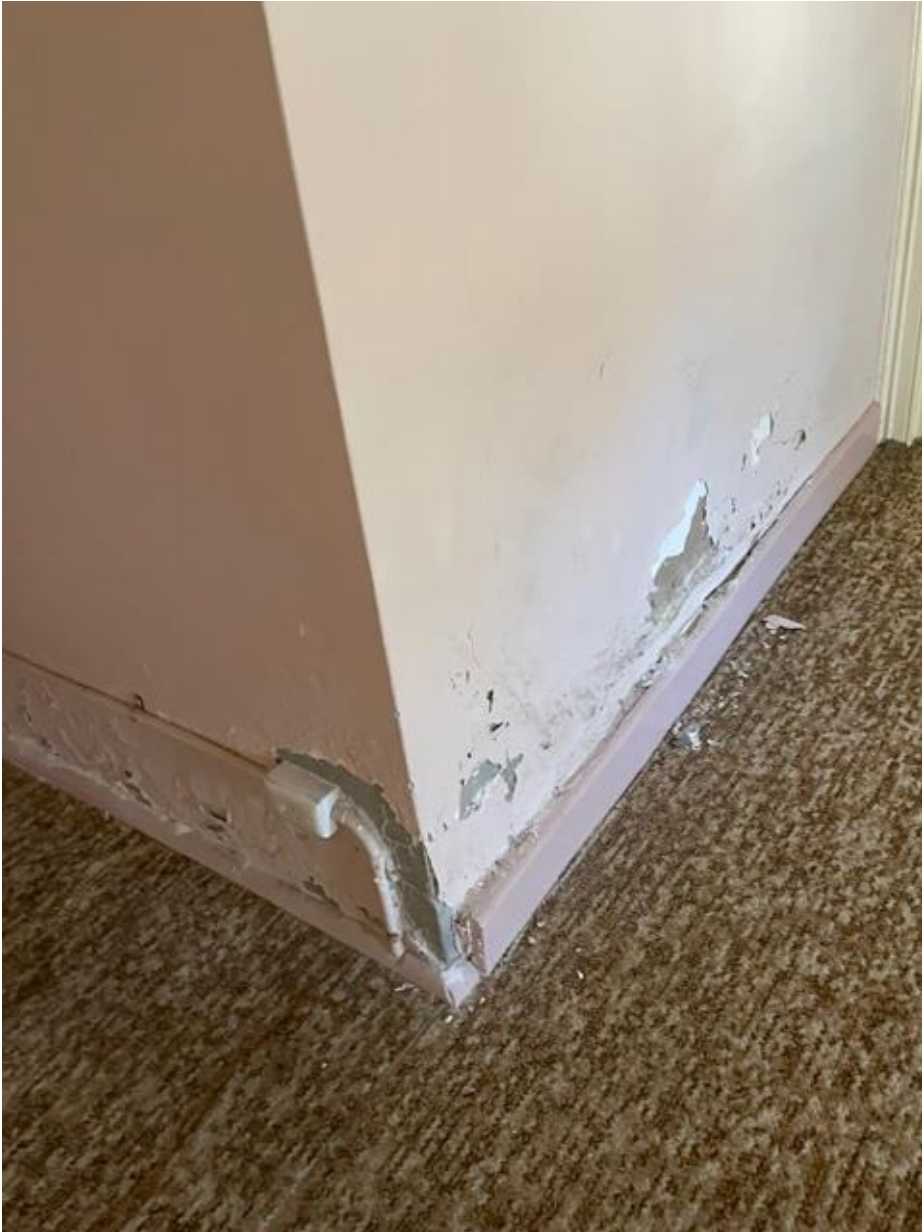
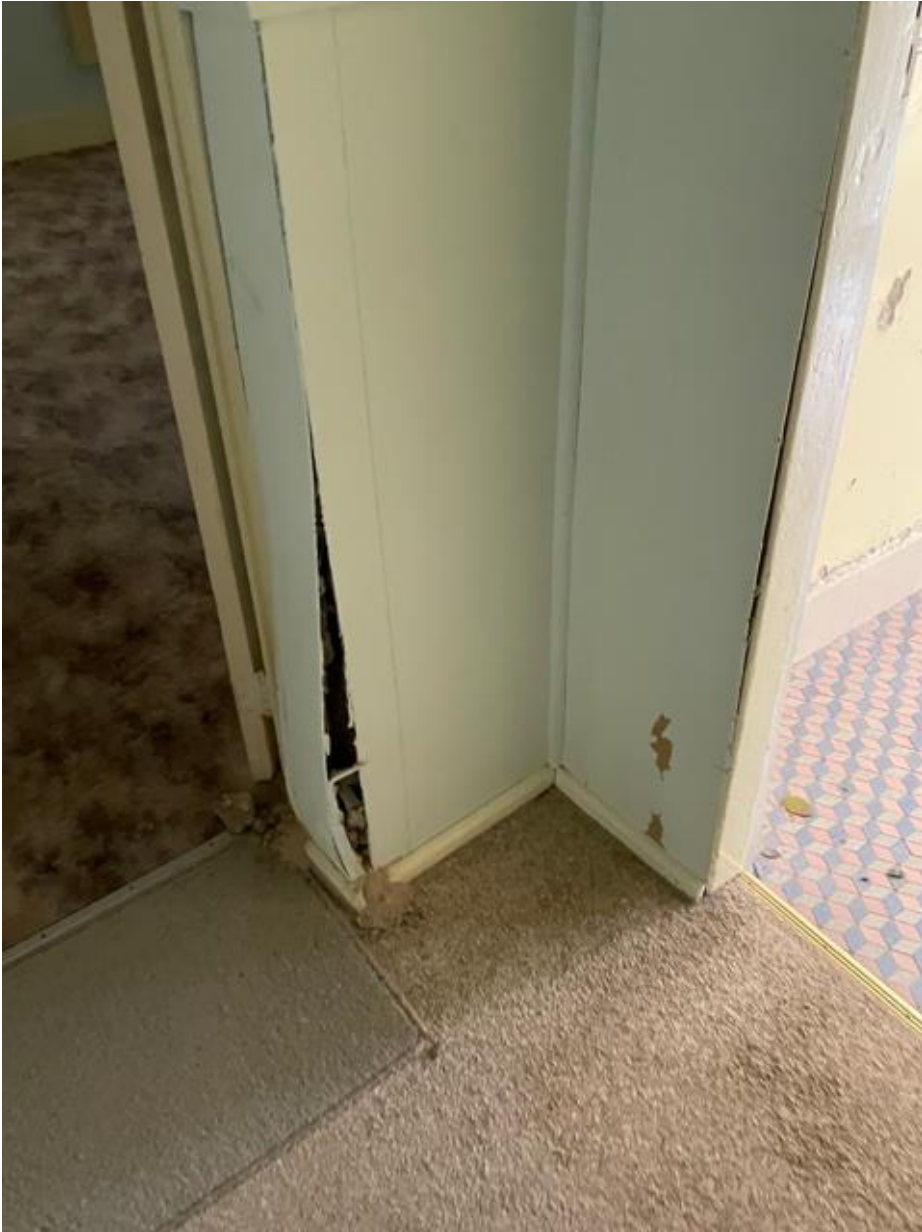
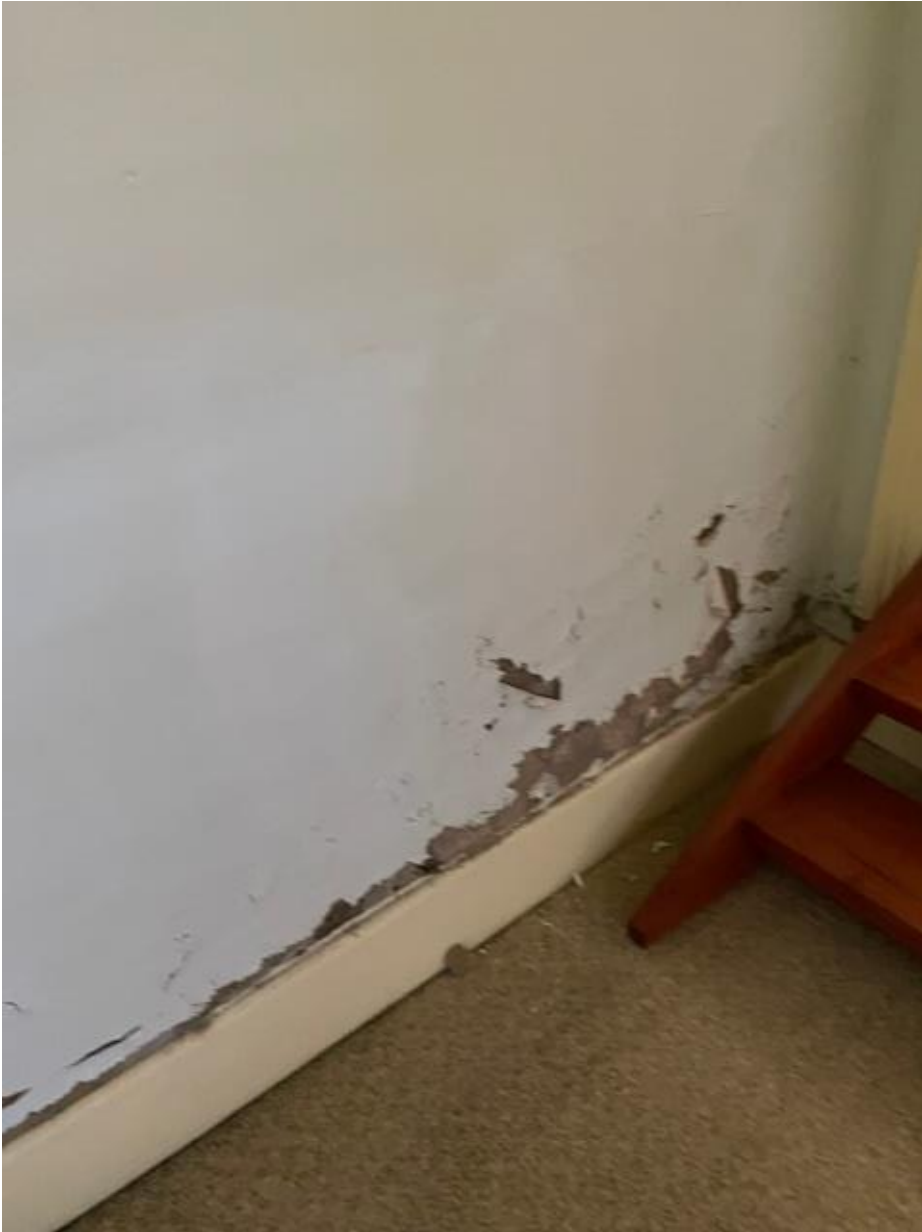
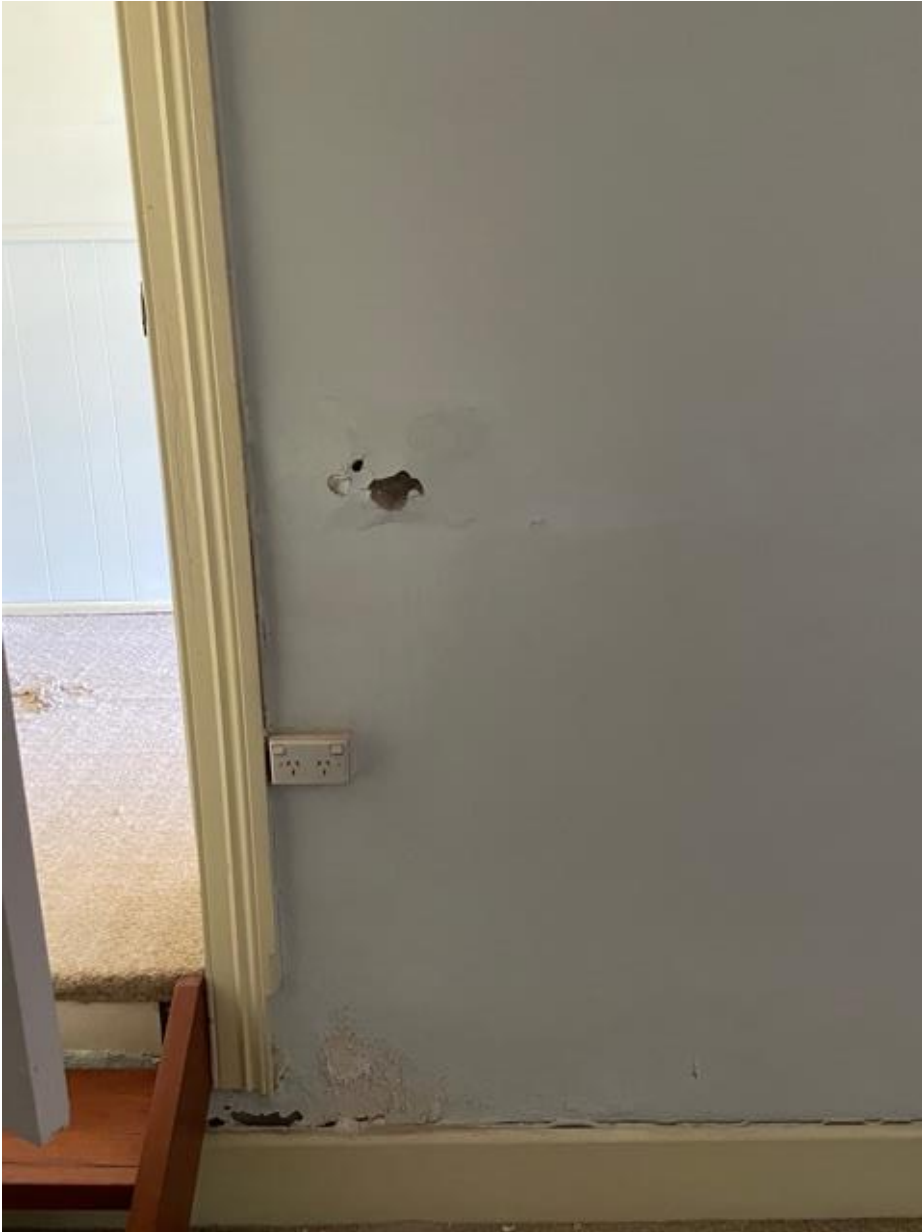
Please open second attachment and observe pictures 9851 to 9858. This is the salt and rising damp damage from inside building.

In most areas throughout the house the rising damp issues have been covered over with a timber fret border to hide damage. Instead this has made things worse, as these old walls need to breath. This has caused the salt and moisture to rise even further and faster without doing any prevention.

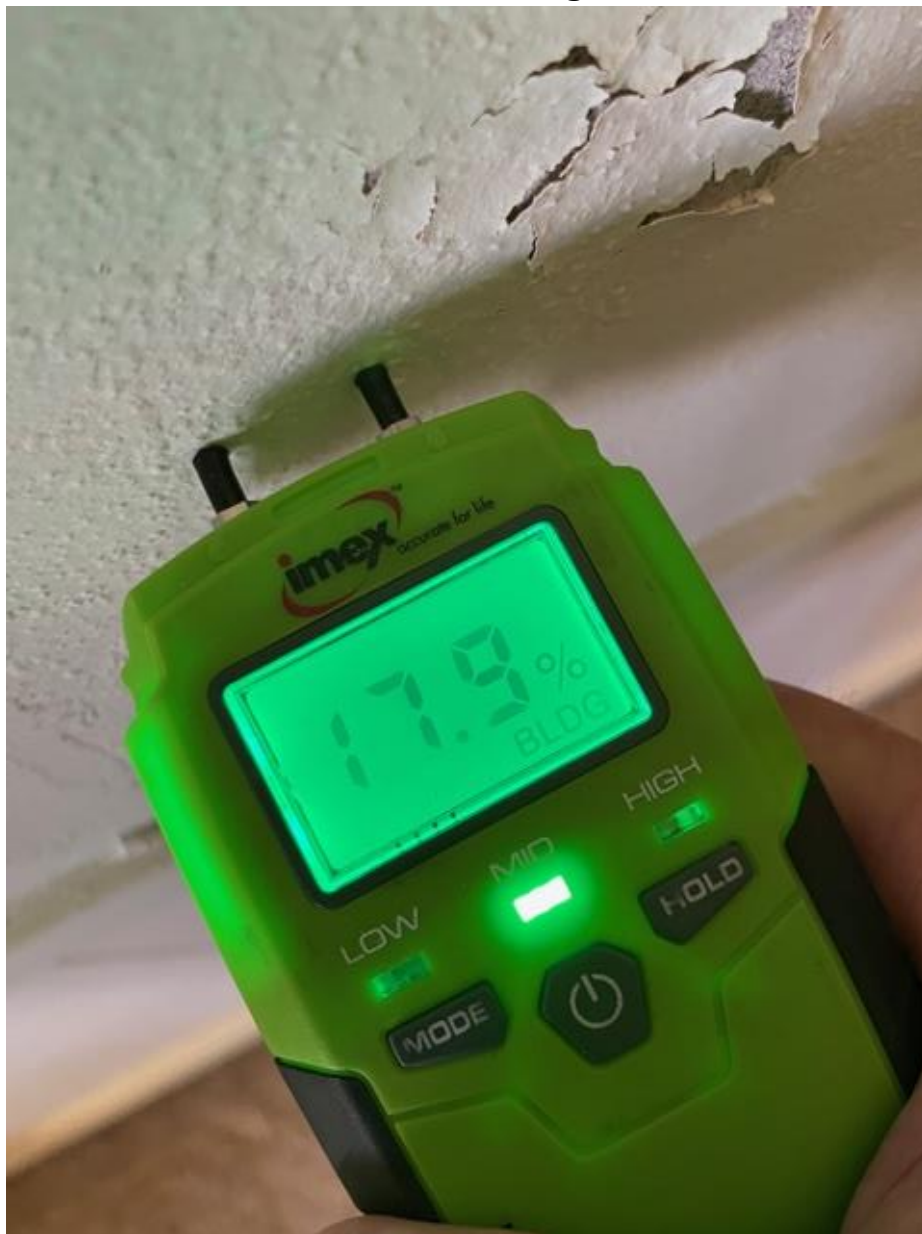
Photo 9859

Pictures 9859 & 9860 in areas where minimal damage is evident are showing readings of Med range from 18.1% to 19.9%.

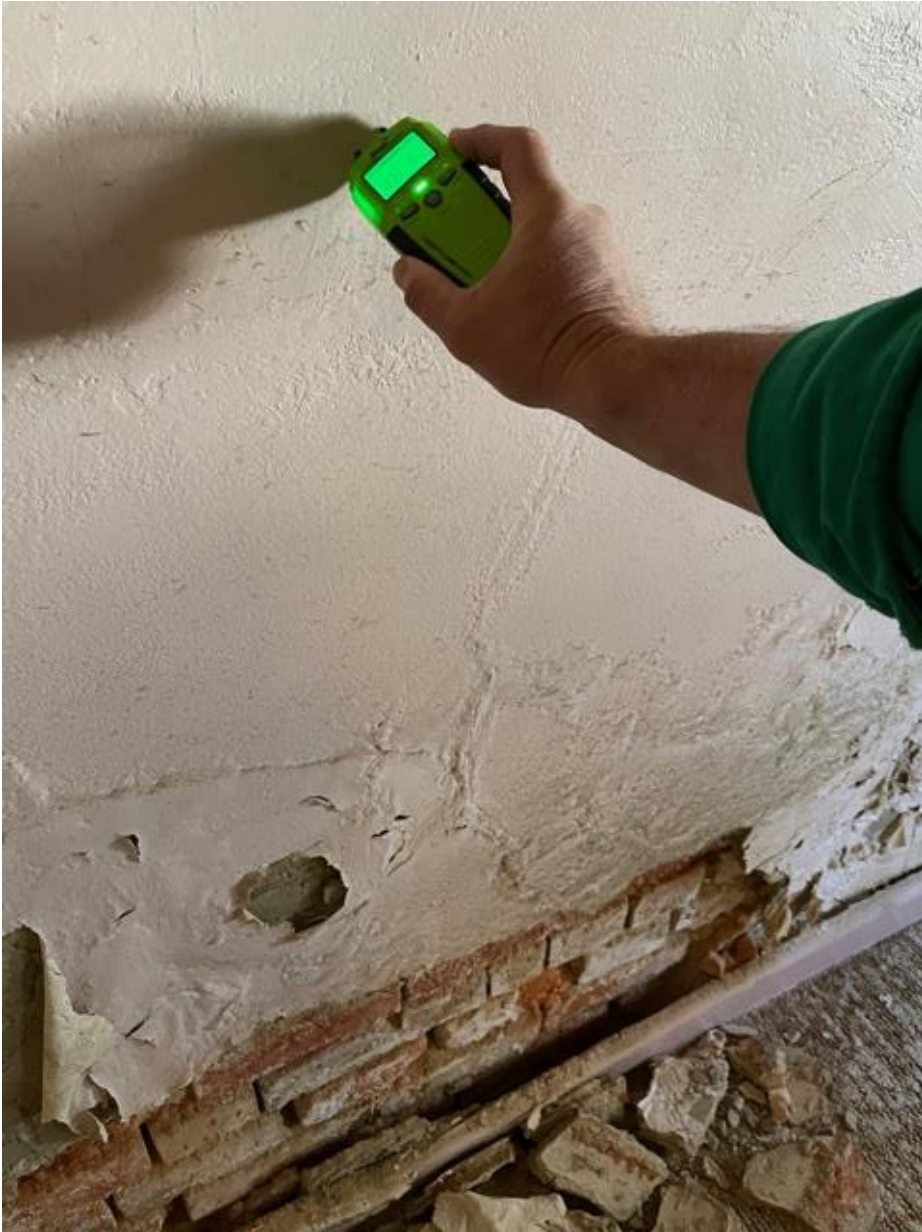
Photo 9861

Picture 9861, 9862, 9863, 9864 and 9865. At 1.5 metres off floor level and moving around house it is still showing really high readings in mid-range of 18.5% trough to high moisture reads of 33%.

With really high moisture readings of 33% taken at 1.5m off floor level the house is in stage 3 of 4 to ruin.

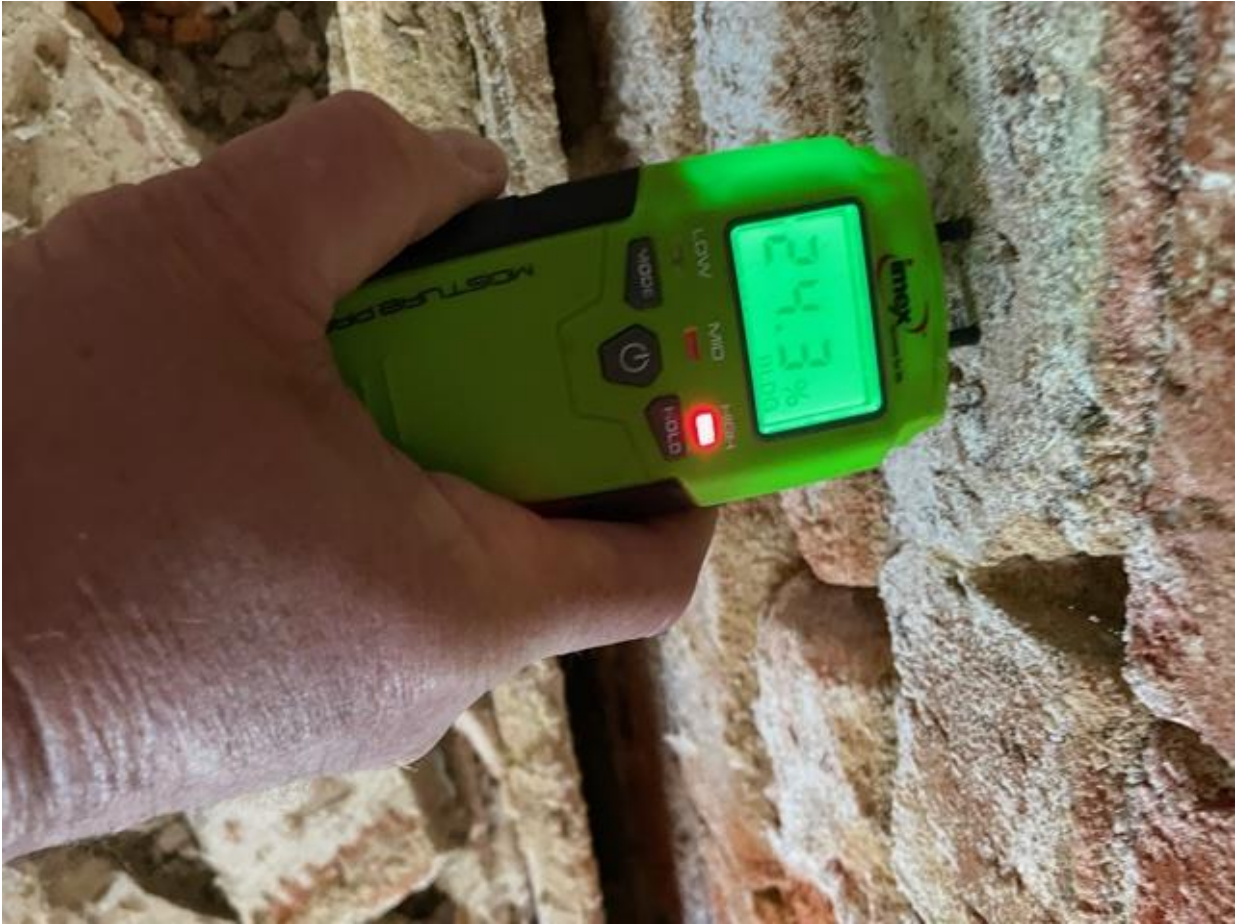
Photo 9866

Picture 9866 is very interesting as majority of the brick has already disintegrated and still reading a very high moisture read.
