Residential Site Investigation Report

Site Address: 705 Kains Flat Road, Kains Flat NSW 2850

(Our Reference: 36296-GR01_A)

Project Name:	705 Kains Flat Road, Kains Flat NSW 2850
Client:	John Grosse
Project No.	36296
Report Reference	36296-GR01_A
Date:	3.05.2021
Revision:	Revision A

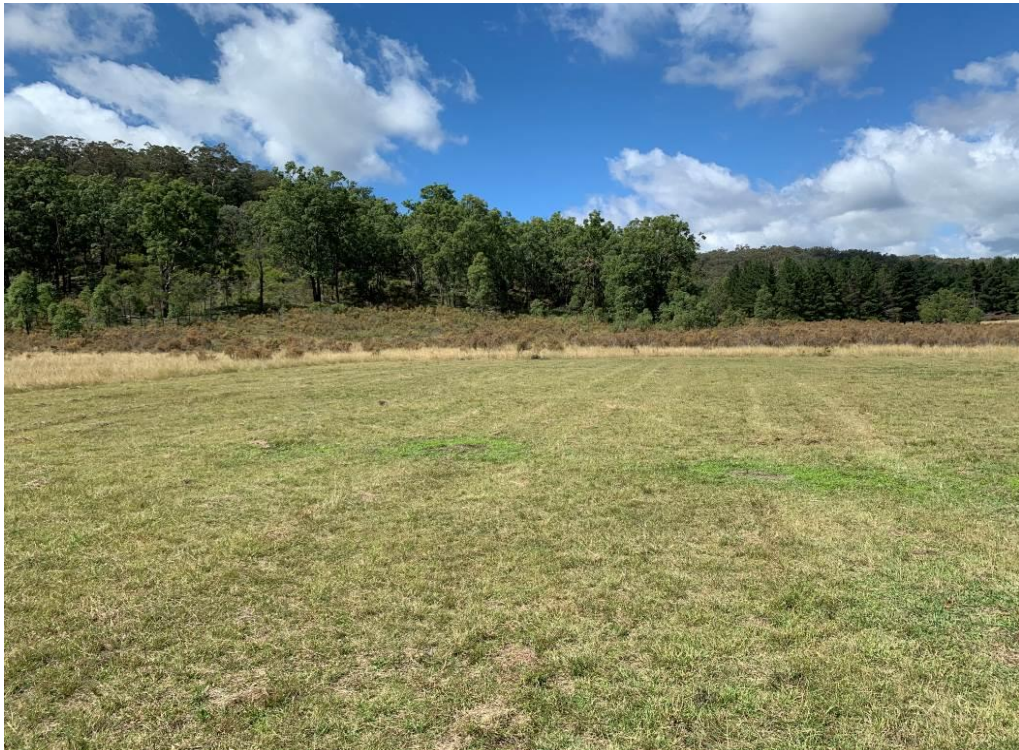
Plate 1 – Southeast facing view.

The site consists of lightly scattered grass and weed cover with no trees onsite.

The site is sloping moderately to the west. The block has existing rural farmland surrounding the area.
