Residential Site Investigation Report

Client: Plan Land

Site Address: 34 Lang Street
Mudgee, NSW 2850

Our Reference: 41129-GR01_A

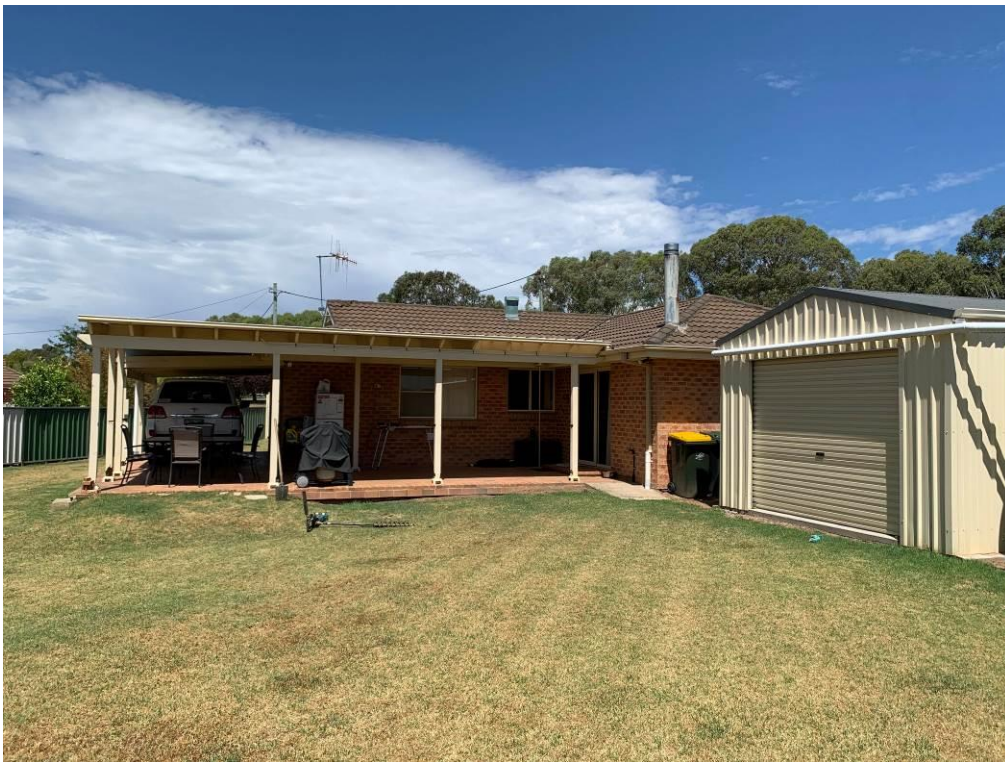
Plate 1 – South facing view.

The site consists of light grass and weed cover with mature trees outside the proposed building location.

The site is sloping slightly to the north west. The block has existing dwelling on block with existing buildings and established houses surrounding the area.

Any trees noted to be within the building zone, should be removed and the excavation remaining should be backfilled with natural material and reinstated in layers to a minimum of 95% Standard Maximum Dry Density.

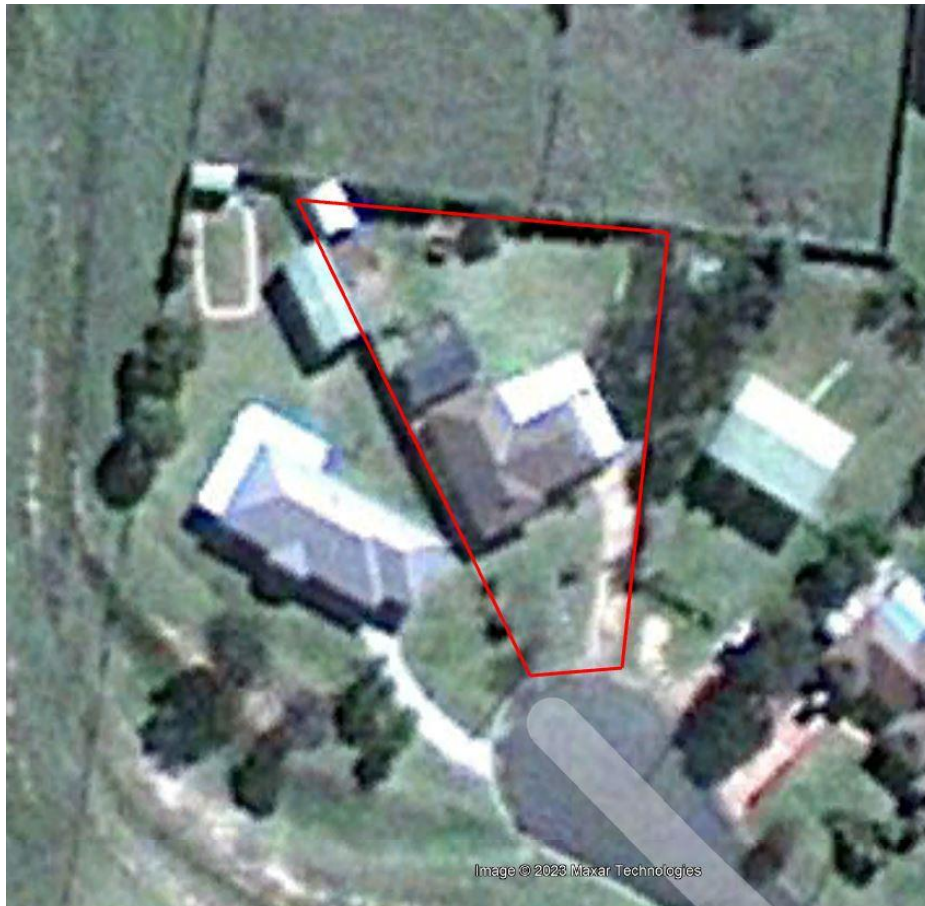
Plate 2 – Aerial Image 2009, Courtesy Google Earth.

A review of Google Earth imagery of the site indicates that the site is in similar condition as to when an image was taken in 2009. The site is therefore assumed to be natural ground with no recent tree removal or fill placed. Images exist back to 1985, yet the image is not clear enough to determine what was on the site. See 2009 aerial image below:
