Residential Site Investigation Report

Site Address: 60 Davies Road,
Kandos, NSW

1 May 2023

Our Reference: 41382-GR01_A

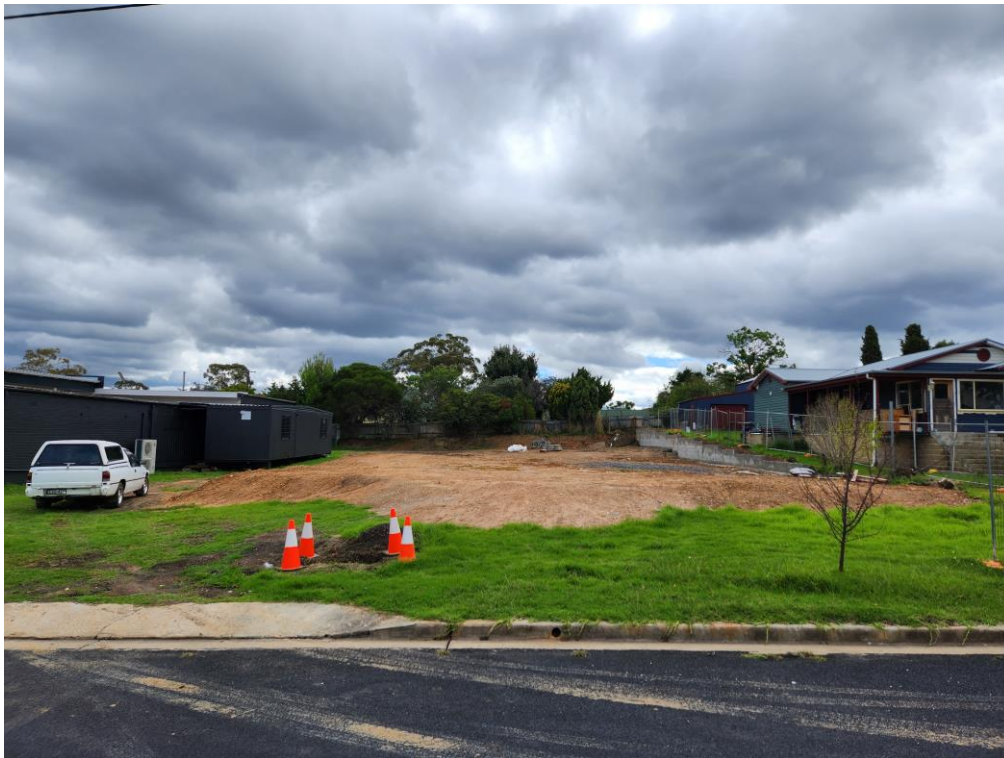
The site consists of fill material at the time of investigation, there are no trees onsite. The site of the proposed development is a rectangular in shape with an area of approximately 1161m².

Plate 1 – General view of the site

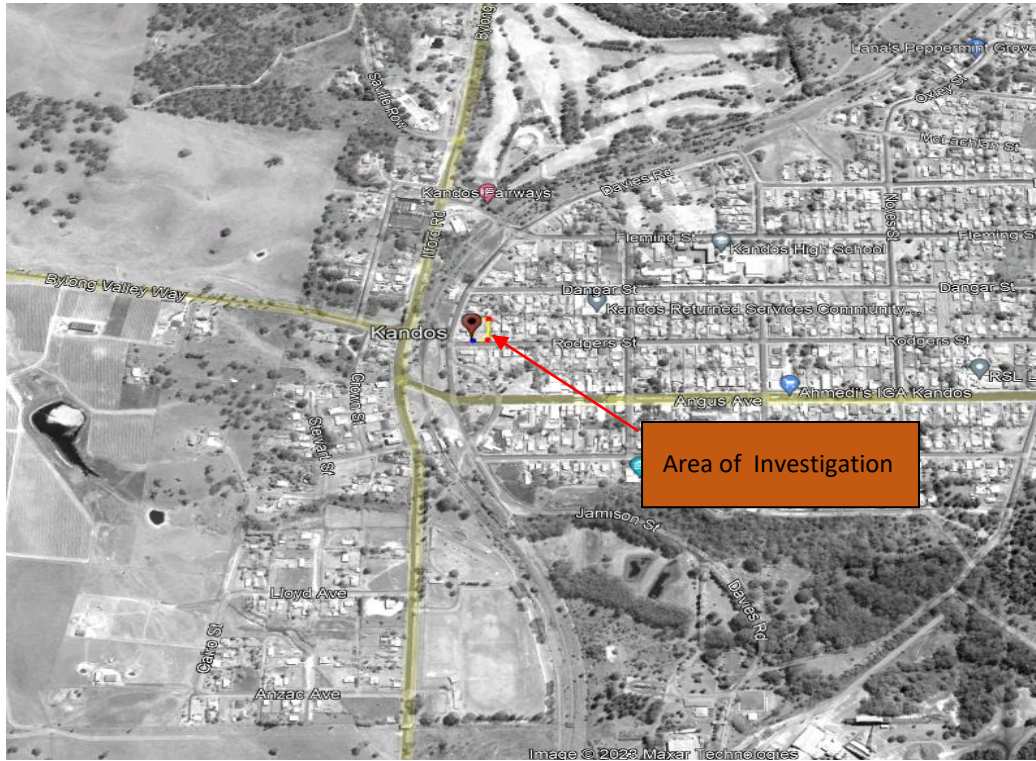
A review of Google Earth imagery of the site indicates that the site is in similar condition as to when an image was taken in 2009. The site is therefore assumed to be natural ground with no recent tree removal. Images exist back to 1985, yet the image is not clear enough to determine what was on the site. See 2009 aerial image below:

Plate 2 – Aerial Image 2009, Courtesy Google Earth.
