Tree Assessment Report

Site Address: 34-36 Inglis St Mudgee NSW 2850.

Date of Inspection: 2nd August 2023

Report date: 5th October 2023 (Version 1)

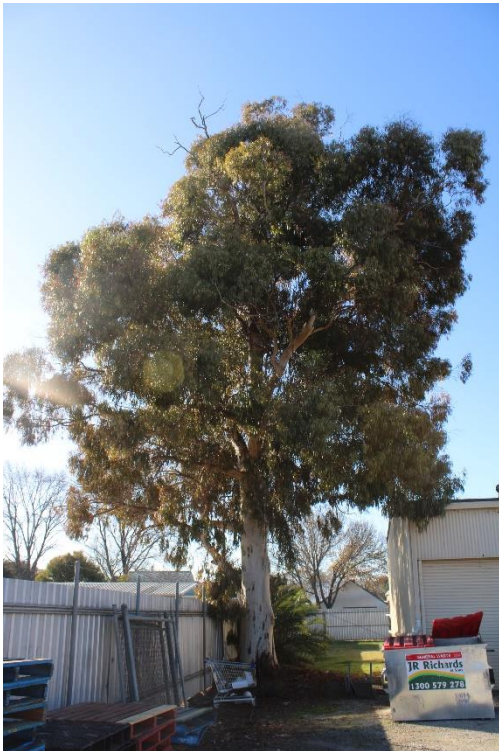
Habitat: Several hollows were observed in (Tree #1) which is listed for removal.

- Tree 1 is a large mature eucalyptus with significant infestation of termite and decay damage in the lower trunk and would more likely extend into the root plate below soil level, probing of the cavity indicated depth and activity of termite. The tree is not suitable for retention in development.
- Tree 2 is a proclaimed weed species.
- Tree 3 is healthy and not compatible with the proposed development.
- Trees: 4, 5, 6, 7, 8, 9, 10, 11, 12, 13 & 14 are in adjacent properties all trees are documented in the Tree Survey Table, minor pruning up to maximum 10% of branch overhang for building and working clearance is required.

- Trees impacted by the proposed plan construction and identified for removal are numbered: TREES # 1, 2 & 3.
- Tree to be protected from development impacts are TREES # 4, 5, 6, 7, 8, 9, 10, 11, 12, 13 & 14.

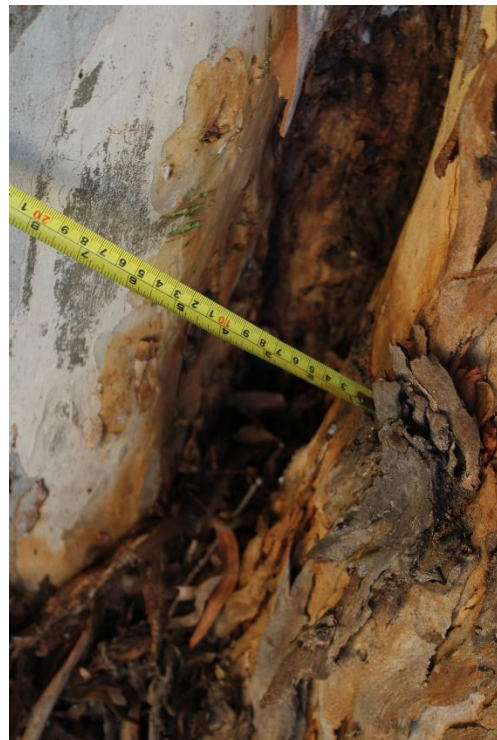
Tree 1 cavity at base

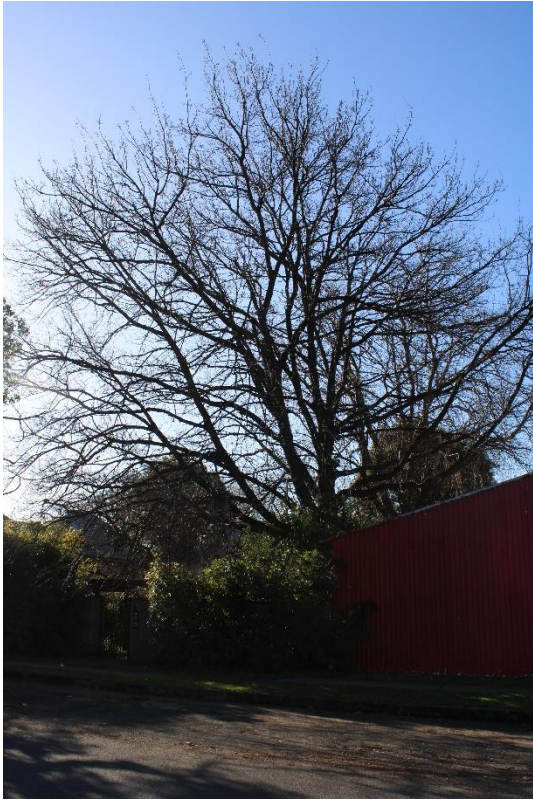
Tree 4

4	S32. 600 54° E149. 588 06°	<i>Quercus robur</i> English Oak	14	60	16	Mature good condition in adjacent property, within 1m of boundary alignment.	90	3.2	7.2	A2 HIGH	RETAIN minor pruning overhang. Tree protection required
5	S32. 600 40° E149. 588 07°	<i>Gleditsia triacanthos</i> Honey Locust	14	60	14	Mature good condition in adjacent property, within 1m of boundary alignment.	80	3.0	7.2	A2 HIGH	RETAIN minor pruning overhang. Tree protection required
6	S32. 600 22° E149. 588 18 °	<i>Melaleuca quinquenervia</i> Paperbark	8	40/40	10	Mature good condition in adjacent property, within 1.5m of boundary alignment.	55	2.6	6.8	A2 HIGH	RETAIN minor pruning overhang. Tree protection required

- Trees #: 4, 5, 6, 8, 9, 10, 11, 12, 13 & 14 will require approved protection fencing 1.8m in height placed at the defined TPZ measurement and must be installed prior to any demolition or earthworks. (*TPZ are noted in the Tree Survey as radius measurements from the centre of the tree trunk*)

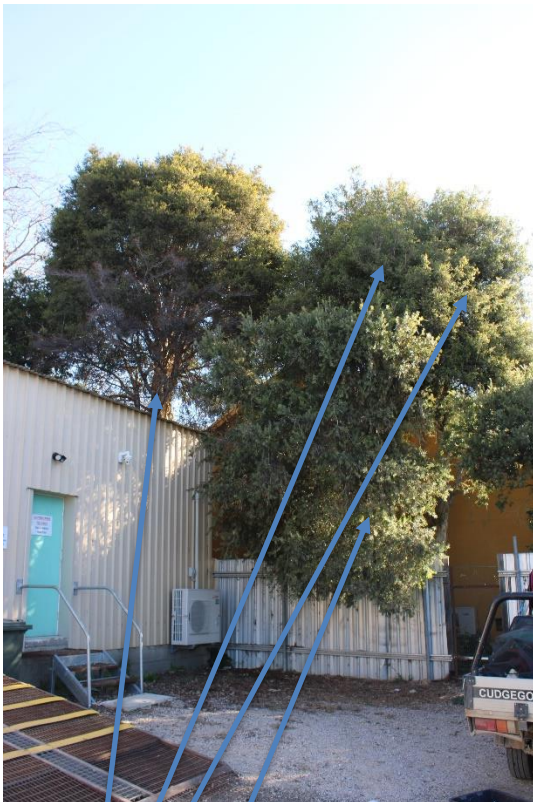
Tree: 6, 7, 8 & 9

7	S32. 600 22° E149. 588 18 °	Melaleuca quinquenervia Paperbark	10	30	4	Mature good condition in adjacent property, within 1.5m of boundary alignment.	60	2.7	3.6	A2 HIGH	RETAIN minor pruning overhang. Tree protection required
8	S32. 600 23° E149. 588 18 °	Melaleuca quinquenervia Paperbark	10	30	4	Mature good condition in adjacent property, within 3m of boundary alignment.	50	2.5	3.6	A2 HIGH	RETAIN minor pruning overhang. Tree protection required
9	S32. 600 25° E149. 588 17°	Callistemon <i>saligna</i>	7	15	2	Mature good condition in adjacent property, within 1m of boundary alignment.	25	1.8	1.8	A2 HIGH	RETAIN minor pruning overhang. Tree protection required
10	S32. 600 23° E149. 588 20°	Callistemon <i>saligna</i>	8	35	3	Mature good condition in adjacent property, within 1m of boundary alignment.	40	2.3	4.2	A2 HIGH	RETAIN minor pruning overhang. Tree protection required
11	S32. 600 22° E149. 588 29°	Jacaranda <i>mimosaeifolia</i>	8	40	4	Mature good condition in adjacent property, within 3m of boundary alignment.	50	2.5	4.8	A2 HIGH	RETAIN minor pruning overhang. Tree protection required

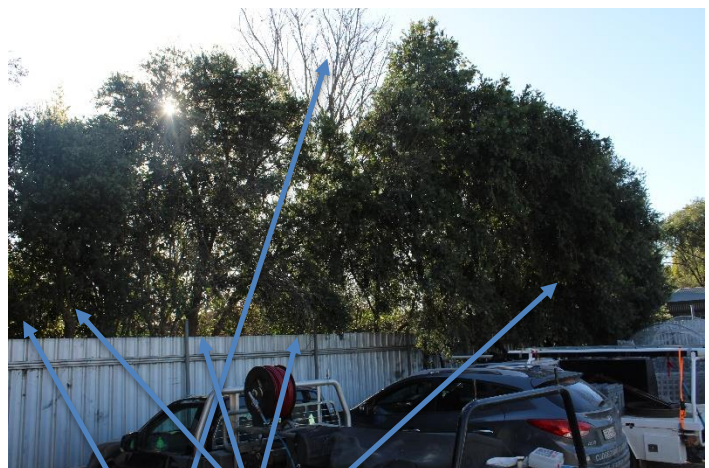
Tree 10, 11, 12 & 13

12 x4	S32. 600 22° E149. 588 20 °	Callistemon <i>saligna</i>	10	40	4	Mature good condition in adjacent property	55	2.6	4.8	A2 HIGH	RETAIN minor pruning overhang. Tree protection required
13	S32. 600 16° E149. 588 20°	Callistemon <i>saligna</i>	8	30	4	Mature good condition in adjacent property	50	2.5	3.6	A2 HIGH	RETAIN minor pruning overhang. Tree protection required
14	S32. 600 05 ° E149. 588 67°	Liquid amber	10	40	12	Mature good condition in adjacent property opposite side of the lane.	70	2.8	4.8	A2 HIGH	RETAIN Tree protection required
