### Existing fire safety measures:

**Proposed Fire Safety measures:**

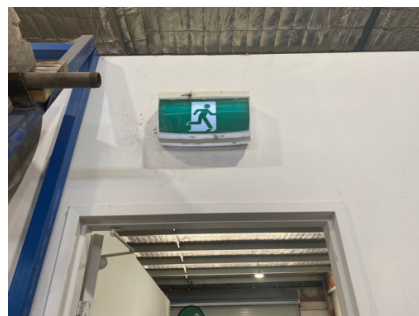
Tenancy 3.

(Southern side of internal wall within workshop area).

Exit signage in tenancy 1 is to be replaced with 'running man' signage. Exit sign currently situated on southern side of internal wall in tenancy 3 to be moved and erected on northern side of internal wall to be seen when entering building from front (to satisfy AS/NZS 2293.1-2018 & BCA NCC E4D5).

3. Exit sign in unit 3 that is approximately halfway into the tenancy needs to be moved to the other side of the wall, so it'll lead occupants out the rear required exit door.
