Geotechnical Investigation Report

Client: Mid-Western Regional Council

Site Address: 10-12 Burrundulla Avenue, Mudgee NSW

Our Reference: 40777-GR01_A

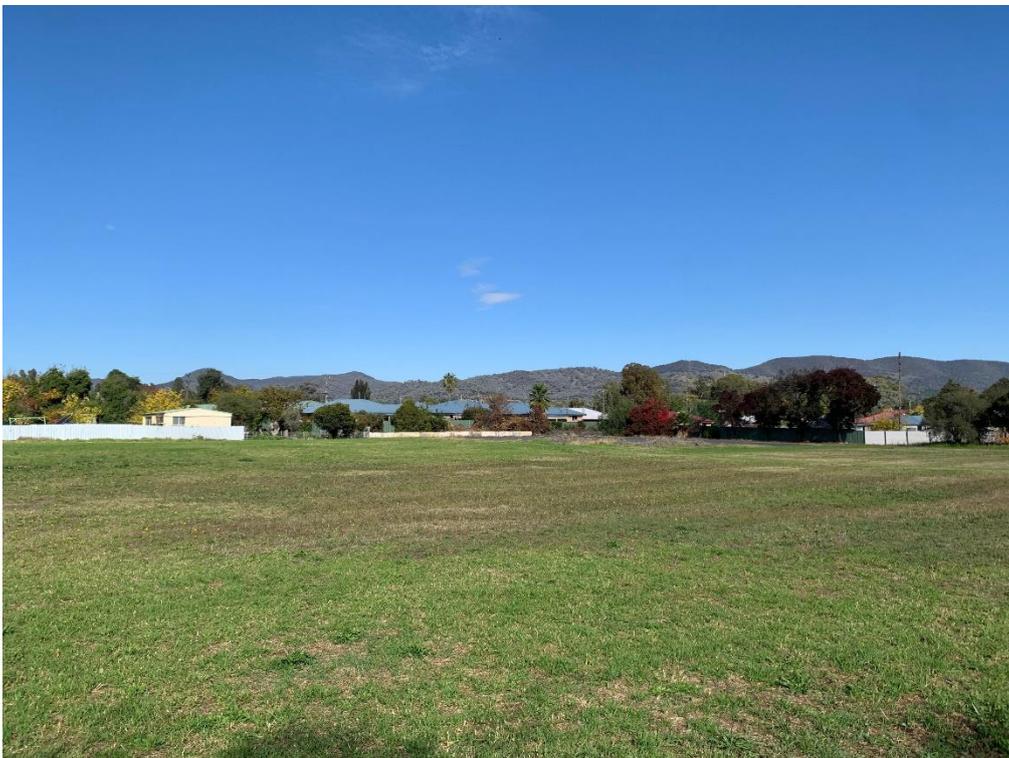
The site consists of moderate grass and weed cover. There are no trees onsite.

The site is undulating. There are existing residential properties surrounding the area.

Plate 2 – General view of site facing southwest.

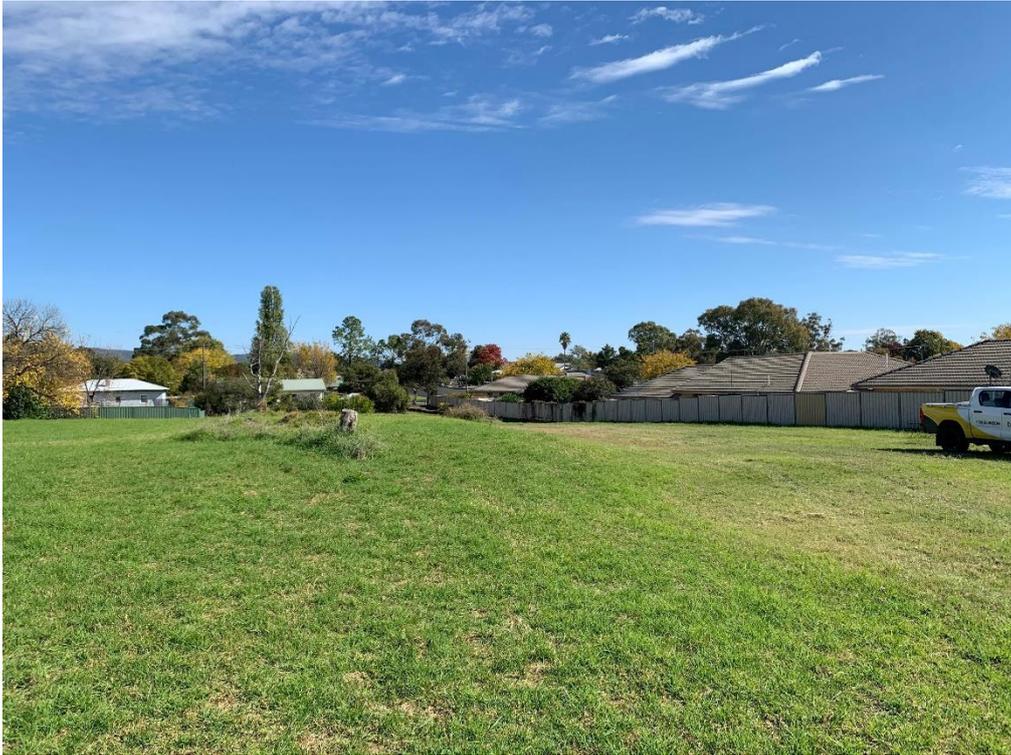
Plate 3 – General view of site facing west.

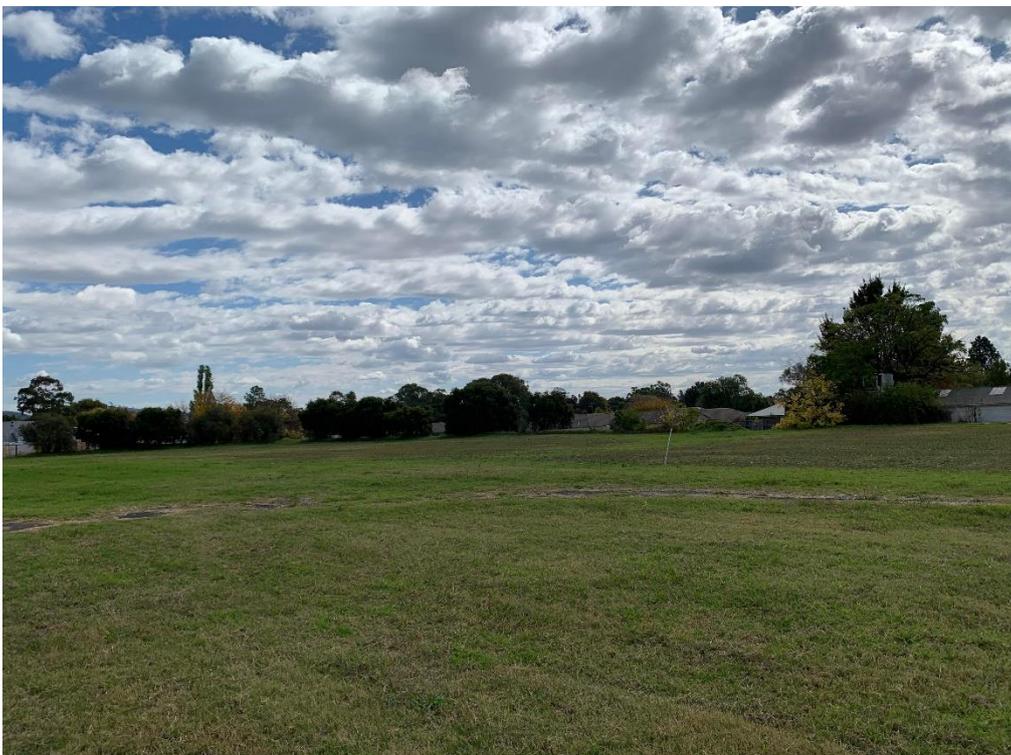
Plate 4 – General view of site facing north.

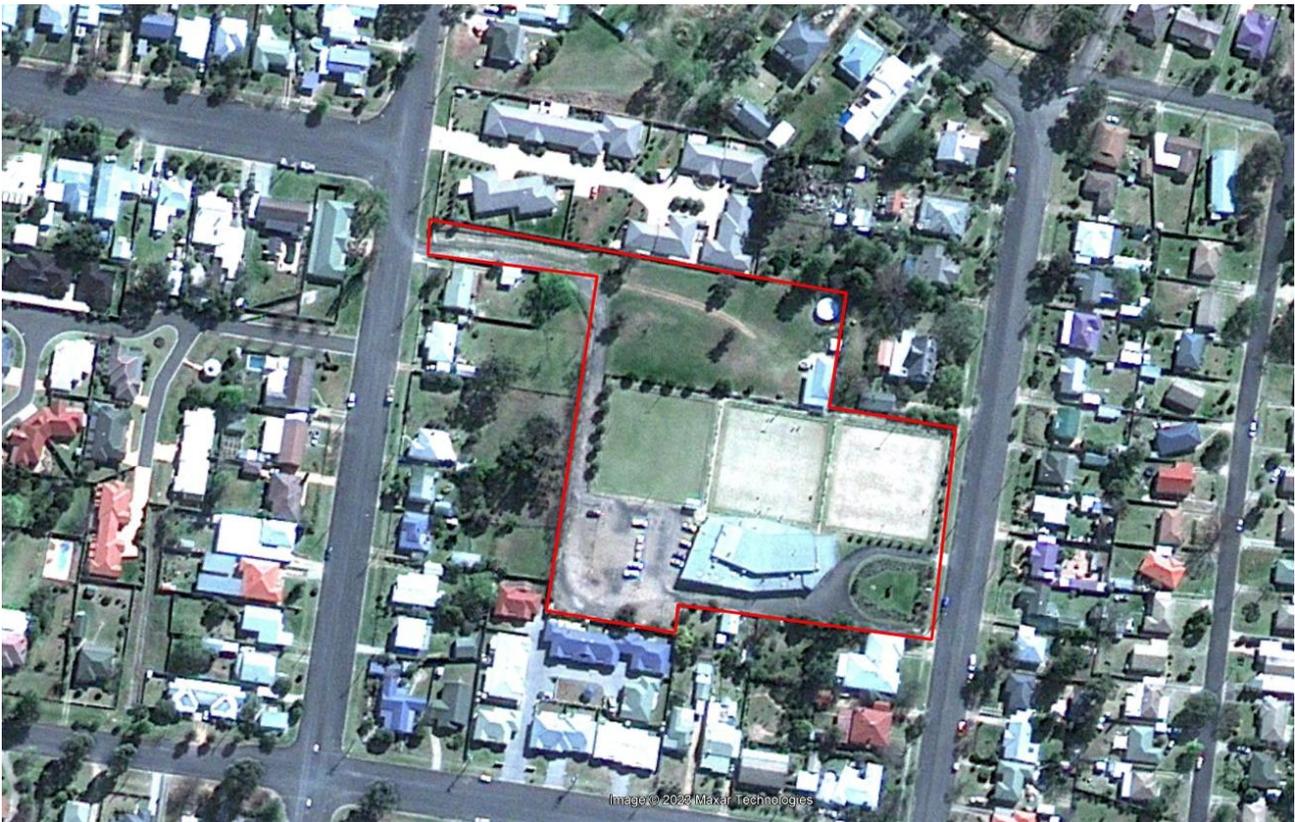
Plate 5 – Aerial Image 2009, Courtesy Google Earth.

A review of Google Earth imagery of the site indicates that a bowling club with lawn bowling greens, carparking and large trees had existed on the site since before an image taken in 2009. Images exist back to 1985, yet the image is not clear enough to determine what was on the site. The Club building is expected to have been constructed well before 2009. Some of the trees have been removed from site but there is no evidence that the excavation was backfilled with natural material and reinstated in layers to a minimum of 95% Standard Maximum Dry Density. See 2009 aerial image below:

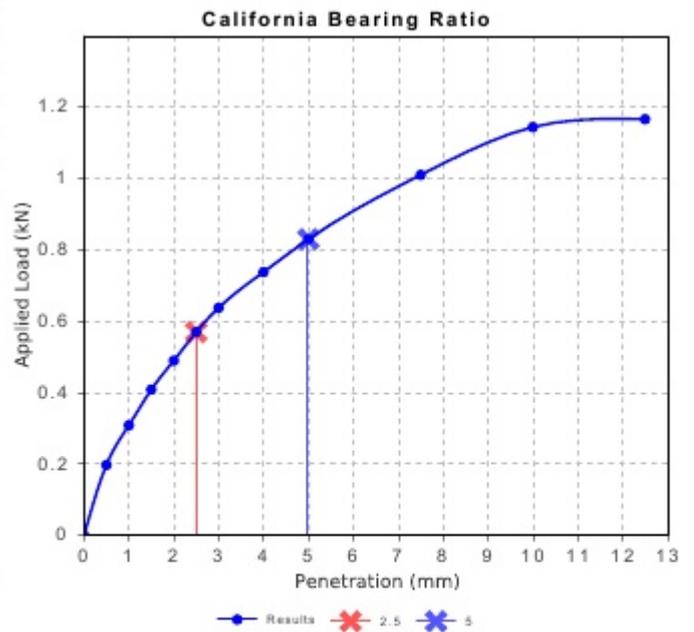
California Bearing Ratio (AS 1289 6.1.1 & 2.1.1)		Min	Max
CBR taken at	2.5 mm		
CBR %	4.5		
Method of Compactive Effort	Standard		
Method used to Determine MDD	AS 1289 5.1.1 & 2.1.1		
Method used to Determine Plasticity	Visual		
Maximum Dry Density (t/m^3)	1.83		
Optimum Moisture Content (%)	13.0		
Laboratory Density Ratio (%)	95.0		
Laboratory Moisture Ratio (%)	98.5		
Moisture Content at Placement (%)	12.8		
Moisture Content Top 30mm (%)	15.8		
Mass Surcharge (kg)	4.5		
Soaking Period (days)	4		
Curing Hours	222.3		
Oversize Material (mm)	19		
Oversize Material Included	Excluded		
Oversize Material (%)	0.0

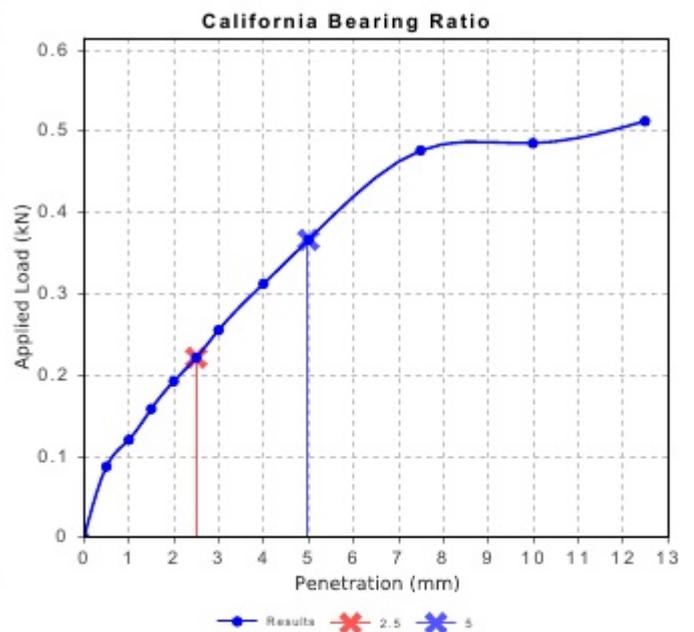
California Bearing Ratio (AS 1289 6.1.1 & 2.1.1)		Min	Max
CBR taken at	5 mm		
CBR %	2.0		
Method of Compactive Effort	Standard		
Method used to Determine MDD	AS 1289 5.1.1 & 2.1.1		
Method used to Determine Plasticity	Visual		
Maximum Dry Density (t/m^3)	1.81		
Optimum Moisture Content (%)	15.0		
Laboratory Density Ratio (%)	95.0		
Laboratory Moisture Ratio (%)	99.5		
Moisture Content at Placement (%)	15.0		
Moisture Content Top 30mm (%)	22.8		
Mass Surcharge (kg)	4.5		
Soaking Period (days)	4		
Curing Hours	220.4		
Oversize Material (mm)	19		
Oversize Material Included	Excluded		
Oversize Material (%)	0.0
