ACM VISUAL SURFACE SOILS CLEARANCE REPORT

Capstone Developments Pty Ltd – 127 Gladstone St Mudgee

Report: CLR1706R01

Date: 18/05/2024

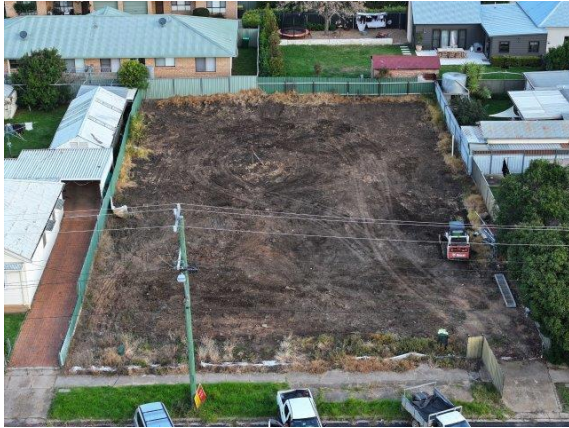
South aspect of the Gladstone St Site

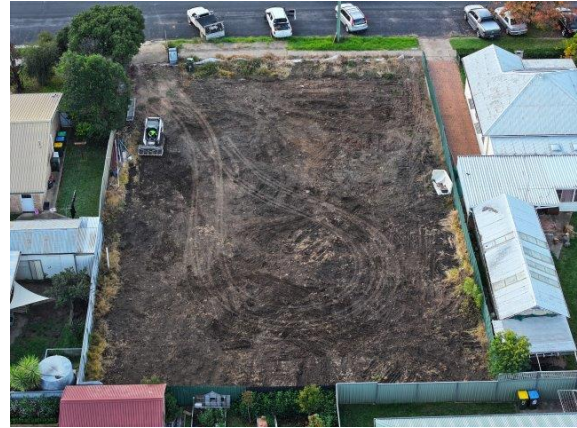
North aspect of the Gladstone St site

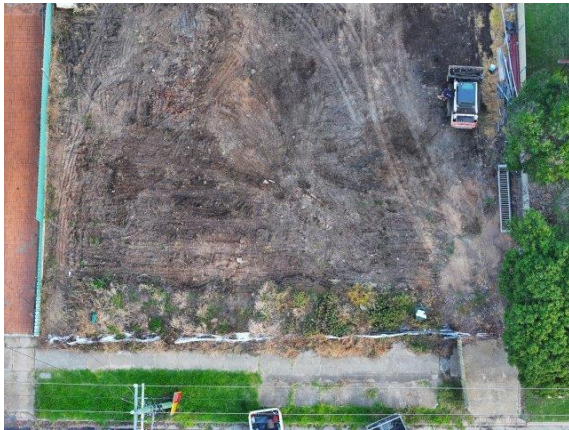
Grid locations 1, 2 & 3

No fibre cement sheet materials observed within the grid.

Two (2) pieces, approximately 12cm², of fibre cement sheet debris observed and removed from the grid.

Garbage waste bin containing Synthetic Mineral Fibre (SMF) insulation.

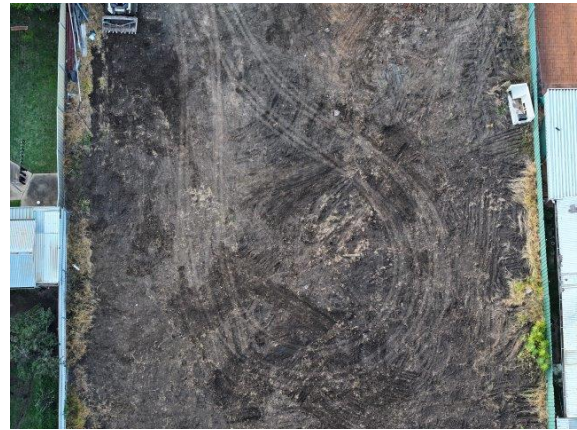
Grid locations 4, 5 & 6

No fibre cement sheet materials observed within the grid.

A fibreglass shower recess adjacent the eastern boundary fence. No fibre cement sheet materials were observed below the shower recess assembly.

Six (6) pieces, approximately 37cm², of fibre cement sheet debris observed and removed from the grid.

Three (3) pieces, approximately 14cm², of fibre cement materials observed and removed from the grid.

Portion of the site adjacent the western boundary fence approximately 15m², which currently harbours building materials in the form of timber, metals – various and PVC.

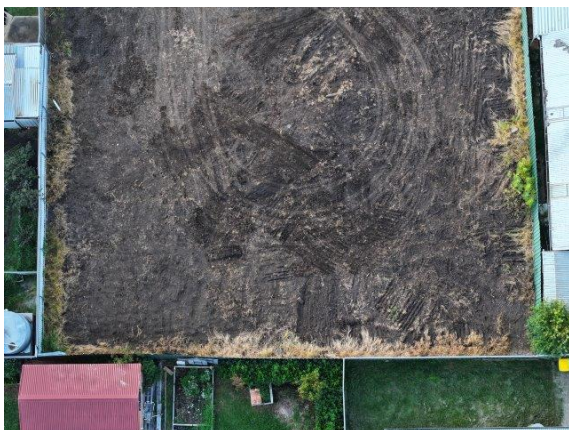
Grid locations 7, 8 & 9

No fibre cement sheet materials observed within the grid.

Two (2) pieces, approximately 36cm², of fibre cement sheet debris observed and removed from the grid.

Eight (8) pieces, approximately 28cm², of fibre cement sheet debris observed and removed from the grid.

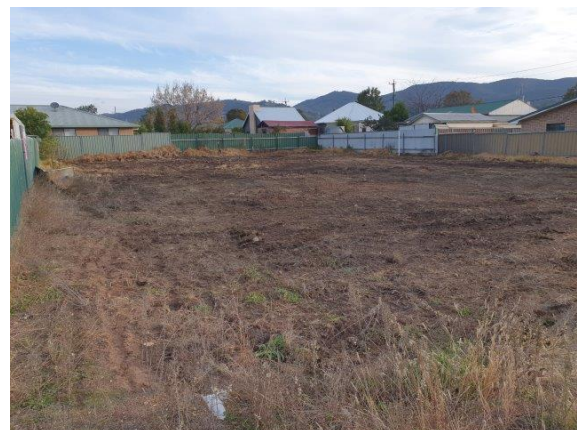
Southwest aspect of remediation area

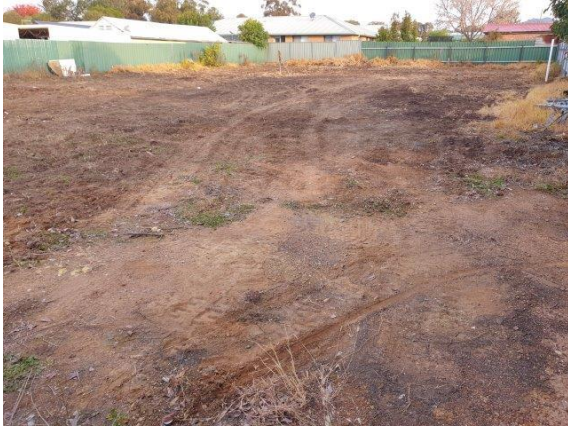
Southeast aspect of remediation area

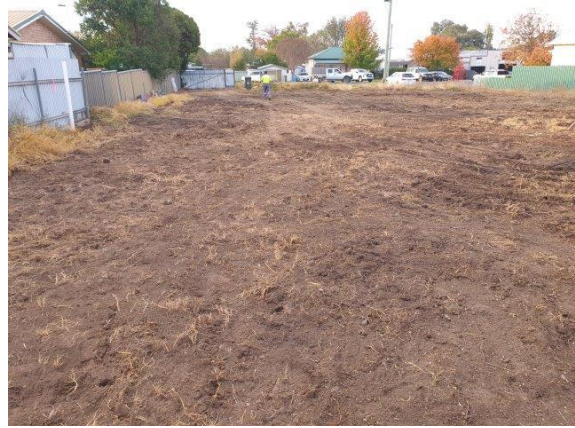
North aspect adjacent the western boundary fence

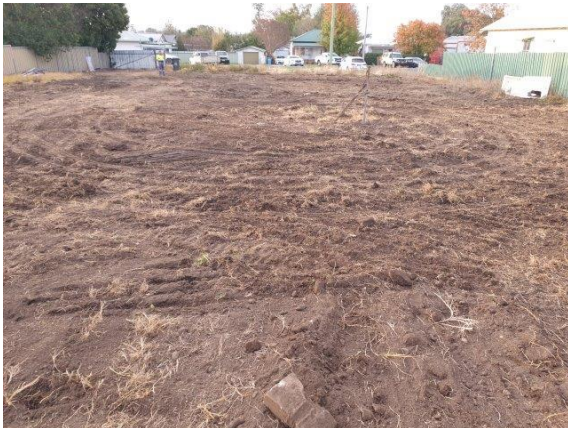
North aspect central portion of the remediation area

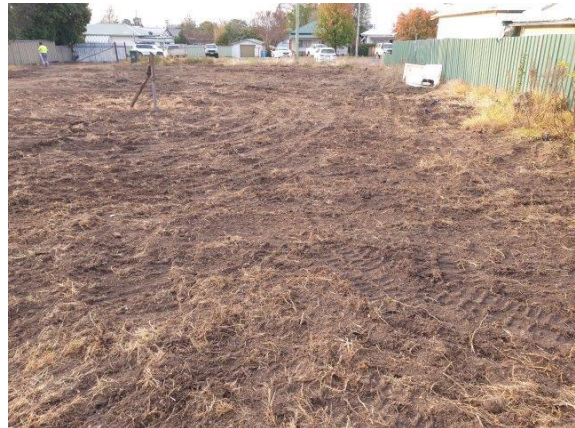
North aspect adjacent the eastern boundary fence

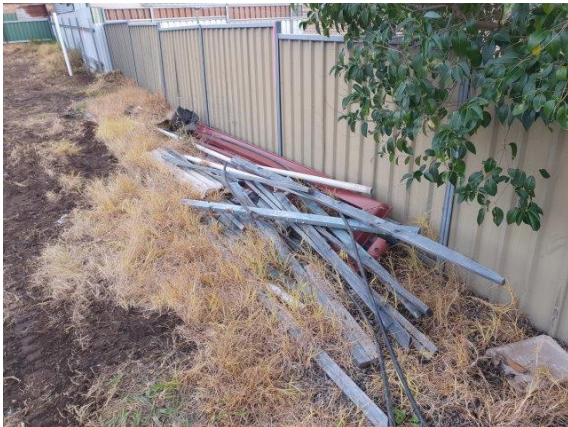
- Sub-soil areas
- Portion of the site adjacent the western boundary fence approximately 15m², Grid 6, which currently harbours building materials in the form of timber, metals – various and PVC. These building materials blanket the area and obscure any visible assessment of the underlying soils surface.

Excluded area containing building materials stockpile
