# Mid Western Regional Council

## Report for Redbank Creek Dam Alternative Stabilisation Works

May 2010

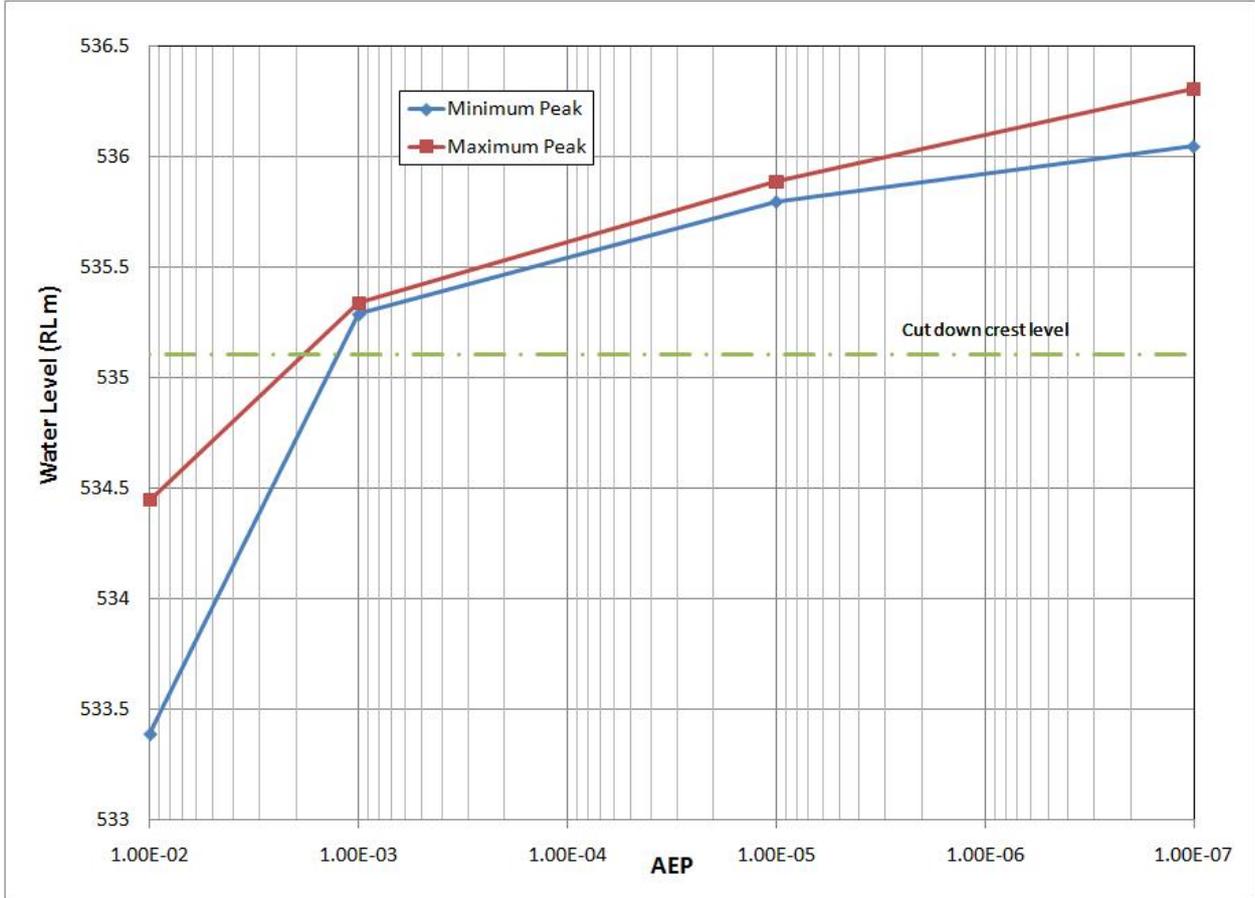
**Figure 7 Redbank Creek Dam Water Level Annual Exceedance Probability**

Note: The above graph indicates the upper and lower envelope for flood inflows with various storm durations. It may be seen that the dam overtops at floods with a return period of about 1:950 years.

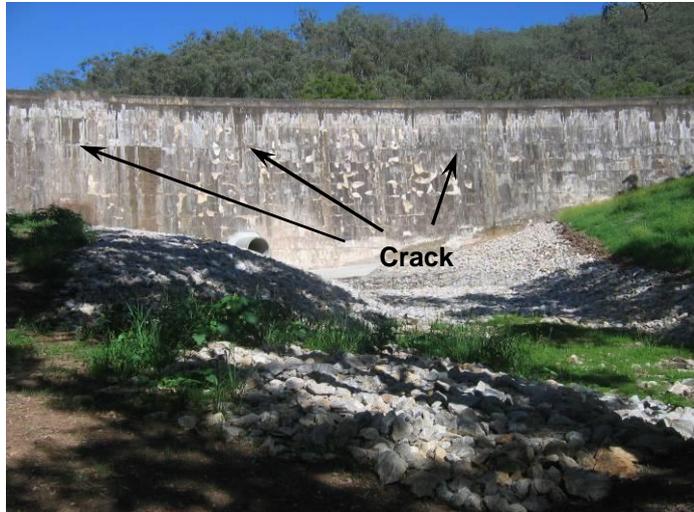
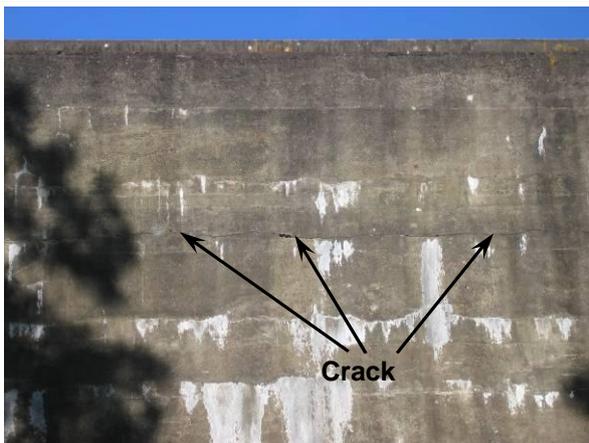
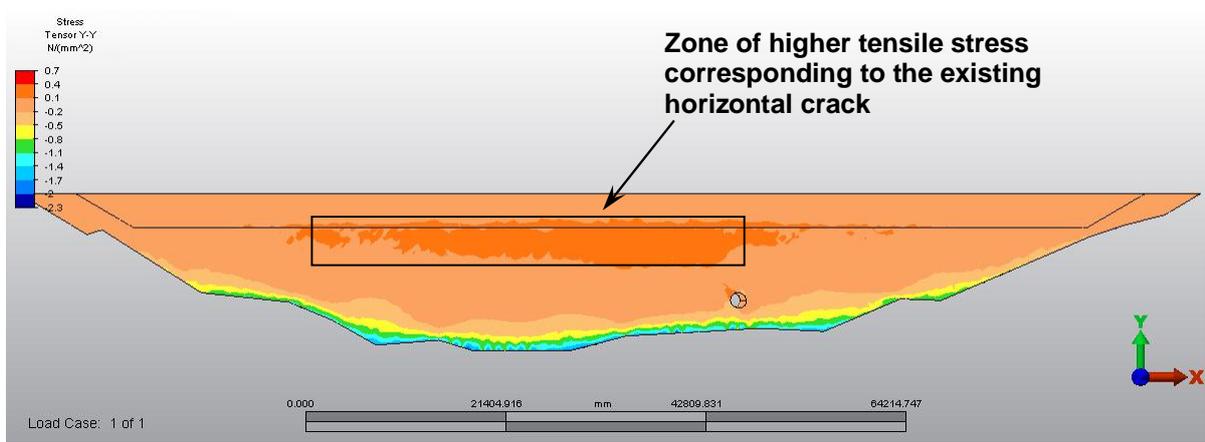
**Figure 13 Redbank Creek Dam Horizontal Crack**

The analyses included the effect of the horizontal cracks located at about 3m below the present crest level. It was found that the crack had a marginal effect on the stress distribution and insignificant effect on the sliding factor of safety of the dam.

The results of the analyses confirmed the 1995 assessment that the dam does not satisfy current acceptable safety criteria in terms of sliding. The earlier assessment did not incorporate the existing vertical cracks and the horizontal downstream crack, which would further destabilise the arch.

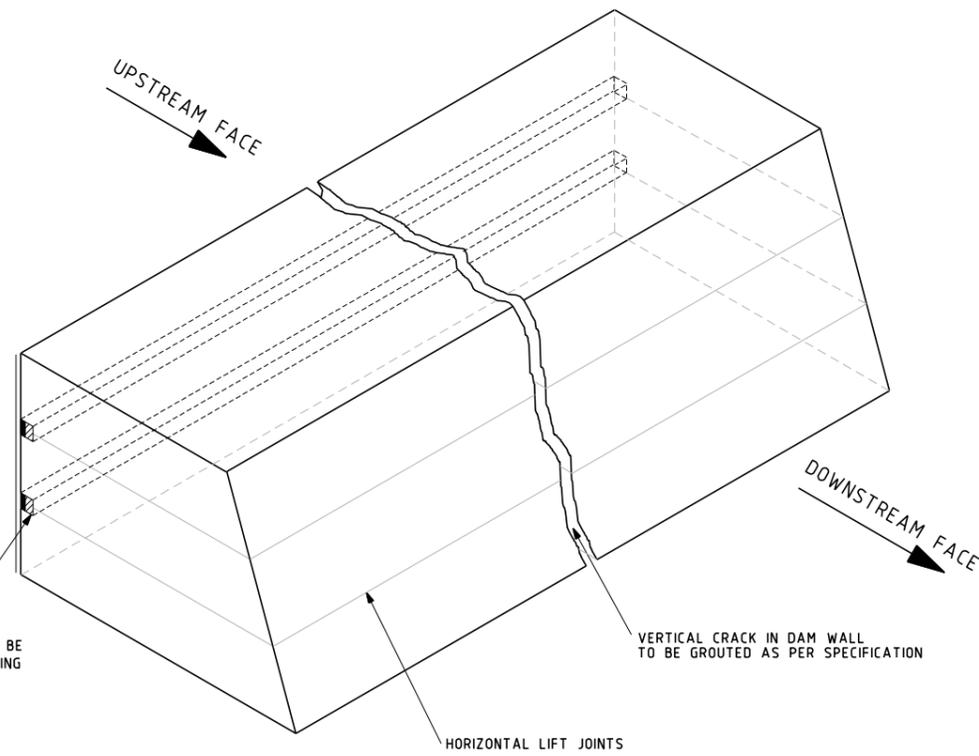
ISOMETRIC SKETCH OF DAM SECTION SHOWING  
VERTICAL CRACK & HORIZONTAL LIFT JOINTS  
NOT TO SCALE

However, this estimate does not make any direct allowance for continuous un-bonded construction joints and cracks. Redbank Creek Dam has a number of cracks which are believed to pass through the dam, principally along the construction joints. A predominant horizontal crack is located approximately 3.7 m below the existing non-overspill crest level. This horizontal crack is within close proximity to a horizontal
