Residential Site Investigation Report

47 Roberts Road, Grattai NSW

(Our Reference:37664-GR01_A)
© Barnson Pty Ltd 2021. Confidential.

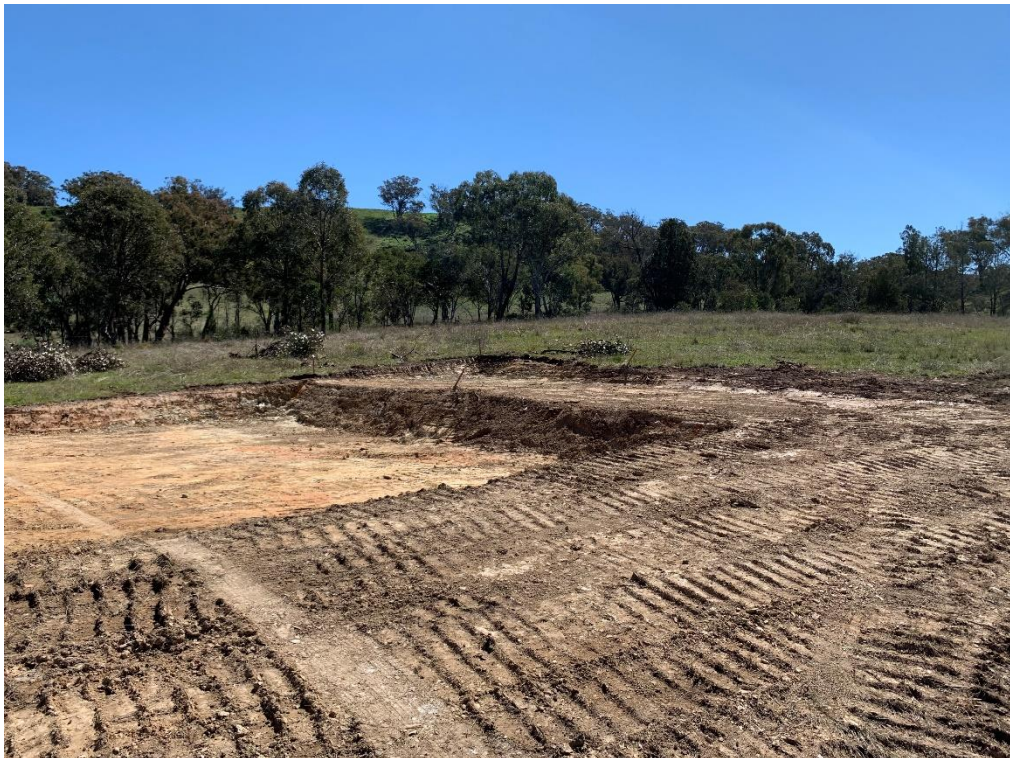
Plate 1 – Northwest facing view.

The site consists of moderately scattered grass & weed cover with mature trees outside the proposed building location.

The site is sloping slightly to the east. The block consists of cut and fill pad for the proposed dwelling with existing rural farmland and grazing land surrounding the area.
