Residential Site Investigation Report

Site Address: 361 Old Grattai Road, Erudgere NSW 2850

Project Name:	361 Old Grattai Road, Erudgere NSW 2850
Client:	Kate Hammill Stone
Project No.	36162
Report Reference	36162-GR01_A
Date:	30.07.2021
Revision:	Revision A

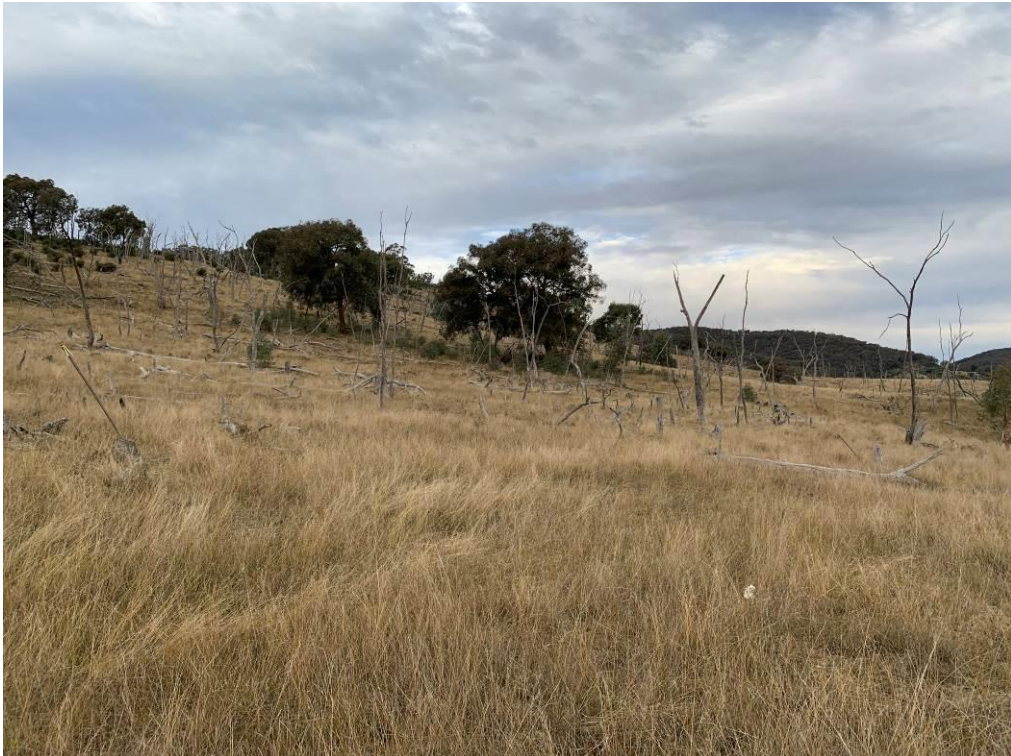
Plate 1 – South facing view.

The site is sloping heavily to the west. The block has existing rural farmland surrounding the area.

Any trees noted to be within the building zone, should be removed and the excavation remaining should be backfilled with natural material and reinstated in layers to a minimum of 95% Standard Maximum Dry Density.
