# Residential Site Investigation Report

Site Address: 361 Old Grattai Road, Erudgere NSW 2850

(Our Reference: 36162-GR02\_A)

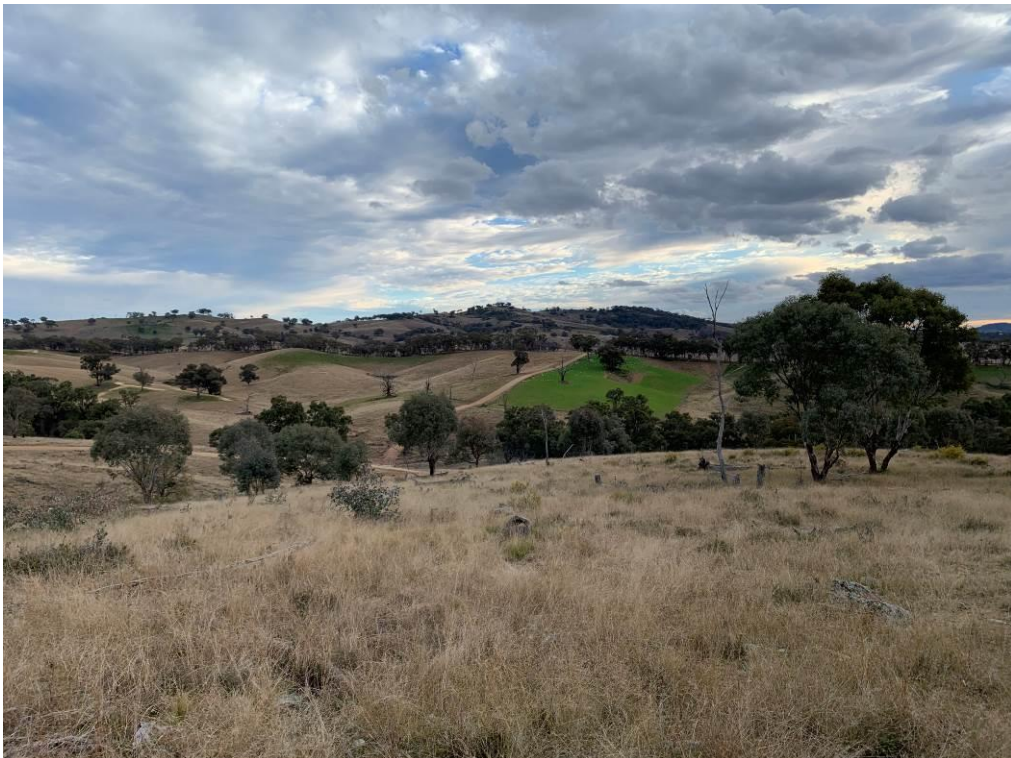
Plate 1 – Northwest facing view.

The site consists of light scattered grass and weed cover with mature trees scattered over the site.

The site is sloping heavily to the west. The block has existing rural farmland surrounding the area.

Any trees noted to be within the building zone, should be removed and the excavation remaining should be backfilled with natural material and reinstated in layers to a minimum of 95% Standard Maximum Dry Density.

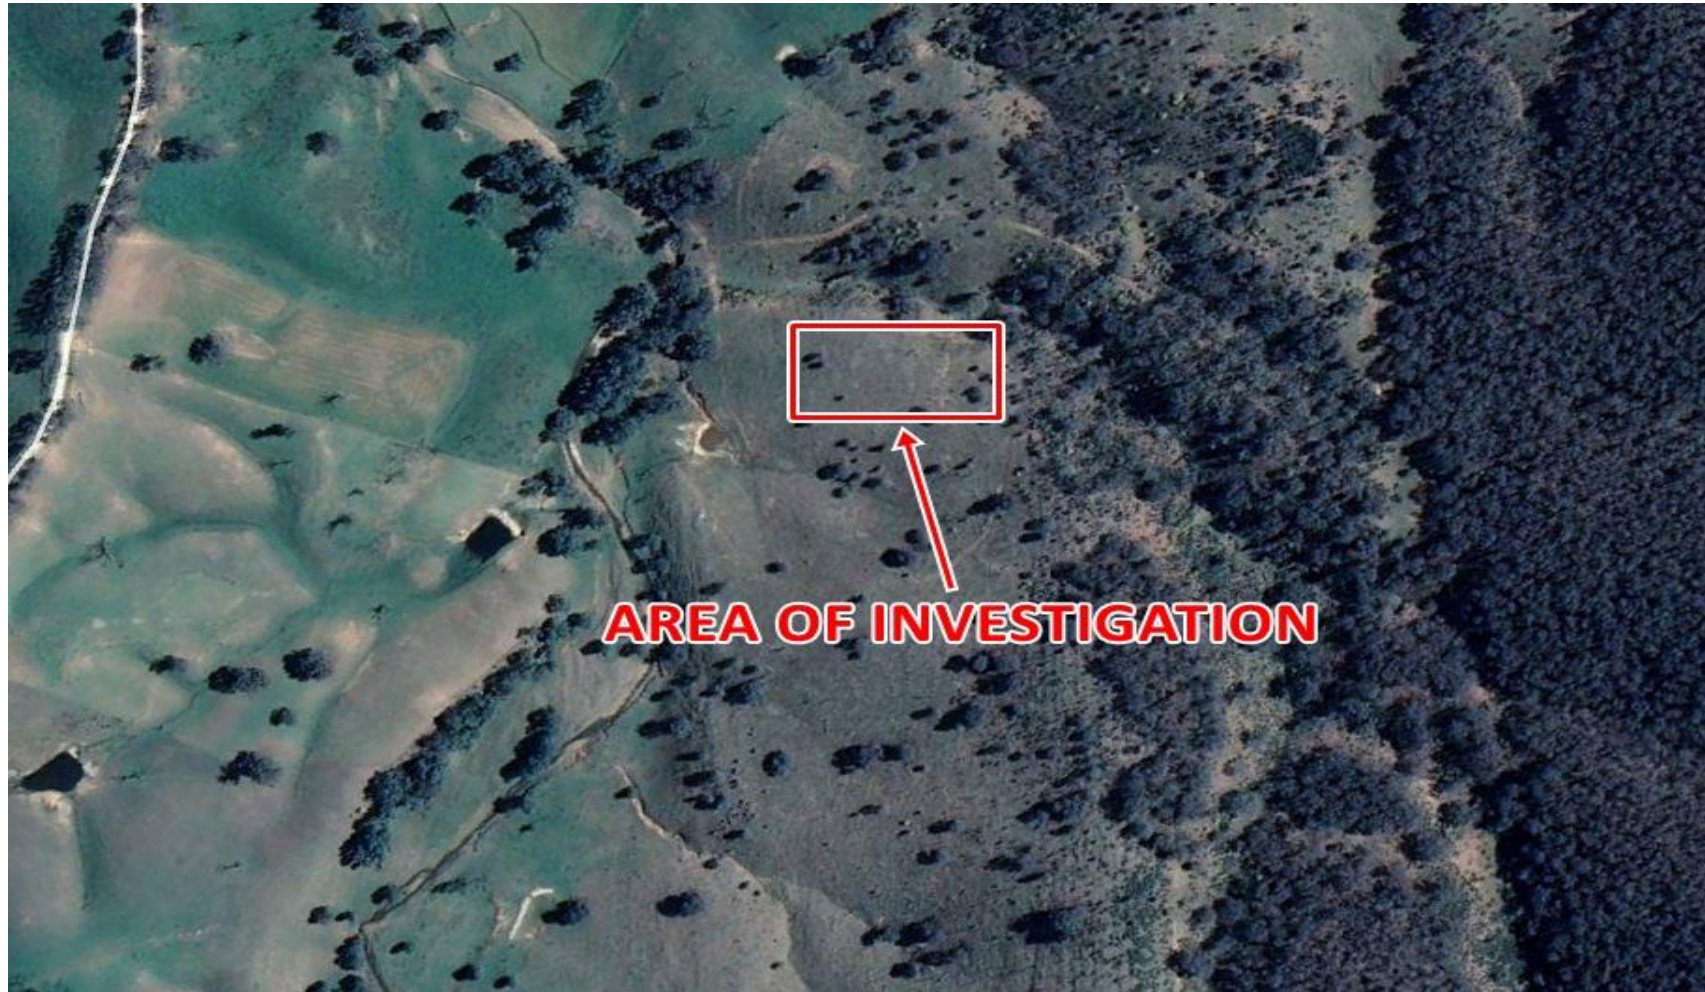
Plate 2 – Area of Investigation.

The site has mature trees scattered over the area which will cause abnormal soil moisture content. Due to this extraordinary site feature, it is our opinion that a *Site Classification of 'P'* should be adopted for the site in its present condition. The overall seasonal surface movement of the site in its present condition is noted above. The soil reactivity is advised to be 'M-D' classification. If the trees are at a minimum distance of their mature height from the buildings, the site classification is 'M-D class'.
