# Residential Site Investigation Report

5 Holleys Lane, Gulgong NSW

<b>Project Name:</b>	5 Holleys Lane, Gulgong NSW 2852
<b>Client:</b>	Mudgee Builder
<b>Project No.</b>	38088-GR01_A
<b>Report Reference</b>	38088
<b>Date:</b>	11.01.2022
<b>Revision:</b>	Revision A

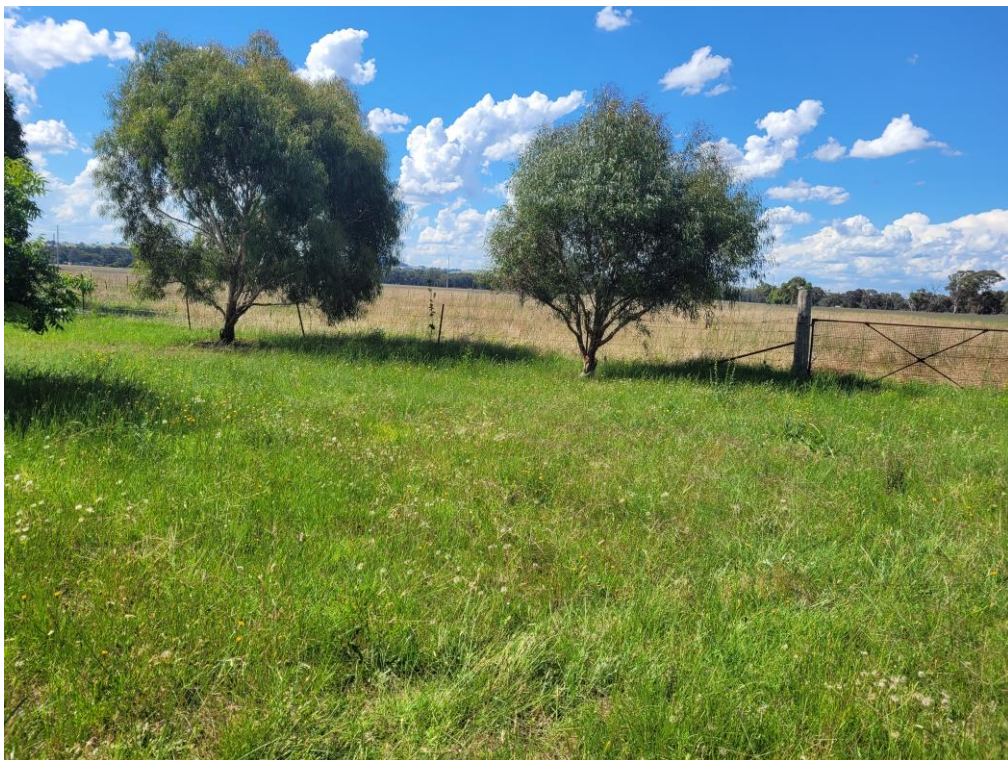
Plate 1 – West facing view.

The site is sloping slightly to the north west. The block has existing dwelling on block with rural farmland surrounding the area.

Any trees noted to be within the building zone, should be removed and the excavation remaining should be backfilled with natural material and reinstated in layers to a minimum of 95% Standard Maximum Dry Density.
