Residential Site Investigation Report

209 Mortimer Street, Mudgee
NSW

(Our Reference:39037-GR01_A)
© Barnson Pty Ltd 2022. Confidential.

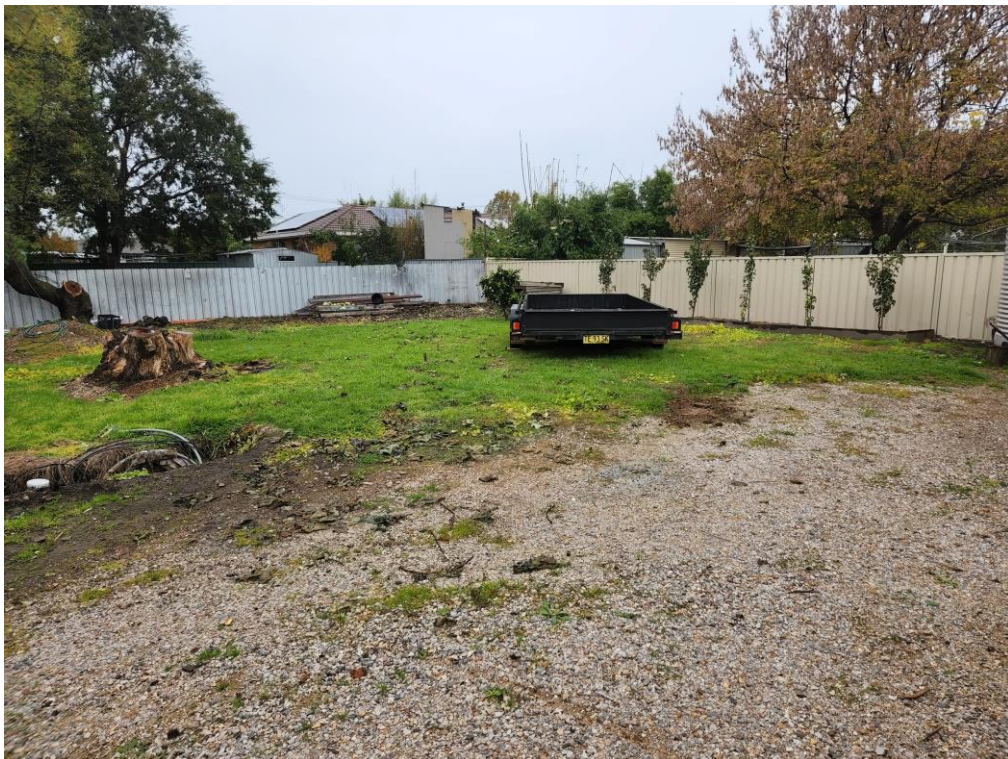
The site consists of light grass and weed cover with mature trees within the proposed building location.

The site is relatively flat. The block has existing buildings and established houses in the vicinity.

Plate 1 – South West facing view

*Any trees noted to be within the building zone, should be removed and the excavation remaining should be backfilled with natural material and reinstated in layers to a minimum of 95% Standard Maximum Dry Density
