## Residential Site Investigation Report

45 Nullo Mountain Road,  
Olinda NSW

(Our Reference:39173-GR01\_A)  
© Barnson Pty Ltd 2022. Confidential.

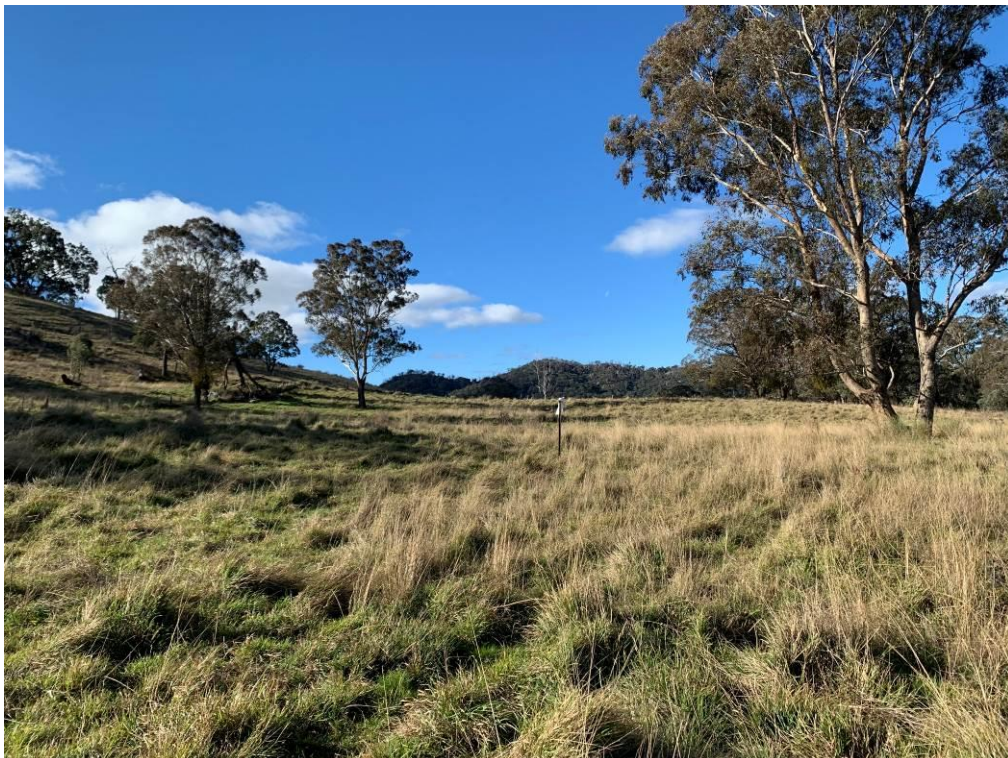
Plate 1 – North facing view

The site consists of light scattered grass and weed cover with mature trees outside the building location.

The site is sloping moderately to the south east. The block has existing dwelling on block with rural farmland surrounding the area.

Any trees noted to be within the building zone, should be removed and the excavation remaining should be backfilled with natural material and reinstated in layers to a minimum of 95% Standard Maximum Dry Density.
