Residential Site Investigation Report

Site Address: 569 Hill Road, Erudgere NSW 2850

(Our Reference: 36600-GR01_A)

Project Name:	569 Hill Road, Erudgere NSW 2850
Client:	Gerard Turrisi
Project No.	36600
Report Reference	36600-GR01_A
Date:	24.05.2021
Revision:	Revision A

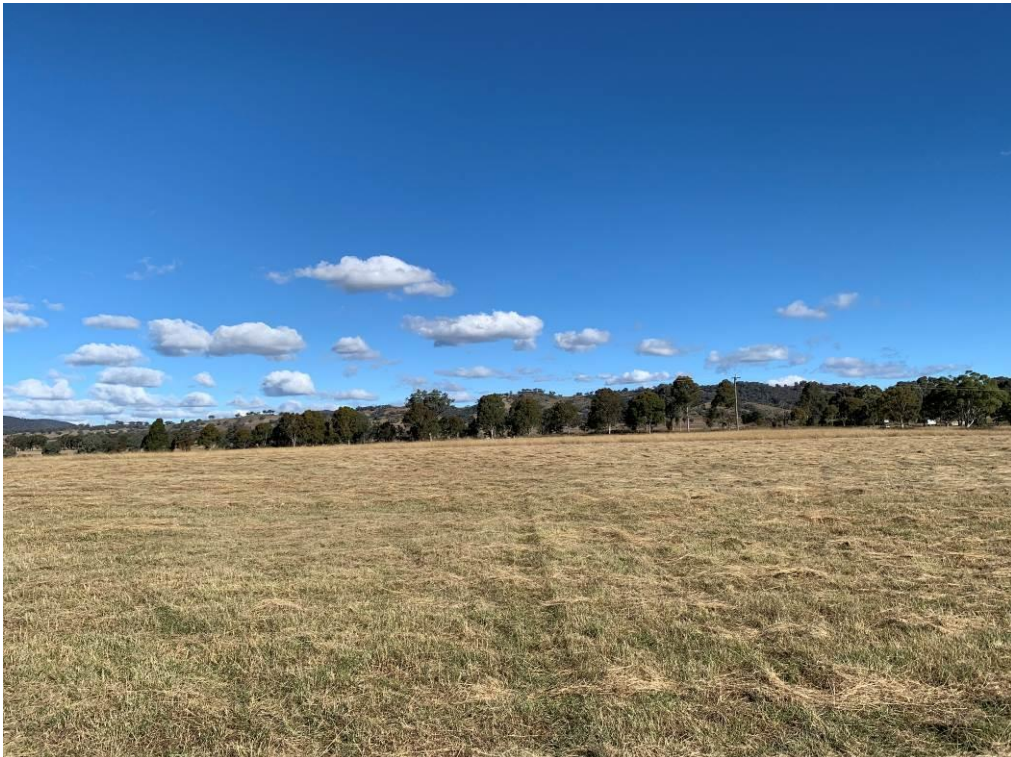
Plate 1 – Southwest facing view.

The site consists of light scattered grass and weed cover with no trees onsite.

The site is sloping slightly to the north east. The block has existing rural farmland surrounding the area.
