Geotechnical Investigation Report

Assessment Site: Rylstone Caravan Park, Rylstone NSW 2849

Client: Mid-Western Regional Council

Project Name:	Rylstone Caravan Park, Rylstone NSW 2849
Client:	Mid-Western Regional Council
Project No.	36407
Report Reference	36407-GR01_A
Date:	13.05.2021
Revision:	Revision A

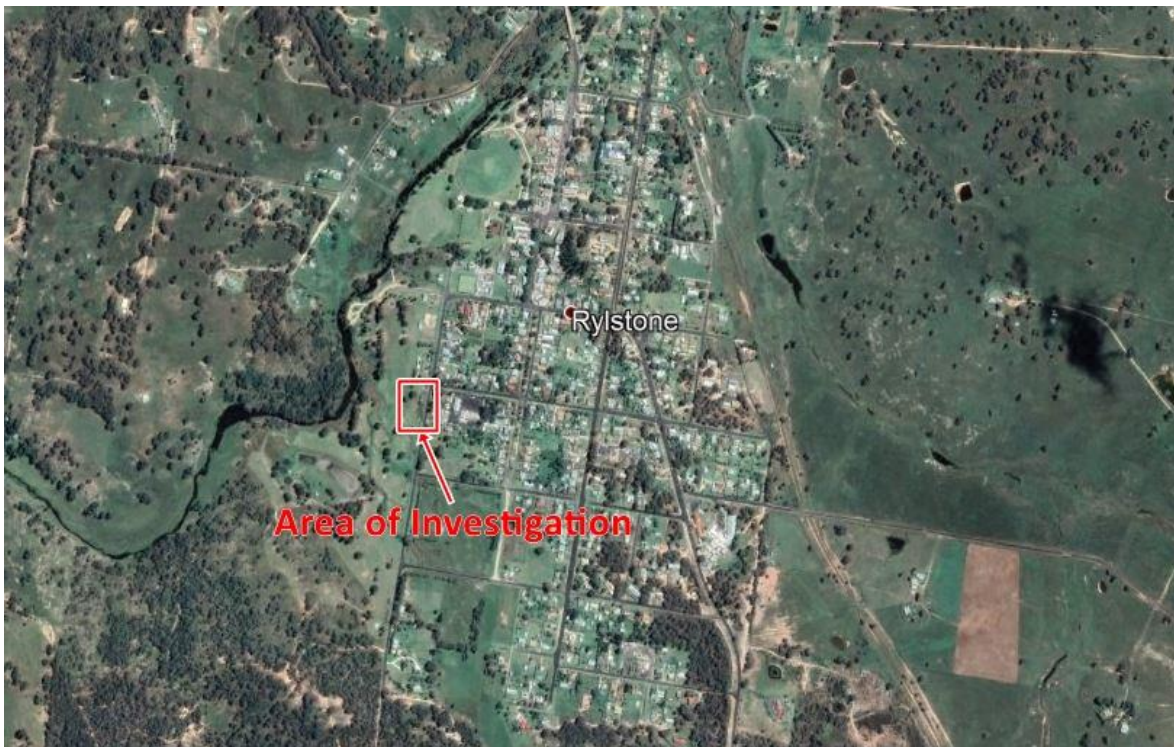
Plate 1 – Area of Investigation

Mid Western Regional Council is proposing to construct new amenities building and cabins at Rylstone Caravan Park, Rylstone NSW. The proposed site features that are covered by this investigation are as follows.

- Proposed New Amenities building.
- Proposed Cabins

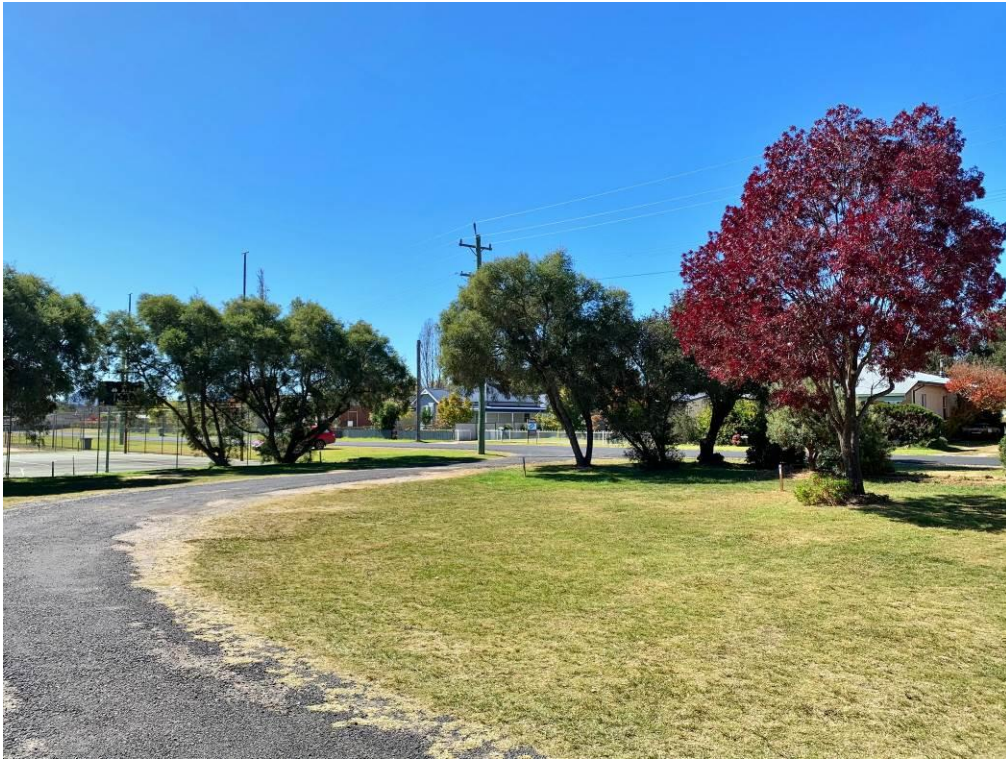
Plate 5 – View of borehole 4 facing northeast.

The site has mature trees scattered over the area which will cause abnormal soil moisture content and at borehole location 4 (BH4), the site was noted to have low bearing capacity of less than 100Kpa as is detailed in section 6.1. Thus, it is our opinion that a **Site Classification of 'P'** should be adopted for the site in its present condition. The soil reactivity indicates a M-D soil classification.

It is anticipated the footings for the proposed building will consist of a stiffened raft slab which can be designed in accordance with section 3 or 4 of AS2870-2011 for the tree affected expected ground movement as indicated in section 4.5 above. The design bearing capacity at depths of 500mm can be taken as 80kPa. This is suitable for support of raft slabs, yet not for pad footings or strip footings, which would need to be founded at a depth of 1.5m at borehole 4 location and 1.0m at other locations.
