Residential Site Investigation Report

Site Address: "Mudgee Pound" Blain Road, Mudgee NSW 2850

Client: Mid-Western Regional Council, P.O. Box 156, Mudgee NSW 2850

(Our Reference: 36406-GR01_A)

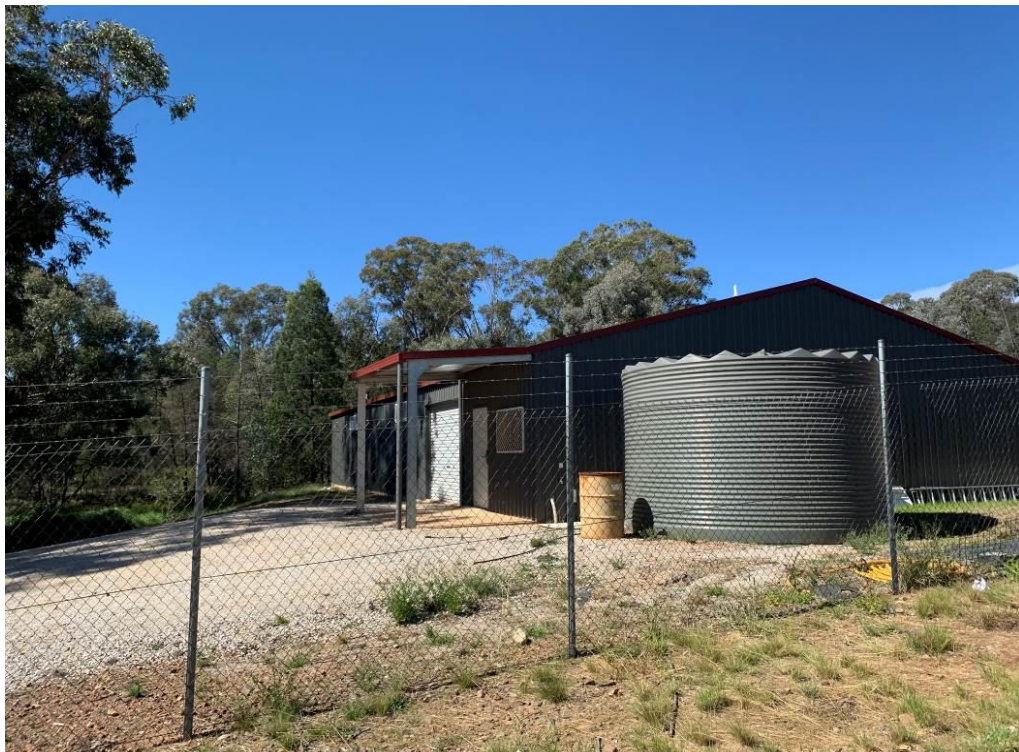
Plate 1 – East facing view.

The site consists of light scattered grass and weed cover with no trees onsite.

The site is sloping moderately to the north. The block has Mid- Western Community Recycling Centre and its associated infrastructures in the vicinity.
