AS2870-2011 SITE CLASSIFICATION

Lot 922 Proposed Road
Mudgee NSW

AS2870 Site Classification

Class P

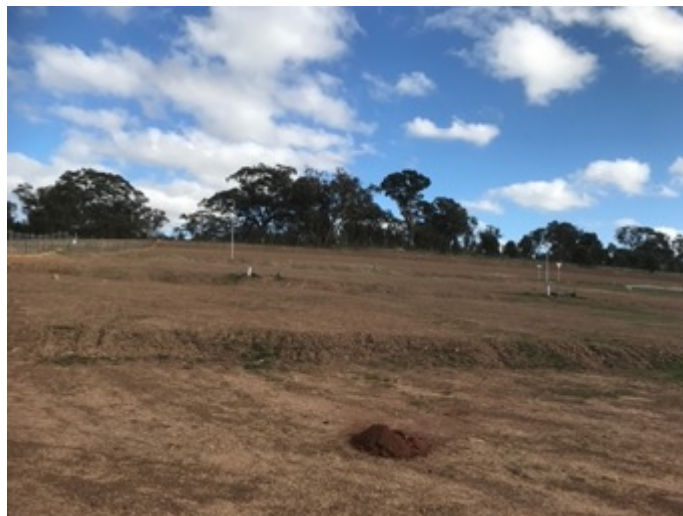
SITE PHOTO:

Site Features:	Vacant Site with grass
Site Drainage:	Fair (At time of testing)
Ground Slope	Slight to Gentle
Water Table/Seepage:	Not present
Fill:	Yes (uncontrolled)
Rock:	Yes
