APPENDIX 1:

OPERATIONAL & MANAGEMENT DETAILS: **BUSINESS ACTIVITY:**

APPENDIX 2:

Existing fire safety measures:

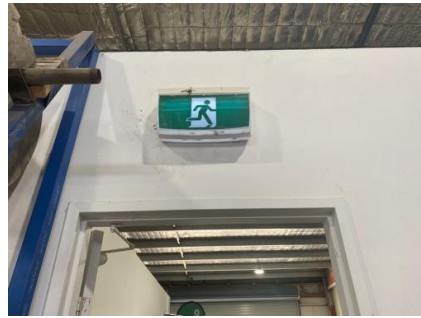
Tenancy 3.

(Southern side of internal wall within workshop area).

2. Portable fire extinguishers to be installed at nominated locations within the tenancies (rear exit doors and front doors).
3. Exit signage in tenancy 1 is to be replaced with 'running man' signage. Exit signage repairs will be carried out to those signs that do not currently illuminate.
Exit sign currently situated on southern side of internal wall in tenancy 3 to be moved and erected on northern side of internal wall to be seen when entering building from front.

3. Exit sign in unit 3 that is approximately halfway into the tenancy needs to be moved to the other side of the wall, so it'll lead occupants out the rear required exit door.
