# Geotechnical Site Investigation Report

41D Robert Hoddle Grove,  
Bombira NSW

(Our Reference:37522-GR01\_A)  
© Barnson Pty Ltd 2022. Confidential.

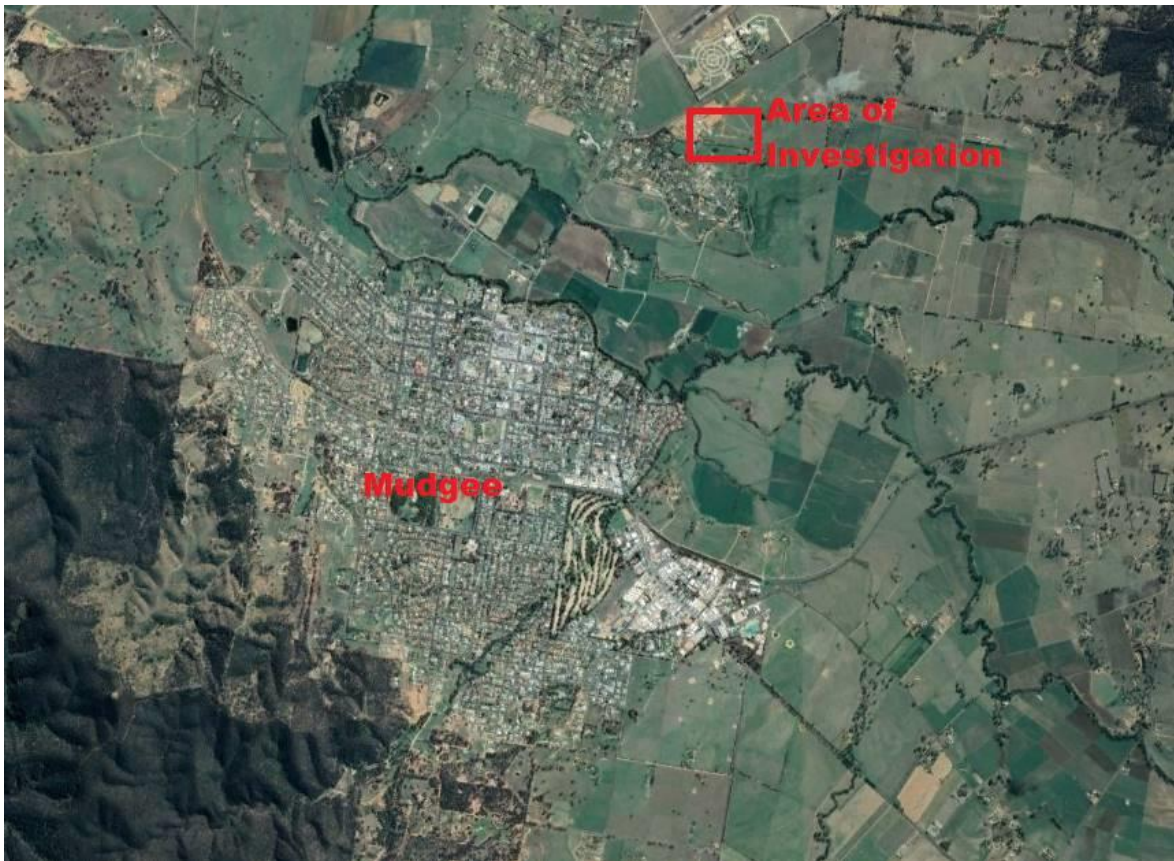
Plate 1 – Proposed Development Area

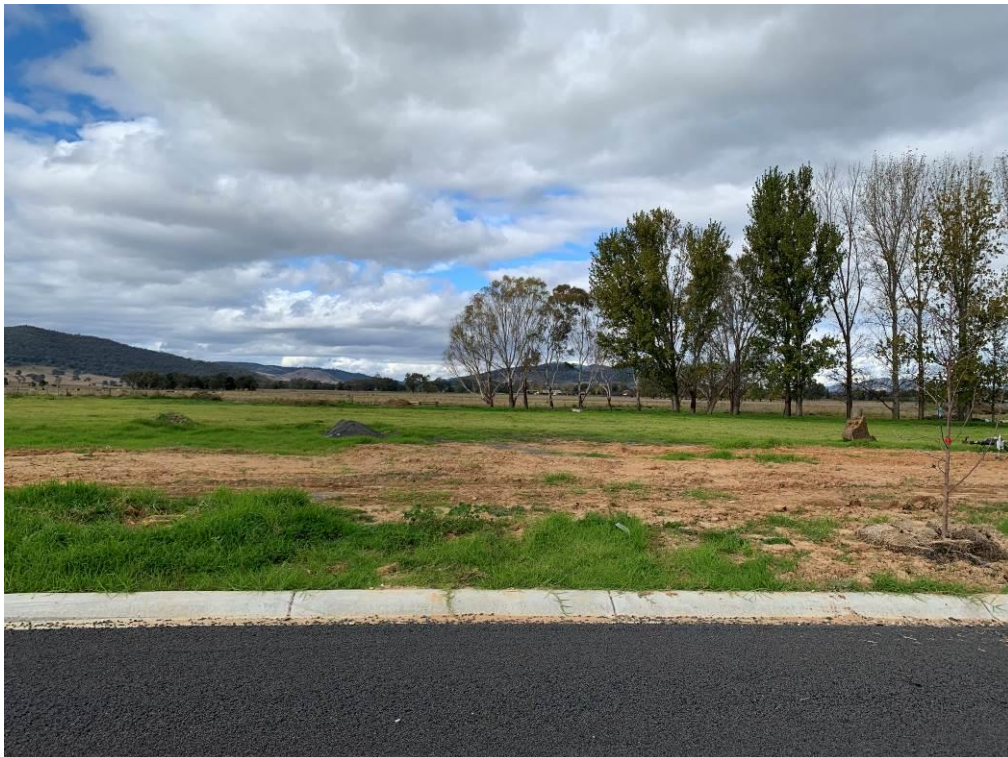
Plate 2 – General view of site facing east.

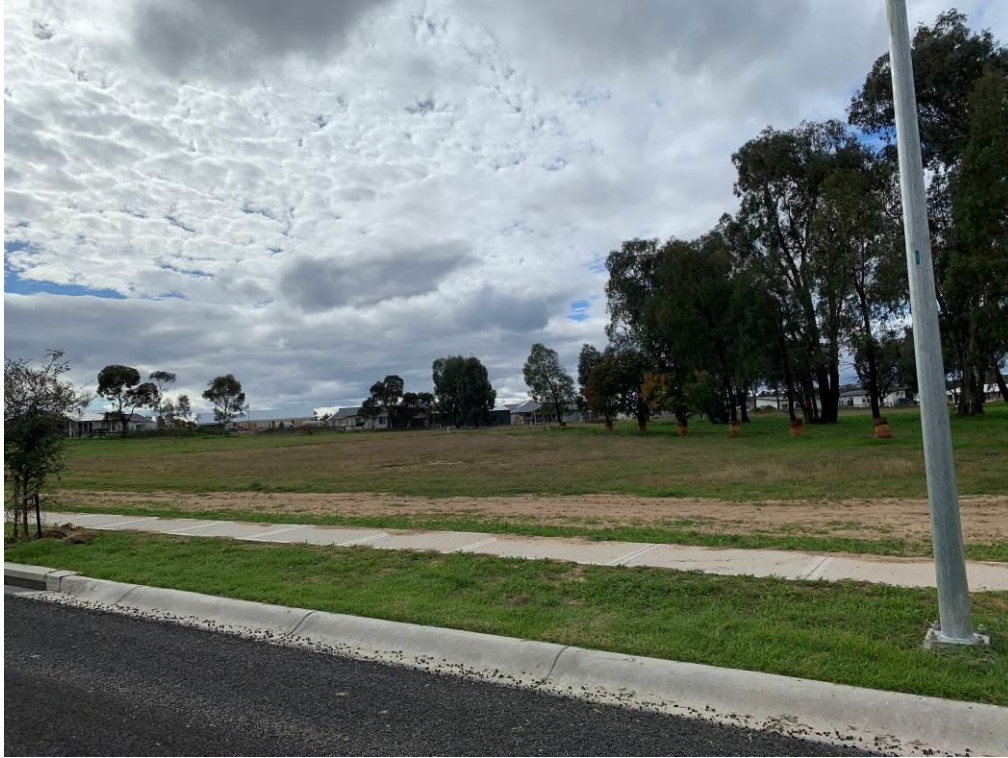
Plate 3 – General view of site facing North.

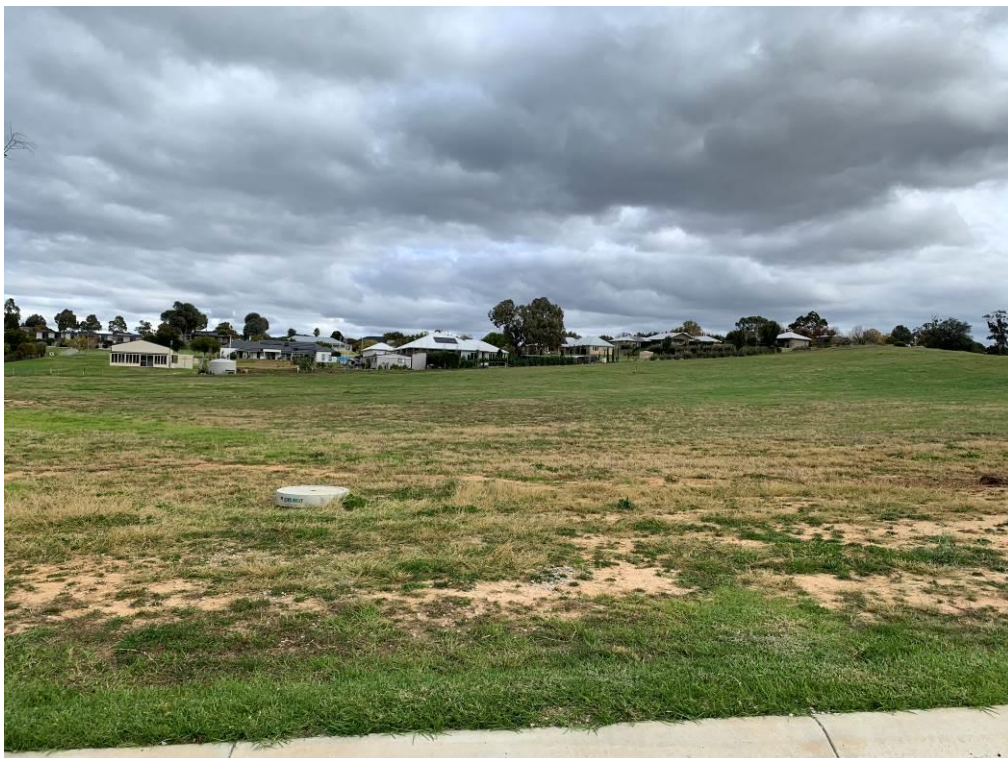
Plate 4 – General view of site facing South.
