Preliminary Site Contamination Assessment

Darthula 194 Hill End Road
Caerleon, NSW

(Our Reference:30336 ER01)

Project Name:	Preliminary Site Contamination Assessment Darthula 194 Hill End Road, Caerleon, NSW
Client:	Mr Peter Shearman
Project No.	30336
Report Reference	30336 ER01
Date:	8/06/2021
Revision:	Final

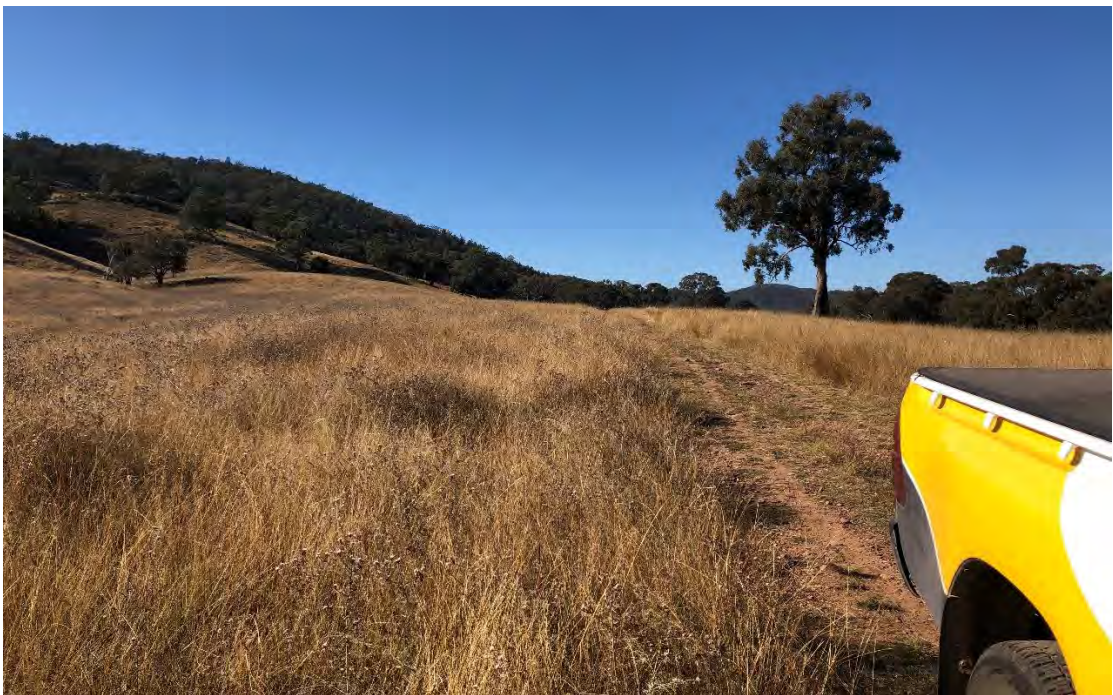
- The Subject Site is fenced and access to the site is controlled. There are several informal vehicle paths traversing the site and there are access gates and paths from all street frontages.
- At the time Barnson conducted the site inspection, most of the Subject Site was covered with pasture grass (see Figure 6.1). Both the eastern and western portions of the Site was attended by vehicle and all visible open ground and prominent features were inspected. No visible discoloration or staining of open ground or soil, and no obvious discoloration or irregularities in the occurrence of vegetation was observed during the site inspection.

Figure 6.1: Vegetation cover of Subject Site surface with informal vehicle track providing access.

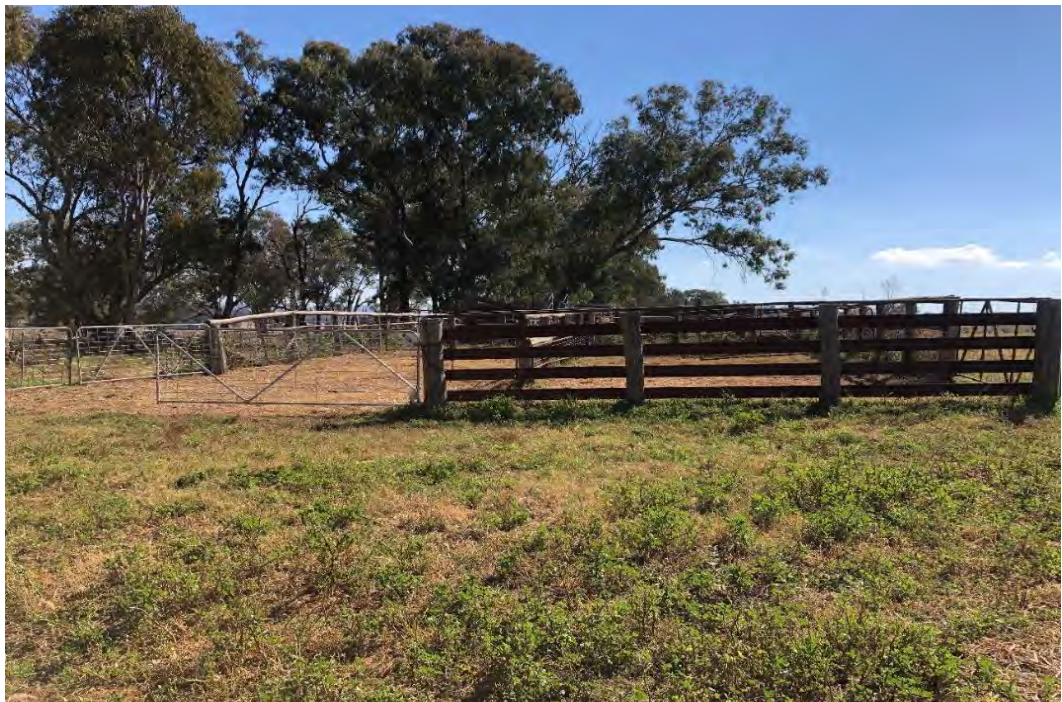
- There is a cattle yard, race and pens located on Lot 20 DP 756897 near the boundary with Gibson's lane (see Figure 6.5 and Figure 6.6).

Figure 6.5: Cattle pens.

Figure 6.6: Tables used during spraying and treatment of cattle.

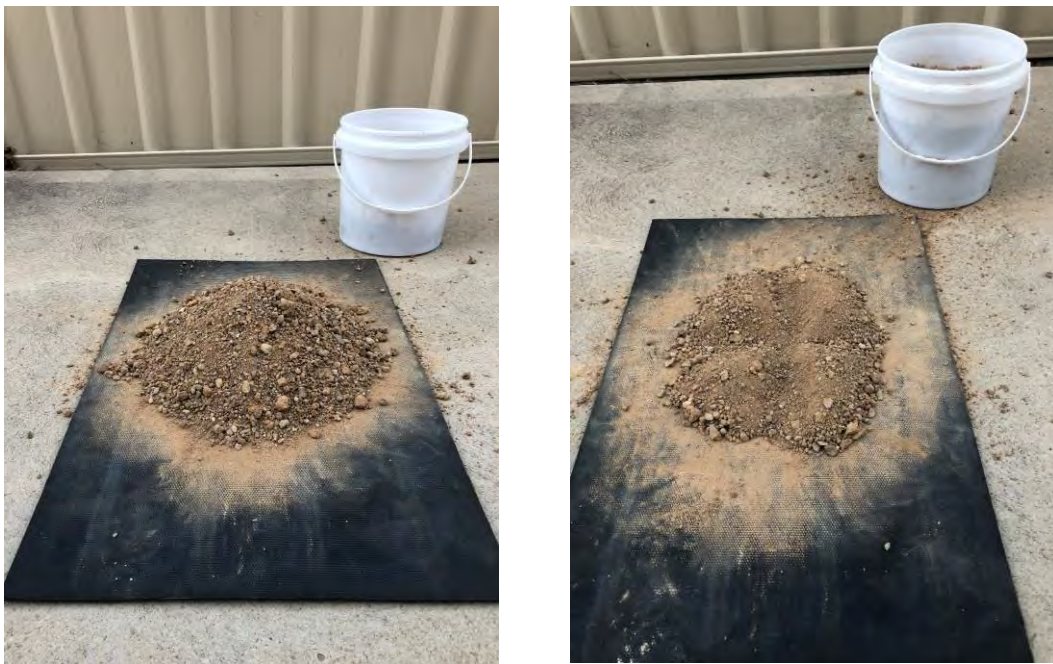
The individual sample increments collected were combined in a 5 litre bucket, as presented in Table 6.1, and transferred to the Barnson office in Mudgee for sub-sampling and laboratory submission. The volume of soil in each bucket was reduced by following a 'cone-and-quarter' technique. The increments in each bucket were thoroughly mixed by heaping into a cone and turning the cone over to form a new cone until the operation has been carried out three times. The heap is flattened and quartered along two diameters which intersect at a right angle in the centre of the cone (see Figure 6.12).

Figure 6.12: Cone and quartering.
