Preliminary Site Contamination Assessment

Darthula 194 Hill End Road
Caerleon, NSW

(Our Reference:30336 ER01)

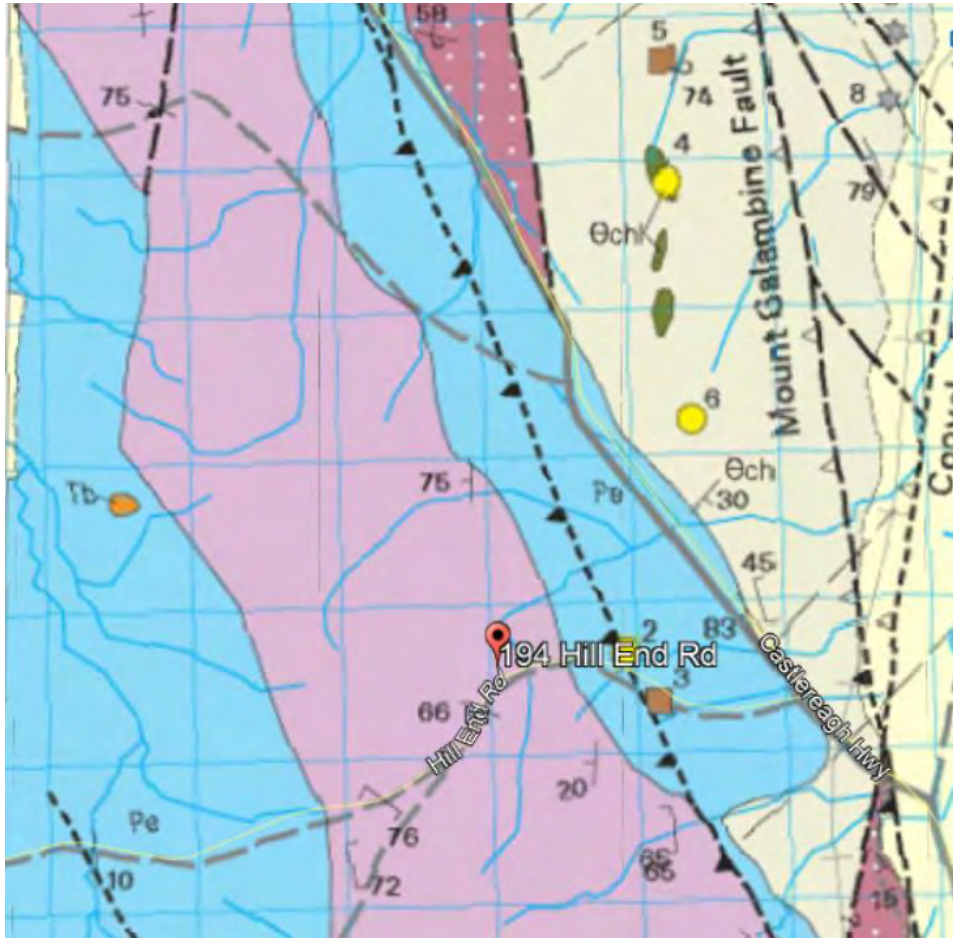
Figure 3.1: Mudgee 1:100000 geology map showing the location of the Subject Site

A review of the 1:1000000 Geology map of Mudgee (refer to Figure 3.1) shows that geologically, the Subject Site is underlain by Permean age units of siltstone, sandstone and conglomerate of the Gunnedah Basin, while the hill in the centre of the Site consists of later (Sularian age) quartz and feldspatic units of the Biraganbil Formation. Refer to Figure 3.1.

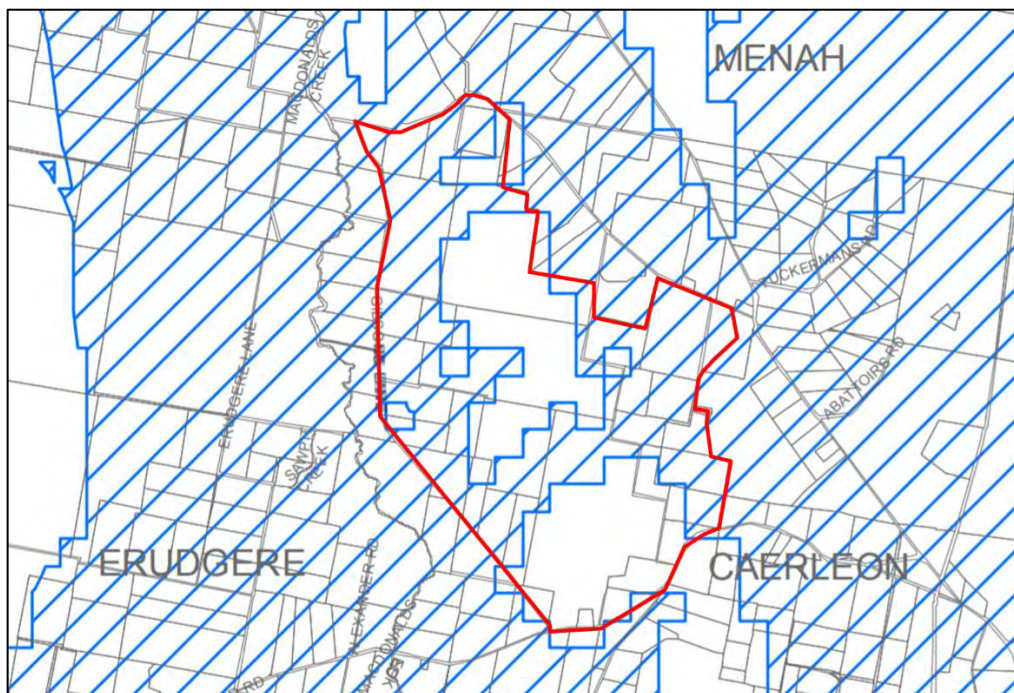
Figure 3.3: Mapped groundwater vulnerability around the Subject Site.

The Mid-Western Regional Council Local Environmental Plan (MWRC LEP, 2011) show the Subject Site inside a zone of groundwater vulnerability (Figure 3.3).

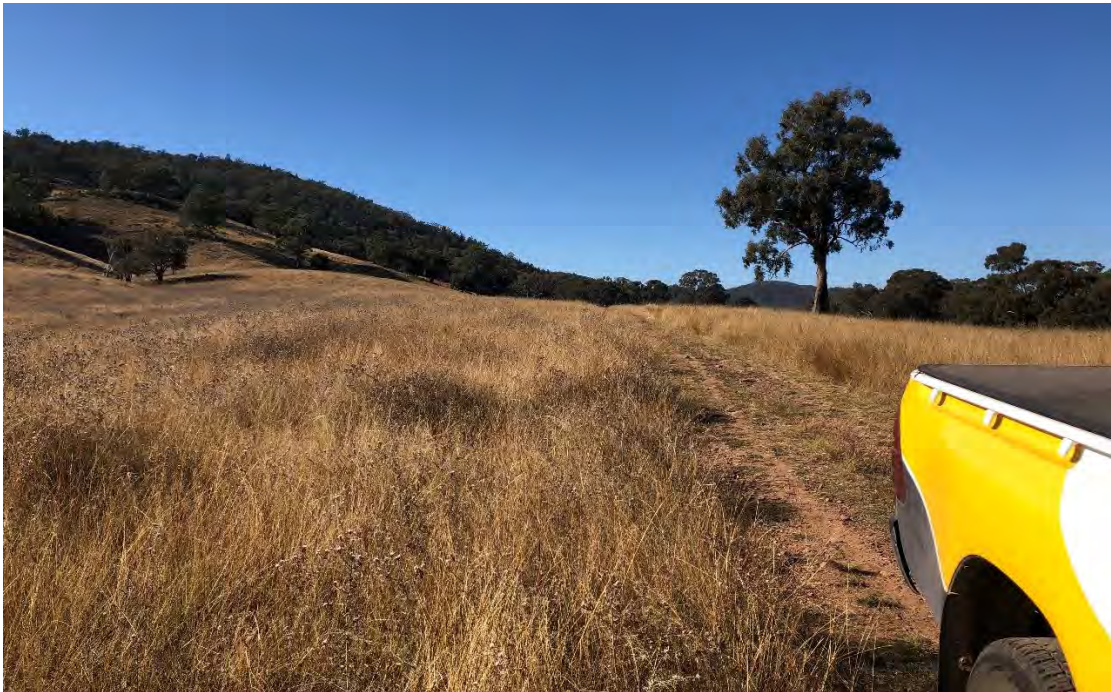
- The Subject Site is fenced and access to the site is controlled. There are several informal vehicle paths traversing the site and there are access gates and paths from all street frontages.
- At the time Barnson conducted the site inspection, most of the Subject Site was covered with pasture grass (see Figure 6.1). Both the eastern and western portions of the Site was attended by vehicle and all visible open ground and prominent features were inspected. No visible discoloration or staining of open ground or soil, and no obvious discoloration or irregularities in the occurrence of vegetation was observed during the site inspection.

Figure 6.1: Vegetation cover of Subject Site surface with informal vehicle track providing access.

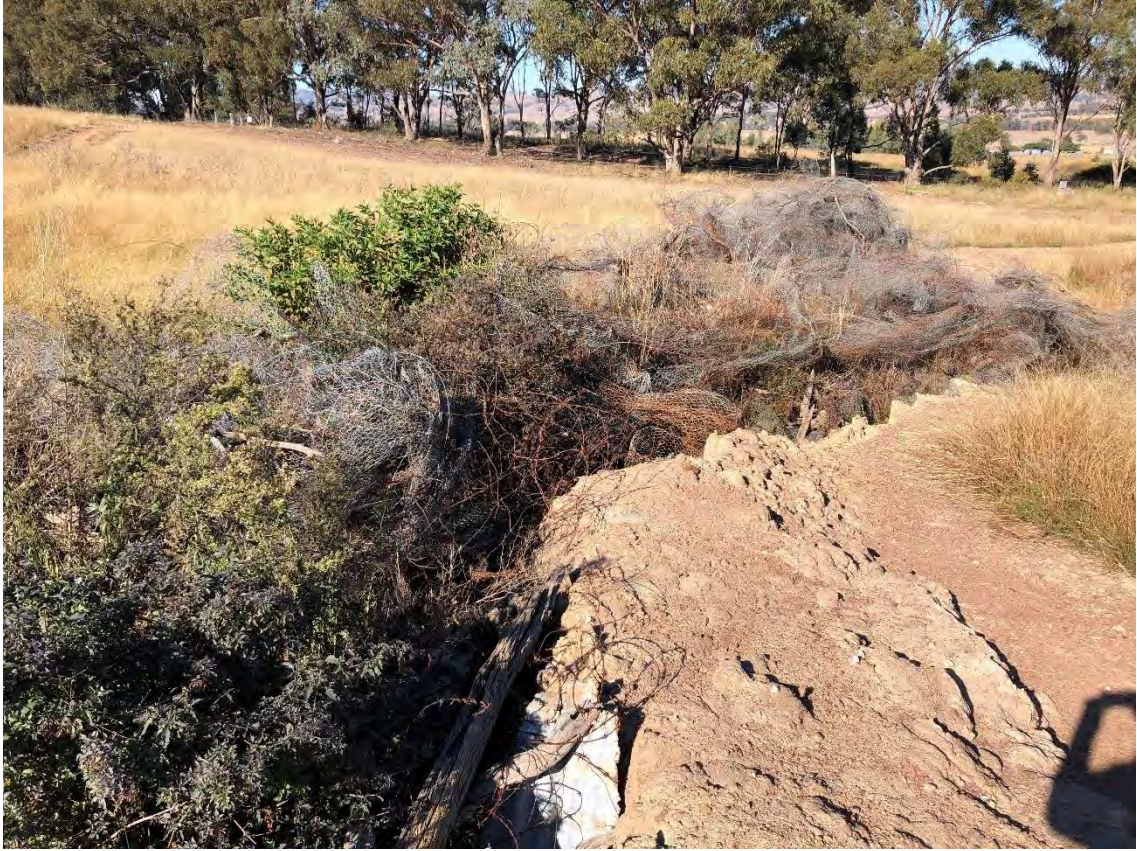
- On lot 81 DP756897, there is a disused earthen dam in which old fencing and posts have been disposed (see Figure 6.2). The disposed materials were visually inspected and no waste other than the timber poles and metal fencing wire was observed.

Figure 6.2: Fencing waste.

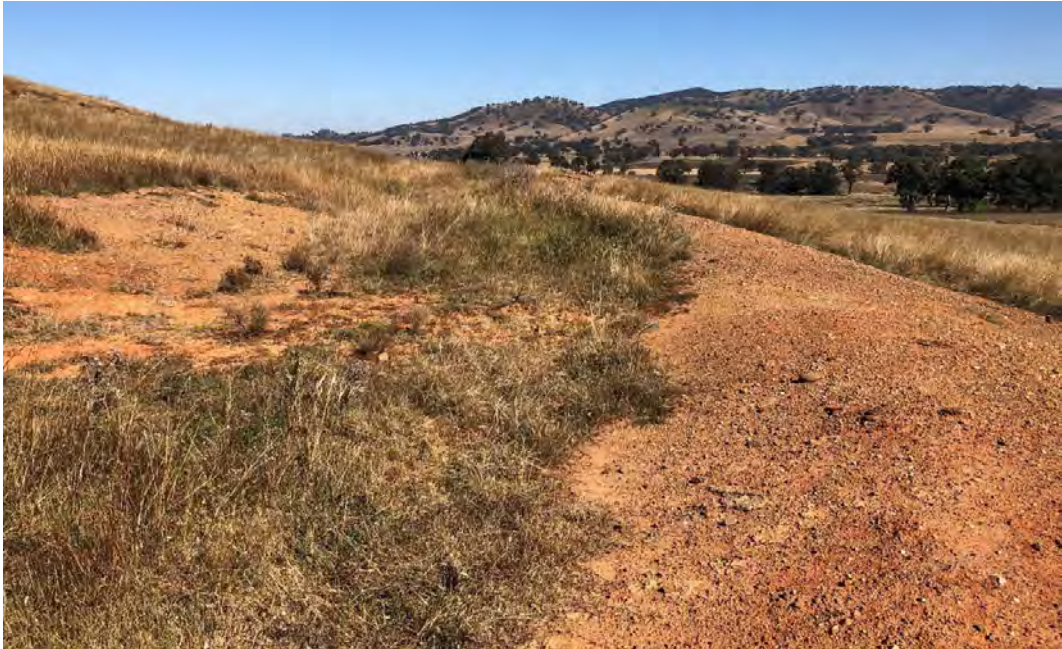
- Material excavated on the site has been placed in a water diversion bund along the foot of round hill (Figure 6.4), in the western half of the subject Site. The diversion bund is to the north of the hill.

Figure 6.4: Bund along the foot of round hill.

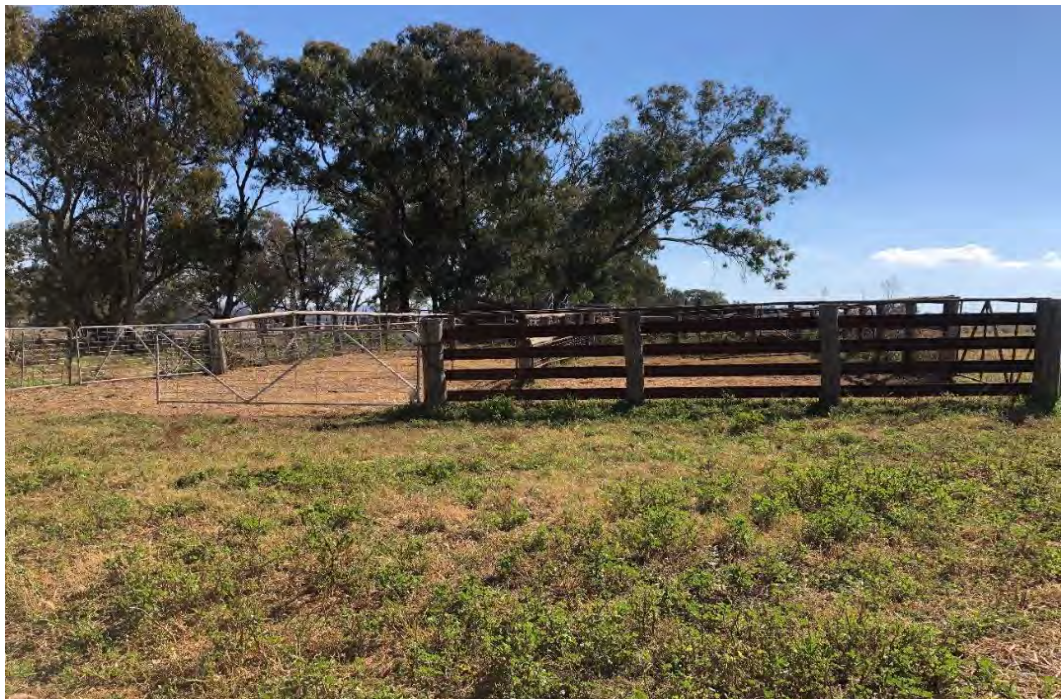
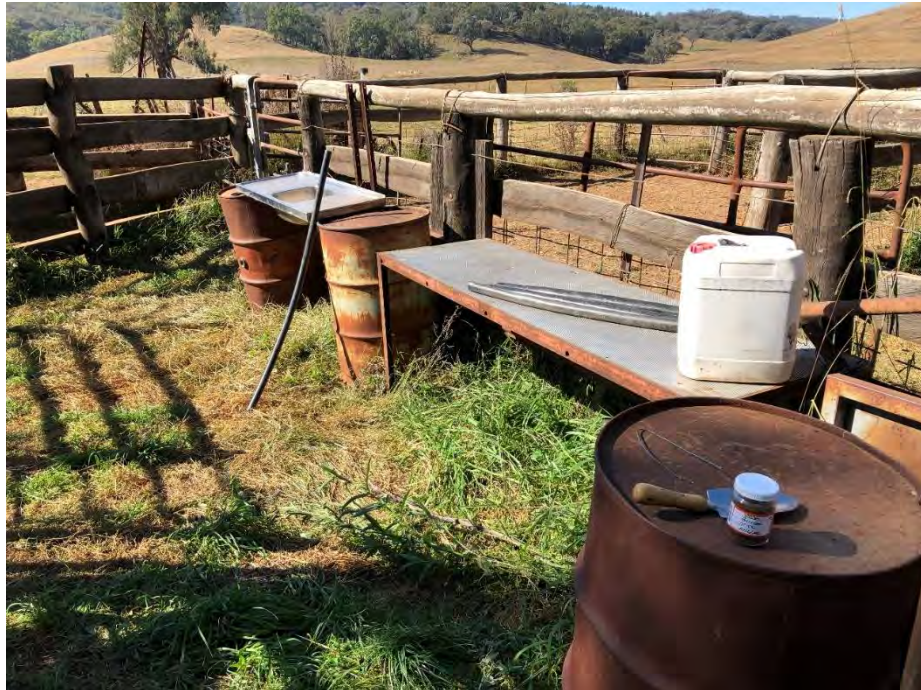
- There is a cattle yard, race and pens located on Lot 20 DP 756897 near the boundary with Gibson's lane (see Figure 6.5 and Figure 6.6).

Figure 6.5: Cattle pens.

Figure 6.6: Tables used during spraying and treatment of cattle.

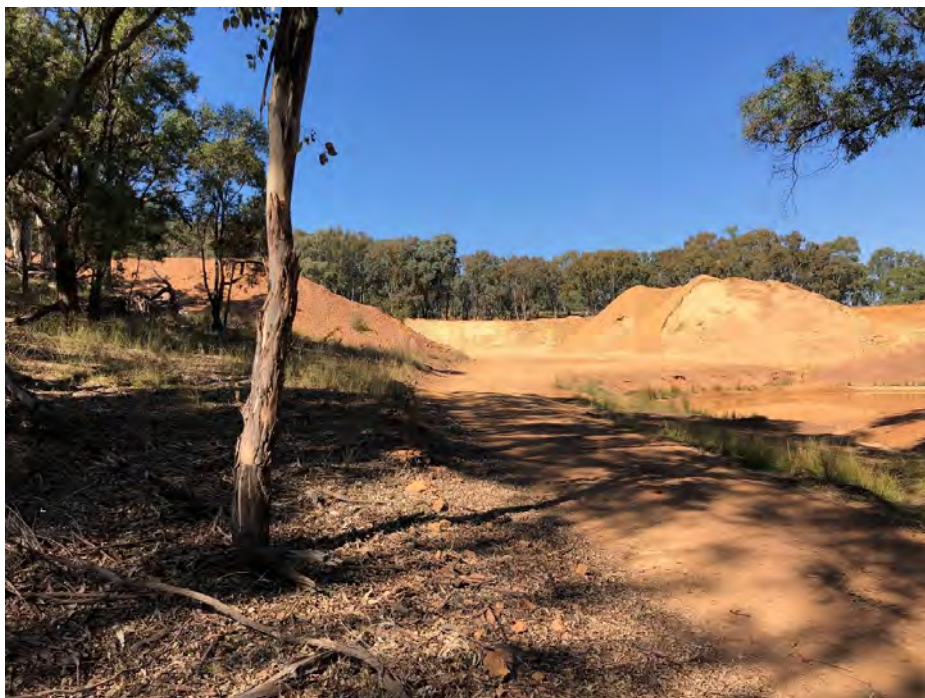
- The Mid-Western Regional Council excavates fill material for use off-site from a small quarry site located on Lot 83 DP756897 (see Figure 6.7). The area is fenced off from the rest of the Subject site and has its own access gate from Lower Piambong Road.

Figure 6.7: Mid-Western Regional Council quarry.

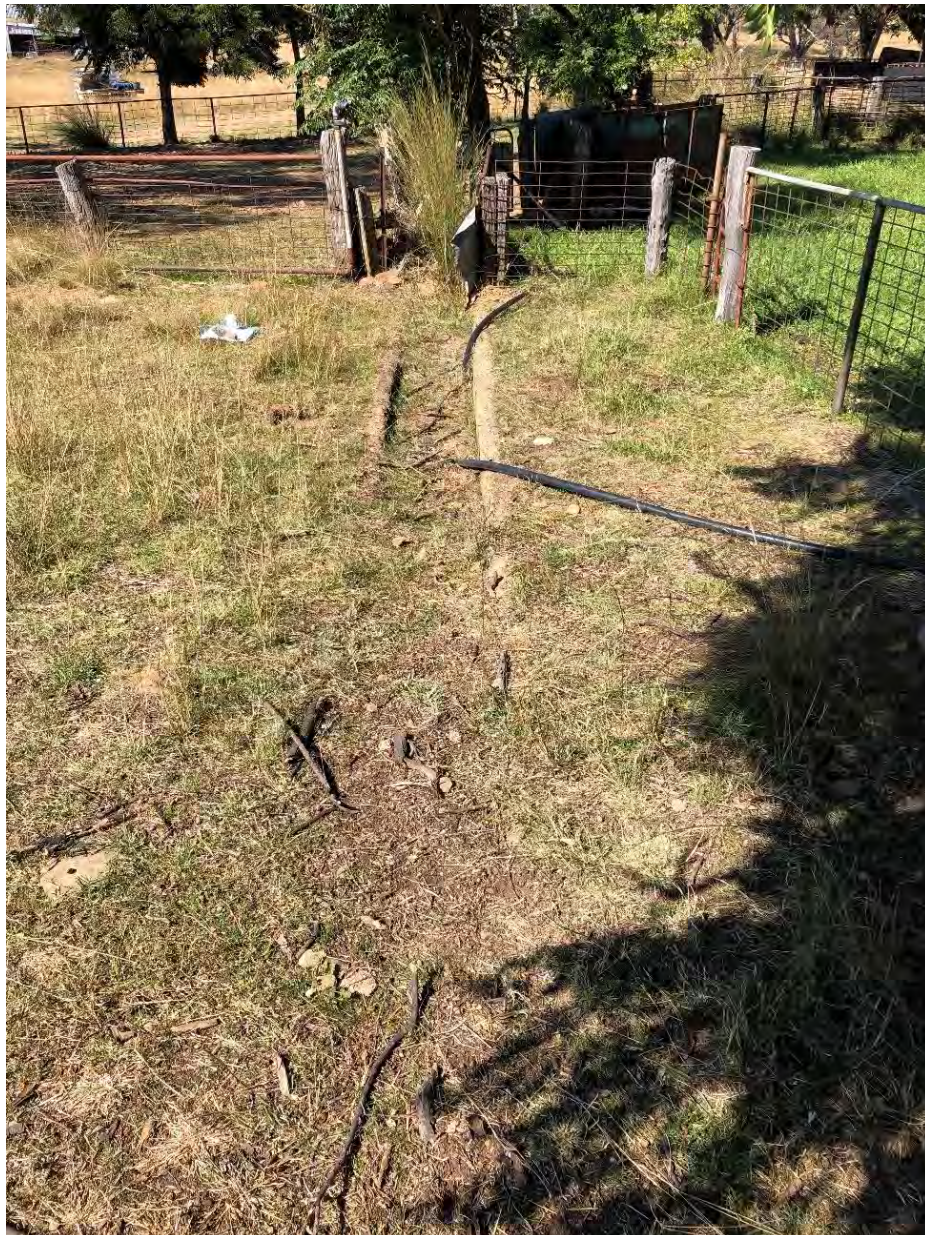
- The farm buildings and homestead are not included in the proposed re-zoning and subdivision (refer Figure 2.9).
- There is a backfilled sheep dip located just outside the yards at the shearing shed (see Figure 6.10). The dip consists of a concrete lined trench with ramps in and out of the trench with a small dish shaped concrete pad on the exit side to collect water dripping from the dipped sheep and channelling it back into the trench.
- No general waste or any demolition waste was observed in any other part of the Subject Site during the site inspection.

Figure 6.10: Backfilled sheep dip.

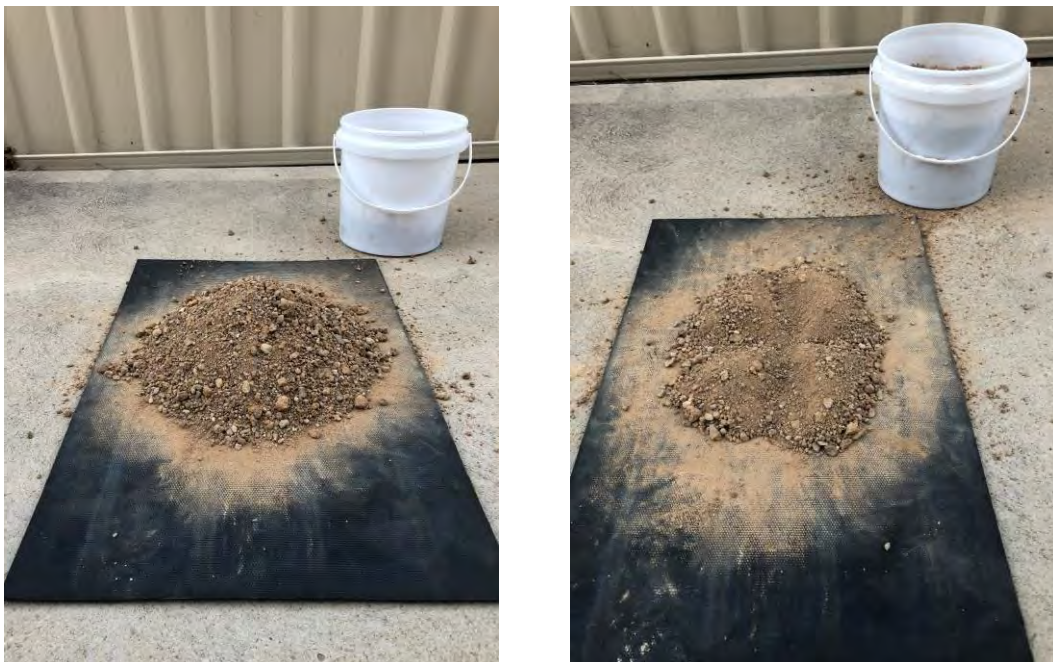
The individual sample increments collected were combined in a 5 litre bucket, as presented in Table 6.1, and transferred to the Barnson office in Mudgee for sub-sampling and laboratory submission. The volume of soil in each bucket was reduced by following a 'cone-and-quarter' technique. The increments in each bucket were thoroughly mixed by heaping into a cone and turning the cone over to form a new cone until the operation has been carried out three times. The heap is flattened and quartered along two diameters which intersect at a right angle in the centre of the cone (see Figure 6.12).

Figure 6.12: Cone and quartering.

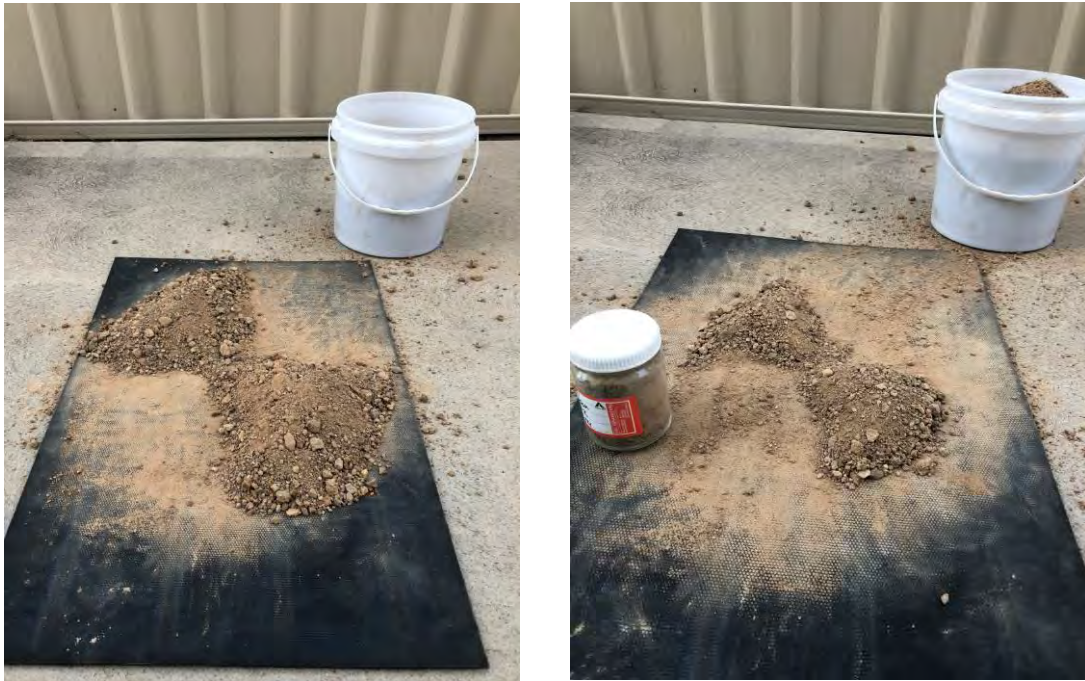
One pair of diagonally opposite quarters are removed and the remainder is scooped into a cone and the procedure repeated until a mass of sample sufficient to fill two 250ml glass jars is produced (see Figure 6.13).

Figure 6.13: Sample volume reduction.
