Geotechnical Investigation Report

Training Camp at Putta Bucca
Road, Mudgee NSW

(Our Reference:38046-GR01_B)
© Barnson Pty Ltd 2021. Confidential.

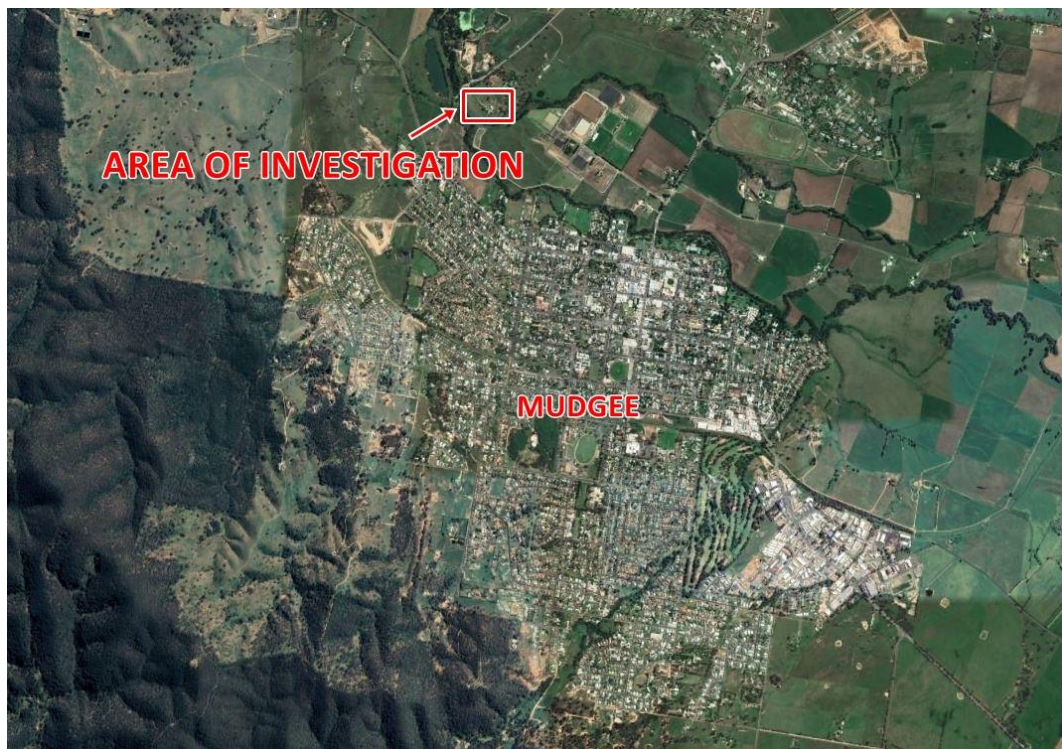
Plate 1 – Area of Investigation

Mid-Western Regional Council is planning to construct a new training camp at Putta Bucca Road, Mudgee NSW. The proposed site features that are covered by this investigation are as follows.

- Proposed Three Training Camp Buildings.

The investigation comprised of six (6) boreholes together with field mapping near the site. Details of the field work and laboratory testing are given in the report together with comments relevant to design and construction practice.

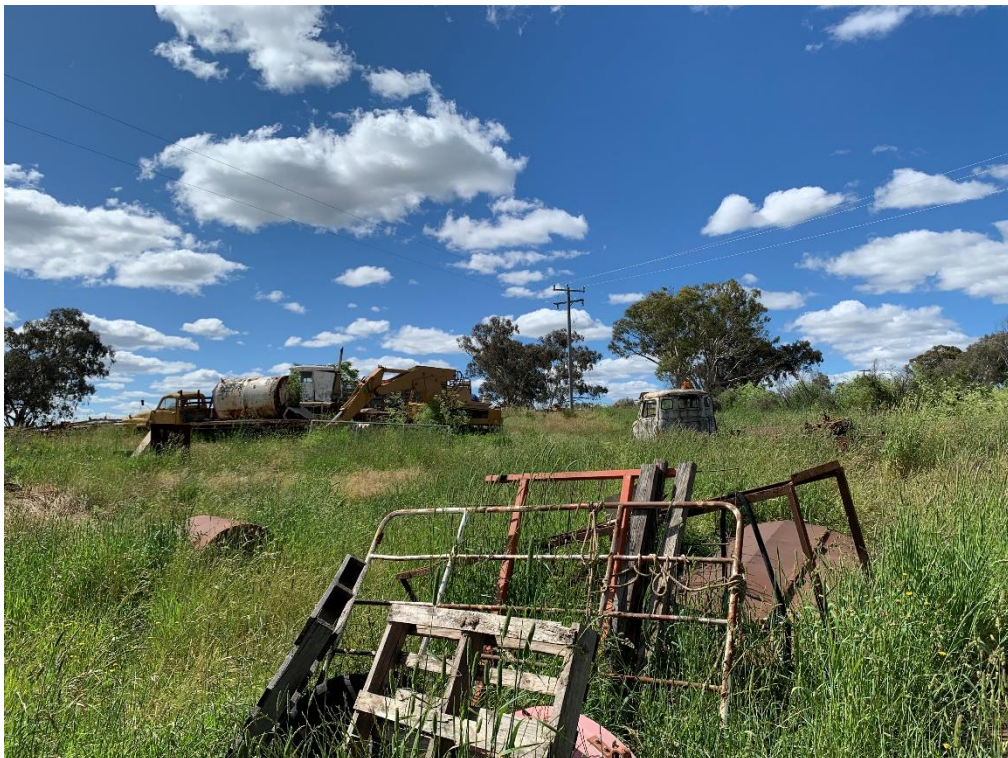
Plate 2 – General view of proposed building A location facing northwest.

The site consists of moderate to heavy scattered grass and weed cover with no mature trees on site. The site is also littered with building rubble and old machinery.

The site is sloping moderately to the west and has existing sheds on the site. The site is adjacent to the Cudgegong River and Lawsons Creek. Established buildings, wetlands, rural farmland and sporting fields exist in the vicinity surrounding the site.
