**64 LAWSON ST, MUDGEE**

## **STATEMENT OF HERITAGE IMPACT**

This Statement of Heritage Impact is for “House” at 64 Lawson Street, Mudgee NSW 2850.

The proposal is for the demolition of the existing “House” c1865 residential building and outbuildings/sheds at 64 Lawson Street, Mudgee and the construction of new residential buildings (primary dwelling at front and second dwelling at rear) on the site.

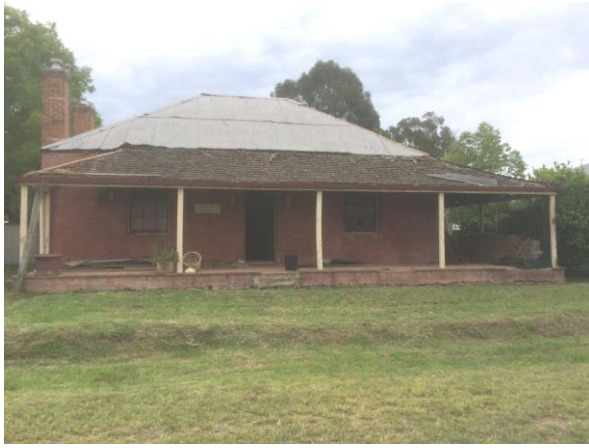
Photo 1: Front of House facing the streetscape

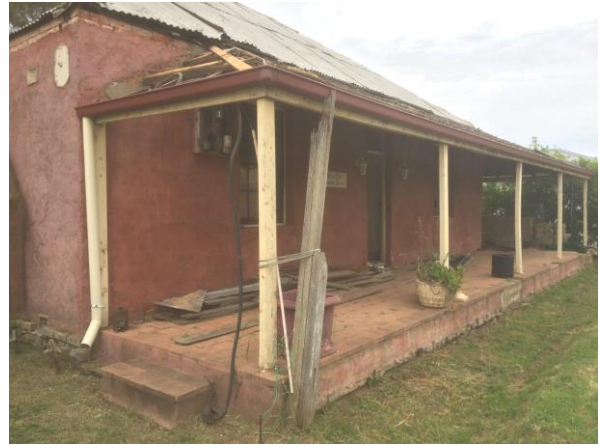
Photo 2: Front facade / verandah of original House

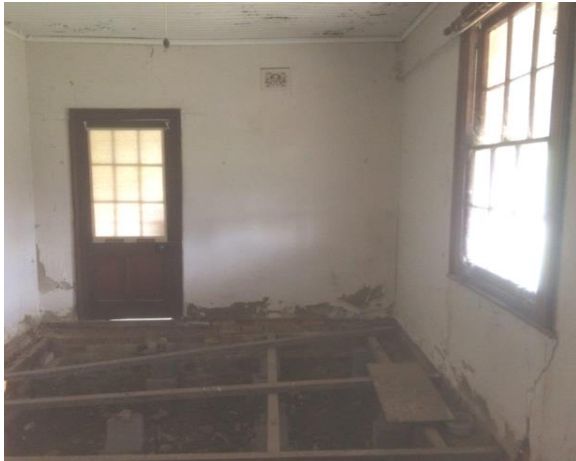
Photo 9: View of Main rooms of House - no floor

The existing house is in very poor structural condition having been extensively altered from its original conditions and a lot of elements in a very poor degraded state. There is damage to the building internally, where some doors and frames have been removed, as well as flooring and flooring structure in several rooms. Where the flooring remains intact, there is evidence of termite damage and there is good ground clearance under the floors. They could be repaired or reconstructed as required.

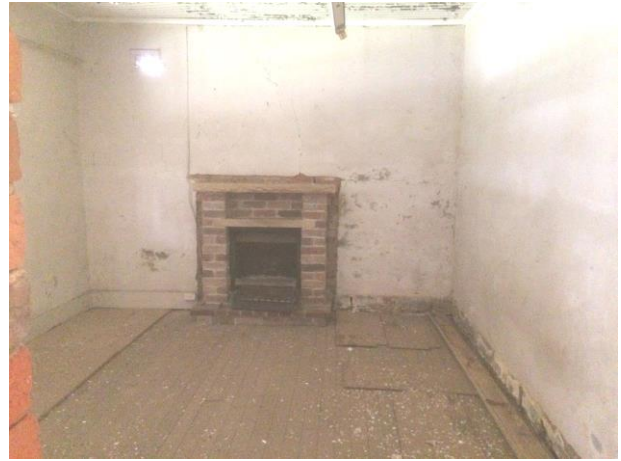
Photo 10: View of front Main room of House - with fireplace

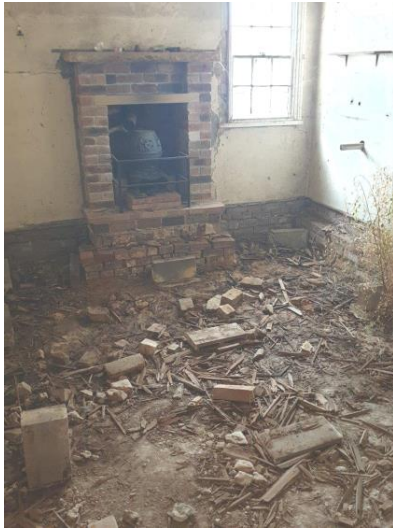
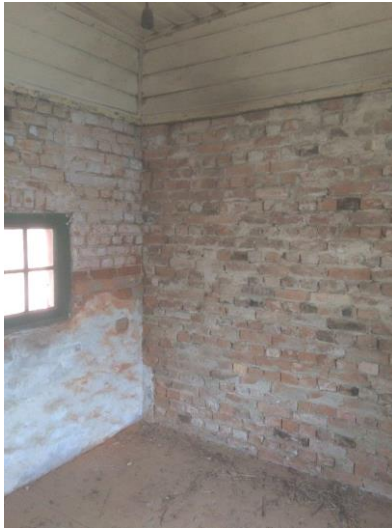
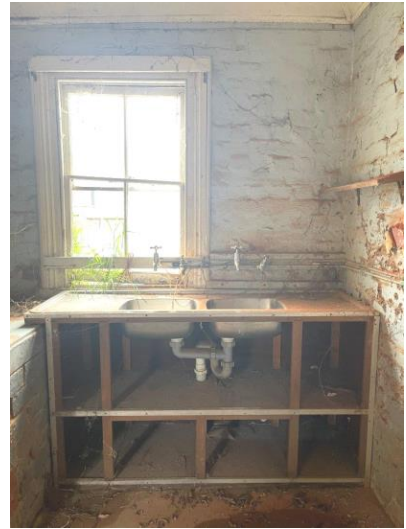
Photos 11, 12 & 13: Views of House rooms showing state of disrepair - no floor, damaged walls and joinery

The dilapidated condition of the main dwelling and detached buildings provides an enormous undertaking to make the building structurally sound, treating and repairing the rising damp wall issues, reinstating flooring structures, doors, windows, repairing floors and making the buildings secure and watertight. As noted in the Council Heritage Memorandum dated 23 August 2020, that it would be possible to insert a mechanical or injected dampcourse to prevent further damage, but it will be necessary to replace the severely damaged bricks and remove as much salt as possible from the walls. Mr David Young, a recognised expert on rising damp and salt attack, has produced several books advising on how to treat 'rising damp' and reference is made to "Salt attack and rising damp" A guide to salt damp in historic and older buildings.

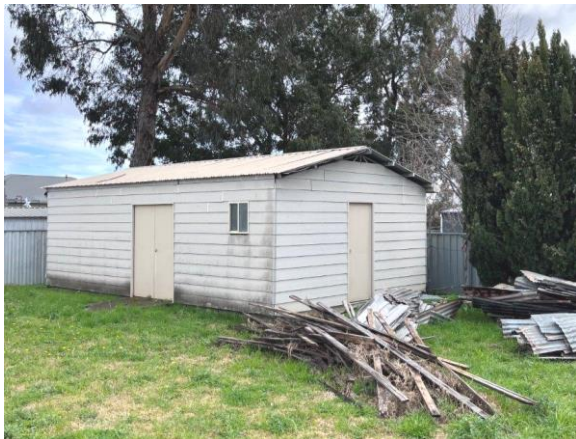
There are two outbuildings at the rear of the property. With reference to Council records, the Owner, C Café submitted Building Application (BA No 31/64) for 'detached garage' with Council approval received 18 May 1964. Later in 1994 the Owner, A&M Borrill submitted Development Application / Building Permit Application (DA183/94 & BA0398/94) 'dwelling additions for workshop/garage' with Council approval received 30 November 1994. The current steel framed fibre cement clad buildings with roller shutters are of the period.

Photo 14: View of Rear Shed 1 - later added

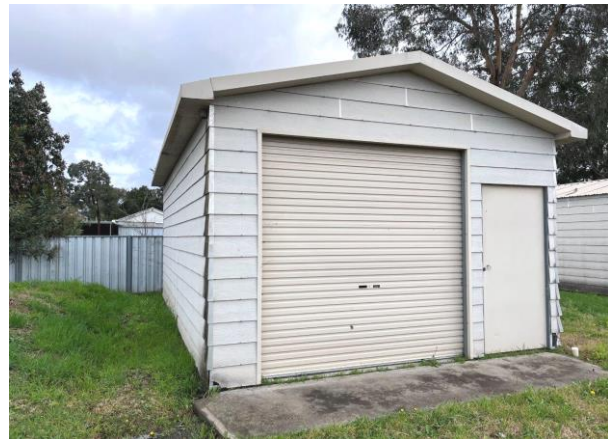
Photo 15: View of Rear Shed 2 - later added

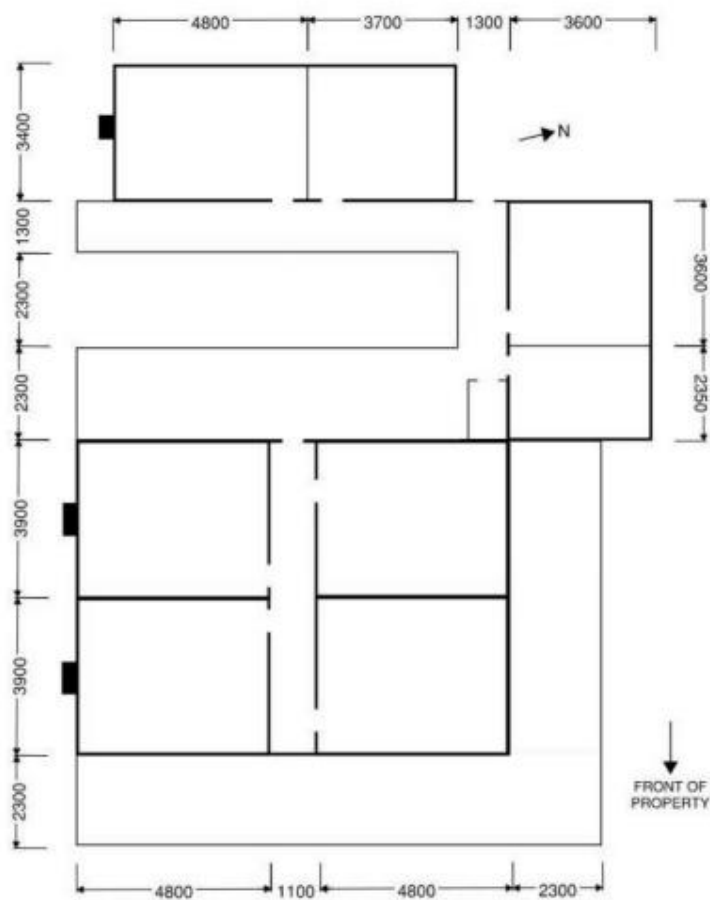
**Figure 2 – Sketch of approximate floor plan**

Two large weatherboard clad sheds are located along the rear fence of the block. A toilet block has been installed to the external edge of the Western wall of the main building. A section of the front yard is raised relative to its surroundings.

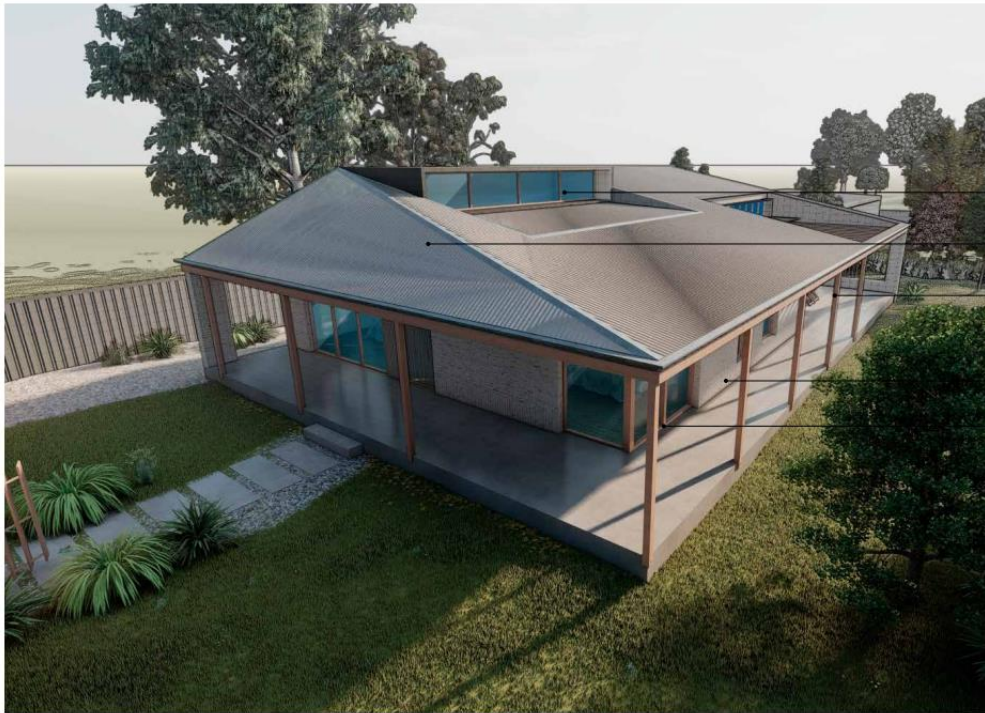
3D VIEW  
OVERVIEW - FRONT

- DORMER WINDOWS ALLOW NORTHERN LIGHT INTO MASTER, ROBE AND ENSUITE
- HIPPED ROOF TO STREET, REFERENCES PREVIOUS HOUSE FORM
- SHALLOWER NORTHERN VERANDAH PROTECTS FROM SUMMER SUN WHILE ALLOWING WINTER SUN INTO THE BUILDING
- DECORATIVE BRICK COURSES
- TIMBER WINDOW FRAMES AND VERANDAH/PERGOLA STRUCTURE

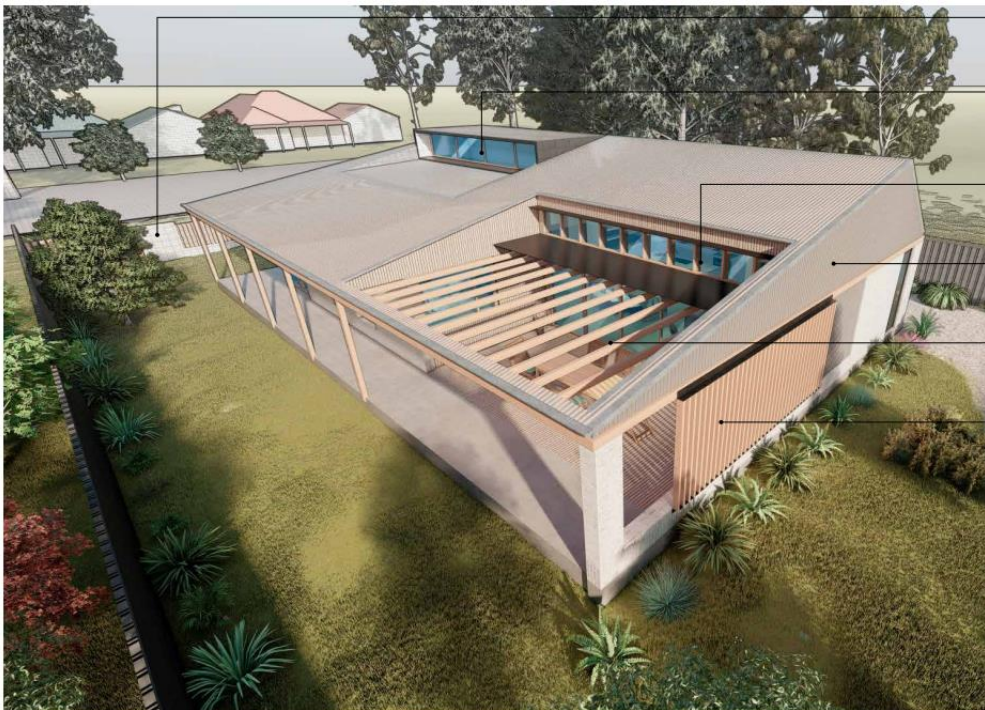
3D VIEW  
OVERVIEW - REAR

- GARDEN WALL WITH LOUVERED OPENINGS PROVIDES PRIVACY TO THE FRONT ROOMS, ALLOWING FOR LARGER AREAS OF GLAZING
- DORMER WINDOWS ALLOW NORTHERN LIGHT INTO MASTER, ROBE AND ENSUITE
- HIGHLIGHT GLAZING ALLOWS NORTHERN LIGHT DEEP INTO THE LIVING AREA
- METAL CLAD GABLE END TO REAR, ALLOWS RAKED CEILING IN LIVING AREA
- CUT AWAY TO PROVIDE AN EXTERNAL DINING AREA WITH PERGOLA STRUCTURE ABOVE
- PERGOLA AND WESTERN LOUVERS PROVIDE SHADING TO THE EXTERNAL DINING AREA. LOUVRE SCREEN COULD SLIDE TO OPEN UP MORE GARDEN VIEWS.
