| DOCUMENT | Razorback Quarry EIS |

Appendix L – Historic Heritage Assessment

HERITAGE ASSESSMENT, 39 RAZORBACK ROAD, RUNNING STREAM, NSW, 2850

HERITAGE ASSESSMENT FOR 39 RAZORBACK ROAD, RUNNING STREAM, NSW

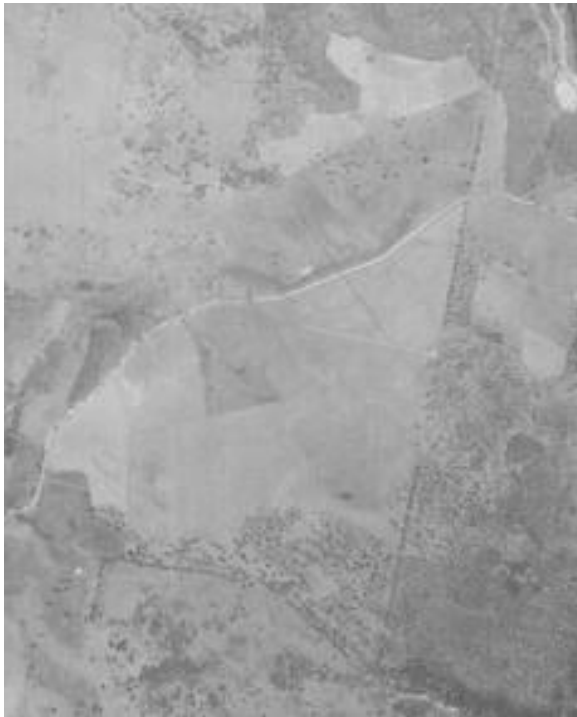
Plate 1 NSW Spatial Services – Historical Imagery – study area 1964.

There is no written evidence of any structures in the Project Area, in addition the earliest available historic aerial image shows no evidence of structures in the area. What is evident is the land, sometime previously had been extensively cleared. While the Project Area is within the Turon Goldfields no written evidence of gold mining was found.

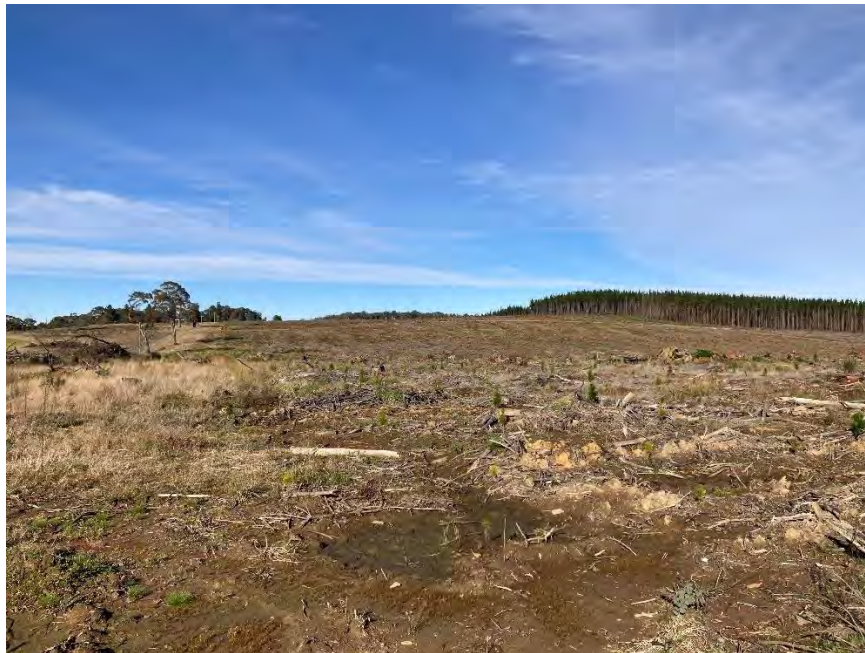
*Plate 2 Note lack of fencing and pine plantation top of frame with previously harvested paddocks in foreground.
Photo: Darrell Rigby 19.5.2022.*

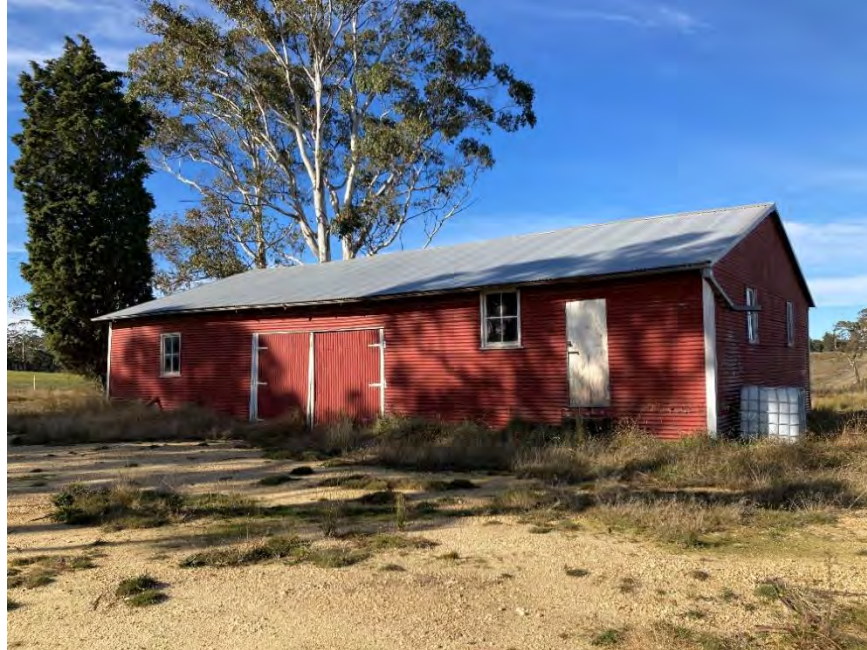
The rudimentary, vernacular style farm machinery shed, and workshop is visible from the main farm gate (Plate 2). The original roofing has been replaced with modern corrugated zincalume. The wall cladding is recycled corrugated iron all round, laid horizontally and appears to be painted externally using red primer, commonly known as “red lead”, which was used due to its high surface adhesion and the protection it provided from the elements and corrosion. Two fixed timber quarter pane glass windows are fitted along each northern and southern wall elevation and also to the western gable end. There are large, hinged doors on the northern elevation that open outwards to allow machinery drive through access to similar doors on the southern elevation. These southern shed door openings have been sealed with modern zincalume and no longer function as an accessway.

Plate 3 machinery shed northwestern $\frac{3}{4}$ elevation. Photo: Darrell Rigby 19.5.2022.

There are two white painted pedestrian access doors towards the western end of the machinery shed with concrete stairs ascending to the northern elevation doorway only. Internally the machinery shed has two separate levels (Plates 3 and 4). The eastern section is set wholly at ground level with a dirt floor taking up approximately three quarters of the available area. The western quarter is elevated on timber stumps and served as a workshop area. This workshop area retains its work bench, shelving and some cabinetry. The working platform is at such a height so that farm utes and similar could drive into the machinery shed and load or unload equipment or other farm materials at an easy working level. It is therefore apparent, the machinery shed was never intended or designed to accommodate horse drawn or other farm animal transportation giving a clue to its earliest construction date as most likely post 1950's. The platform has structural problems in the vicinity of the work bench where a floor bearer has collapsed.

Timber has been used exclusively in flooring, rafters, post uprights, stumps and wall framing. The building is constructed as a fully braced enclosure using wire ropes of various gauges tying the uprights to concrete floor blocks and using smaller guy ropes attached to the side walls at the top plate. The roofing support carpentry uses a combination of trussed sections set into mortice joints at the posts along the centreline of the shed through to buttressed wall supports on the perimeter. Each truss between each post upright uses two rafters spread and braced with a horizontal cross beam with a single "I" beam from its centre to the apex.

The perimeter post uprights along the walls are set into the ground in contrast to the centre post uprights, which are set into concrete pads. The bases of those posts set into the ground have been coated with sump oil to deter termite infestation. The machinery shed generally employs triangulation of its various components to provide strength and structural integrity.

- 1) Whilst there are no plans from the proponent to modify, move or demolish the machinery shed, should it be proposed to do so at some point in the future, prior to this activity occurring archival photography should be conducted to capture the structure and building methodology employed.
- 2) All efforts should be made to retain and maintain the Cypress Pine wind break along Razorback Road.

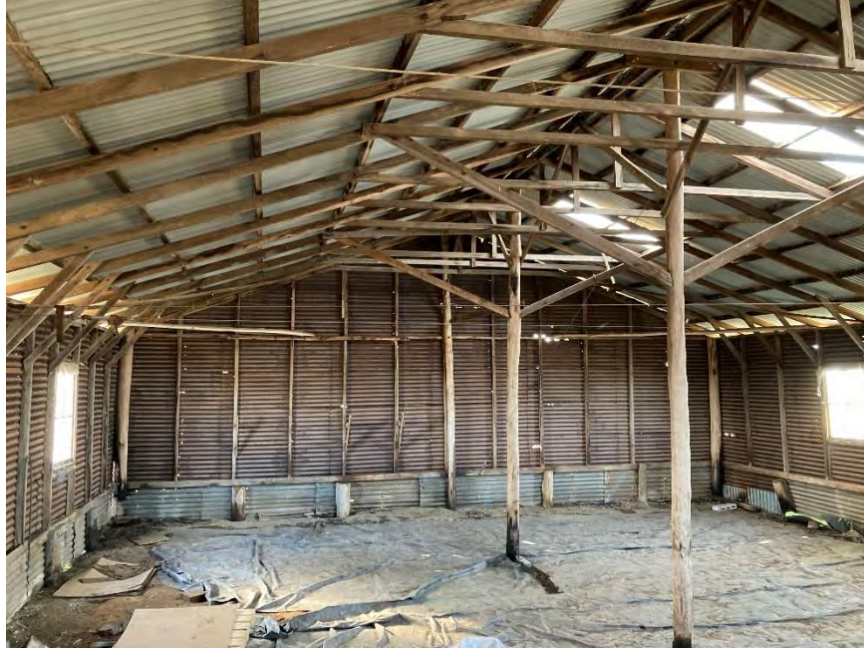
Plate 4 Interior of eastern section of machinery shed. Note earthen floor under plastic sheeting and use of farm sourced posts as uprights. Photo: Darrell Rigby 19.5.2022.

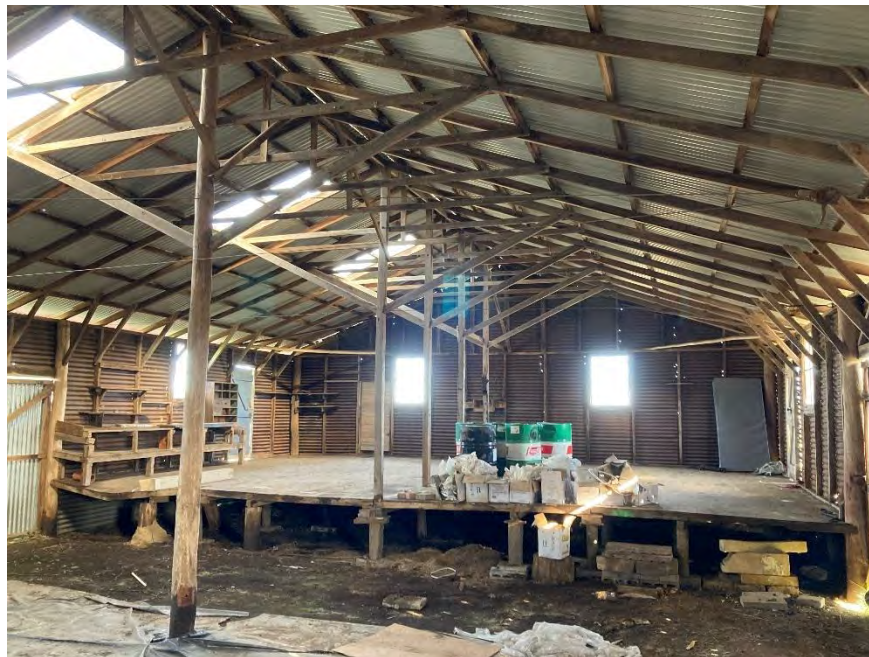
Plate 5 Western interior showing raised workshop area. Note collapsed platform section left of frame. Photo: Darrell Rigby 19.5.2022.

The machinery shed has likely been modified to establish the raised workshop area in the western section apparent from its underpinnings.

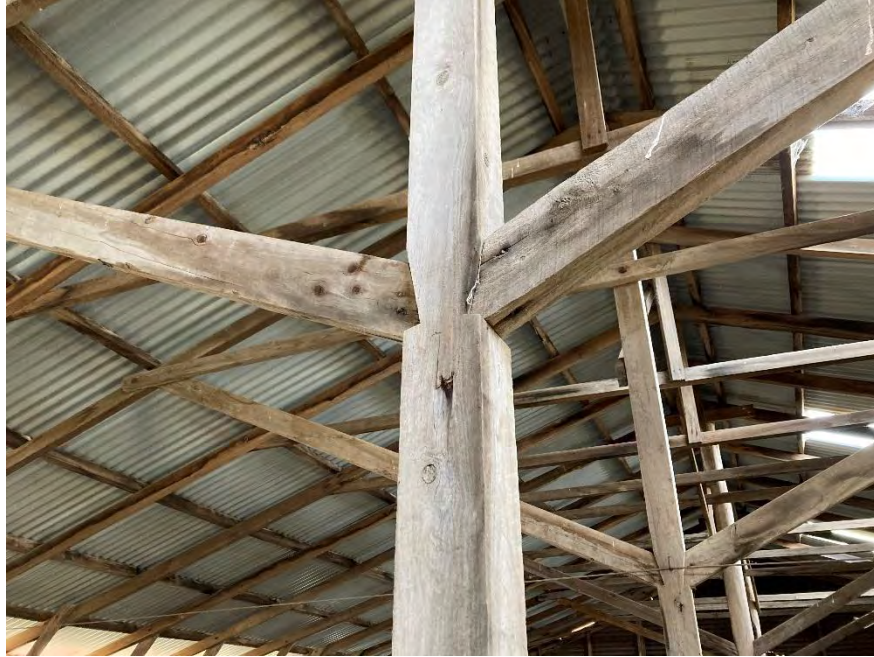
Plate 6 Mortise join on centre post uprights are a feature of the construction. Photo: Darrell Rigby 19.5.2022.

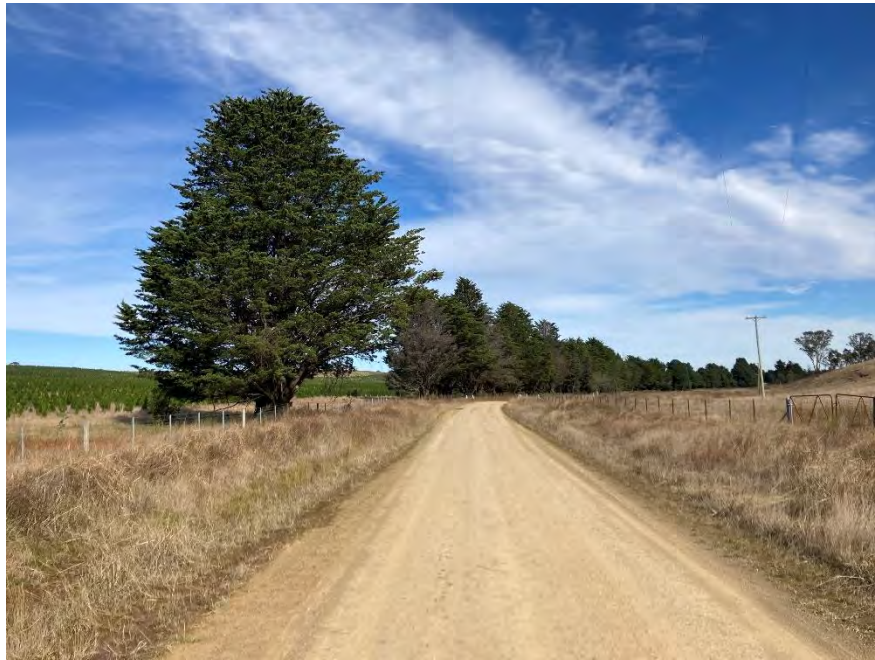
A major feature of the landscape is the wind break perimeter plantings along Razorback Road of what appears to be Cypress Pines. These intentionally planted pines create a visually pleasing framework marking the boundary of the Project Area and defining the route along Razorback Road. A pleasing visual amenity is provided by these mature trees acting as a landscape marker for some distance. Historic aerial photography would indicate some of these plantings were in place in 1964, with the 1973 aerial showing an expansion of them in the interim decade.

Plate 8 Cypress Pine windbreak along Razorback Road should be retained. Photo: Darrell Rigby 19.5.2022.

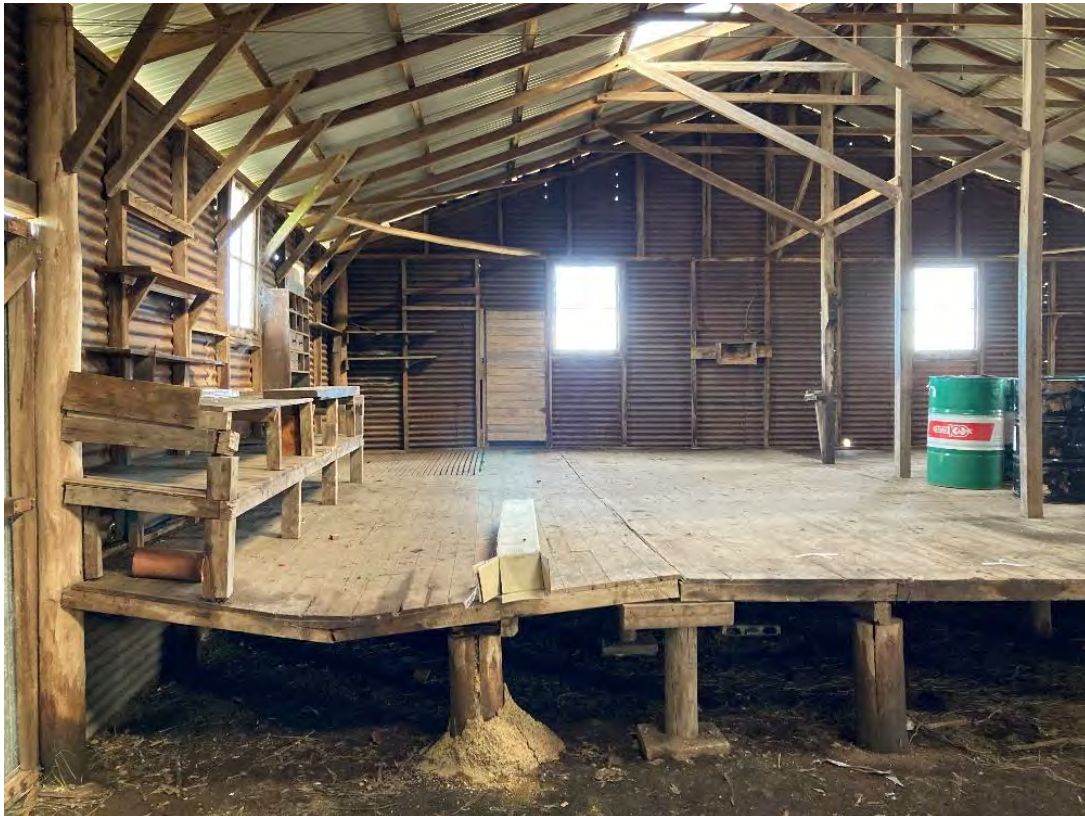
Plate 9 Raised workshop platform is in danger of collapse. Assorted post supports and random construction hint at a later period of construction from the main shed.

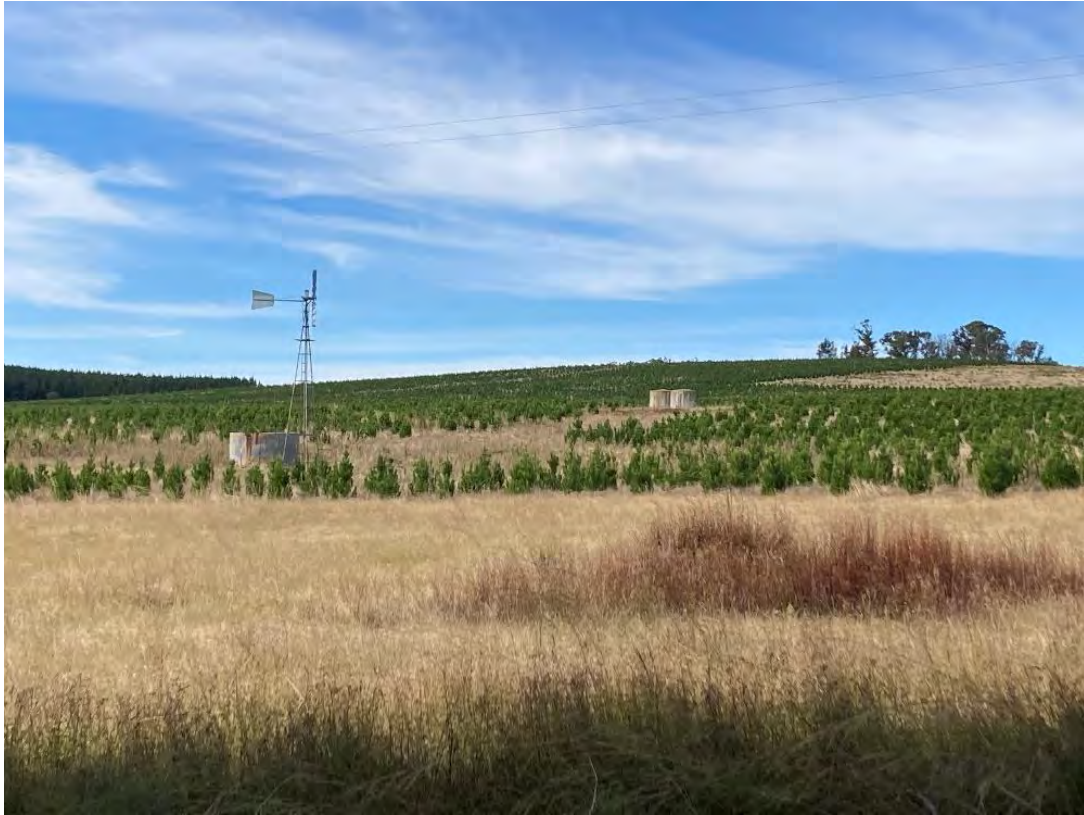
The machinery shed presents as an original fabric structure using vernacular farm building construction practices and timber off the property. The modern residence and associated outbuildings, modern infrastructure items such as water tanks and windmill are in good condition but are of no heritage interest.

Plate 12 Concrete water tanks and windmill infrastructure. Photo: Darrell Rigby 19.5.2022.
