DOCUMENT	Razorback Quarry EIS
PROJECT	Plantation Pine Products Pty Ltd
VERSION	2.0

RAZORBACK QUARRY

Visual Impact Assessment

February 2023

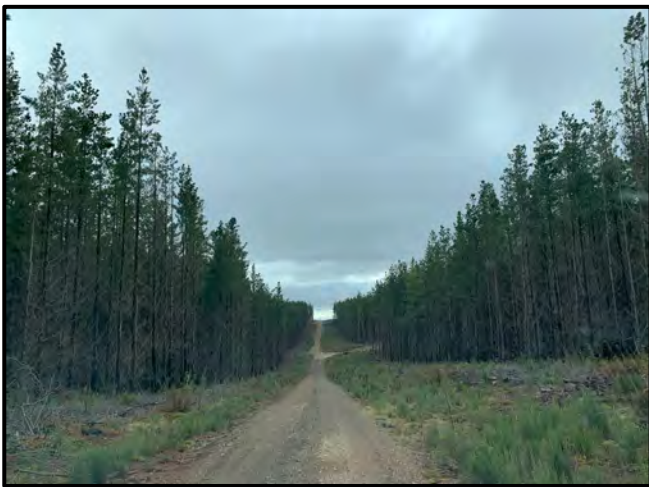
Plate 1: Site road with trees at the estimated height in 25 years' time.

The area around the quarry footprint is an existing pine plantation which was planted in 2021. These trees are required to be under plantation in the area for 25 years to meet carbon commitments. The proposed management activities involve two 14-year rotations of 100% pulp if the factory requires wood. Otherwise, a first thinning will occur at 12 years and a second thinning will occur at 20 years with clear-felling occurring at 25 years.

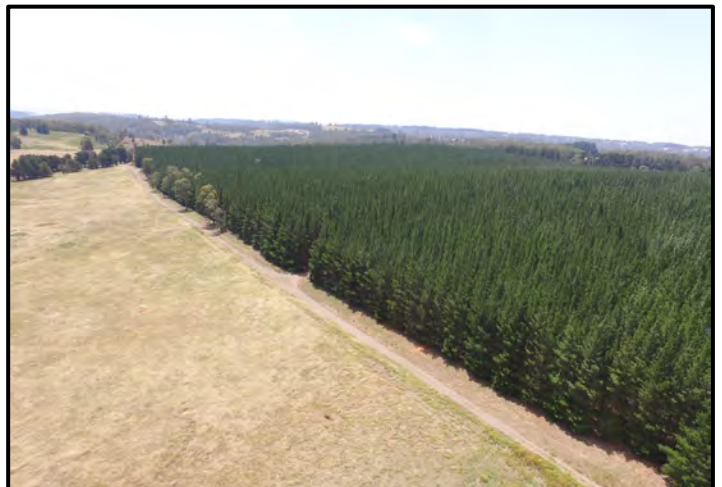
Plate 2: Aerial view of tree line along Razorback Road in 25 years.

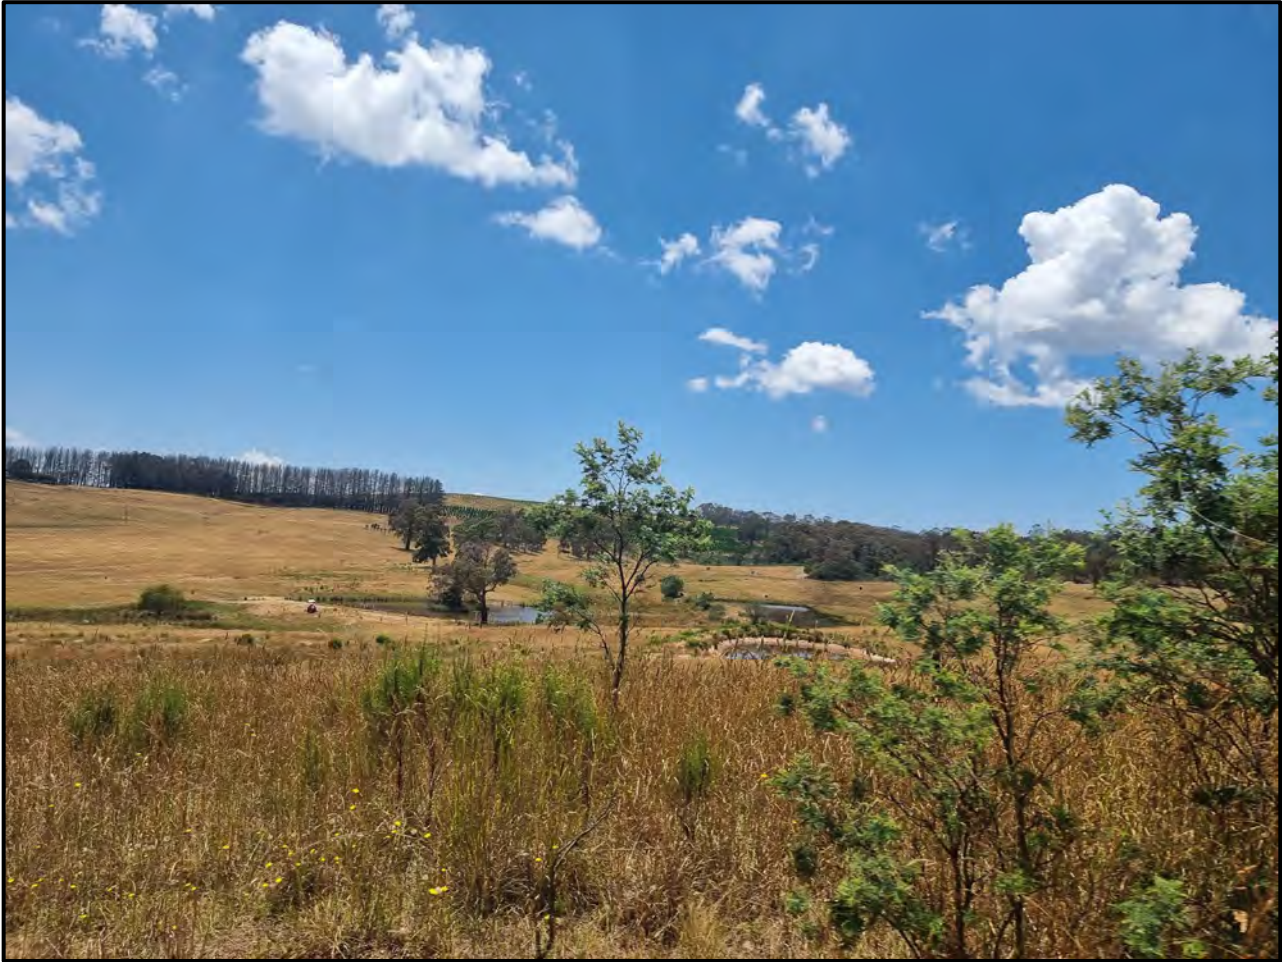
Plate 3: Two Mile Creek looking toward Subject Land.

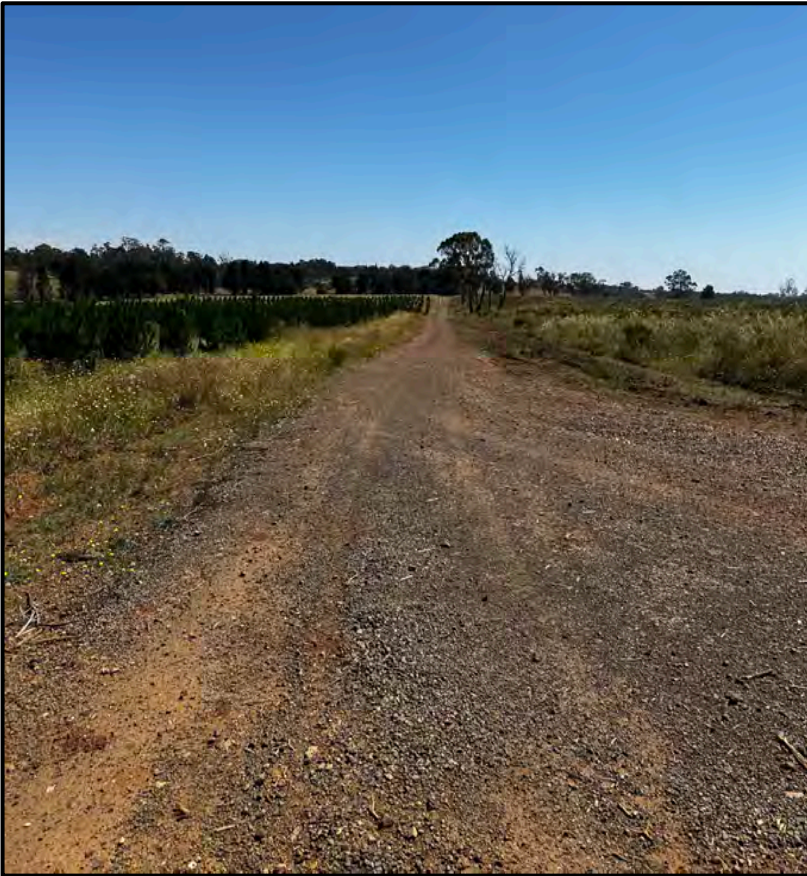
Plate 4: Proposed haul road intersection with Razorback Road looking north

Razorback Road is a local gravel road. It is likely this road will need to be sealed at the intersection where it meets the private haul road, approximately 1 km from the Castlereagh Highway, to ensure dust and noise are minimised.

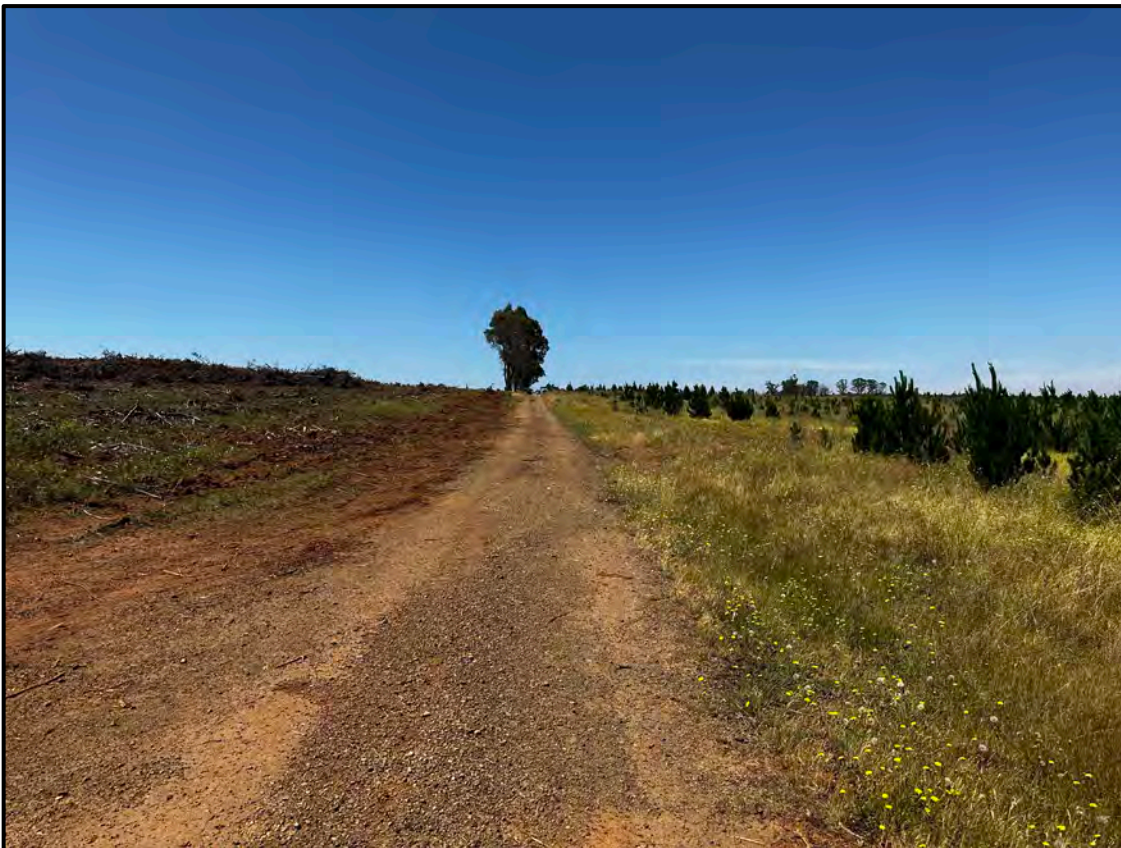
Plate 5: Along proposed haul road entrance to site lodgings looking east. Trees on left have been recently harvested. Trees on right were planted in 2021.

The private haul road will currently use the upgrades from the existing gravel plantations roads before diverting to a 1,000 m long section of gravel haulage road specific for the quarry. To prevent materials from tracking onto the public road, a shaker grid will be installed which connects to a minimum of 30 m of sealed section prior to meeting with Razorback Road.

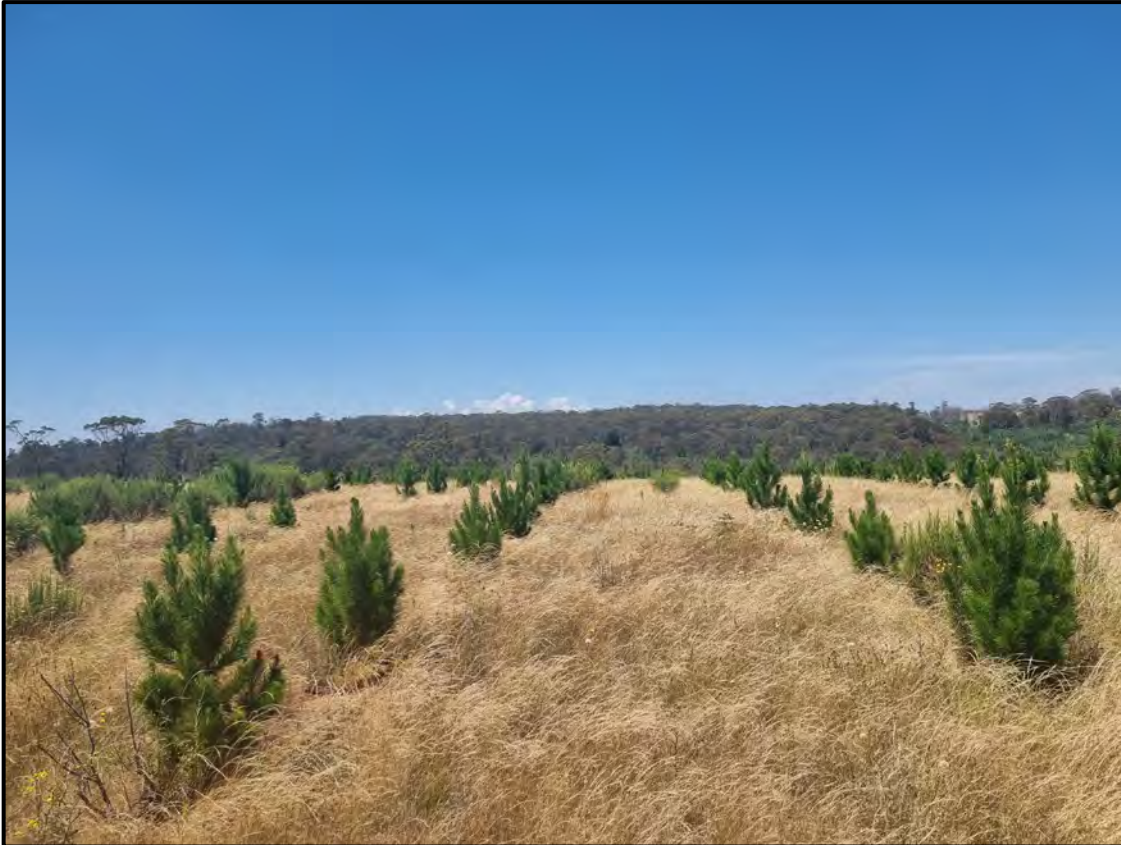
Plate 6: Trees planted in 2021 showing height after 2 years' growth.

Majority of the subject land (over 80%) has been historically cleared of native vegetation and is used as pine plantation. The older trees which were harvested in 2022 were planted in 2000 and at the time of harvesting stood more than 18 m tall. Current pines in the area were planted in 2021 and are approximately 2 – 2.5 m tall (See **Plate 6**). This indicates a projected growth rate of the pines at approximately 0.8m per year.

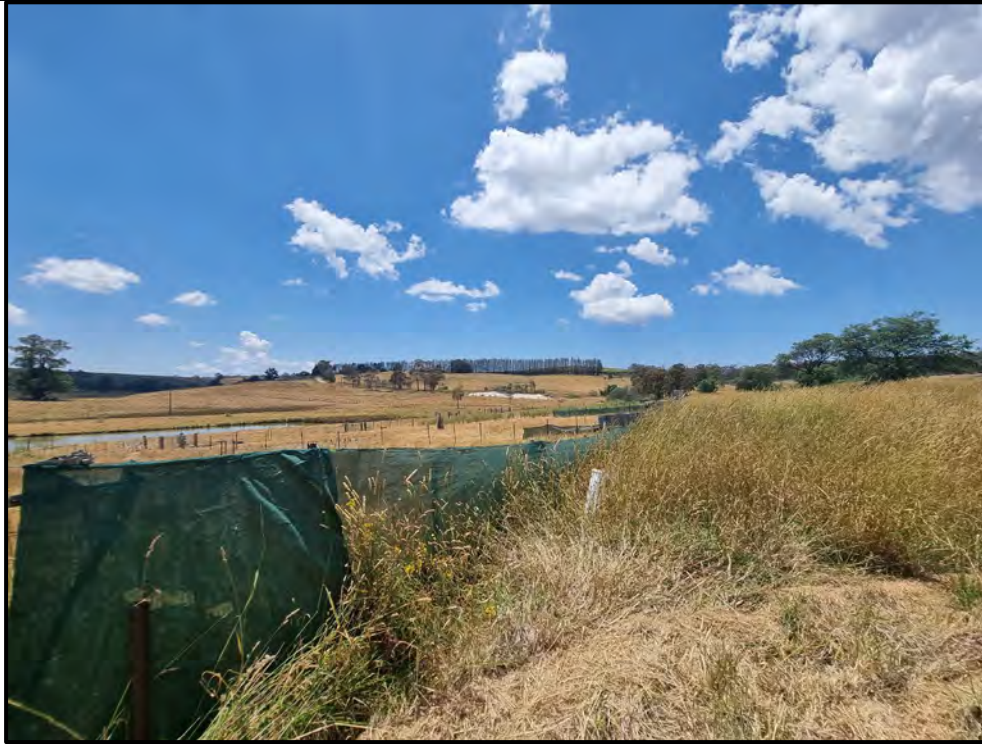
Plate 10: Viewpoint 2 (Razorback Road) as of January 2023.

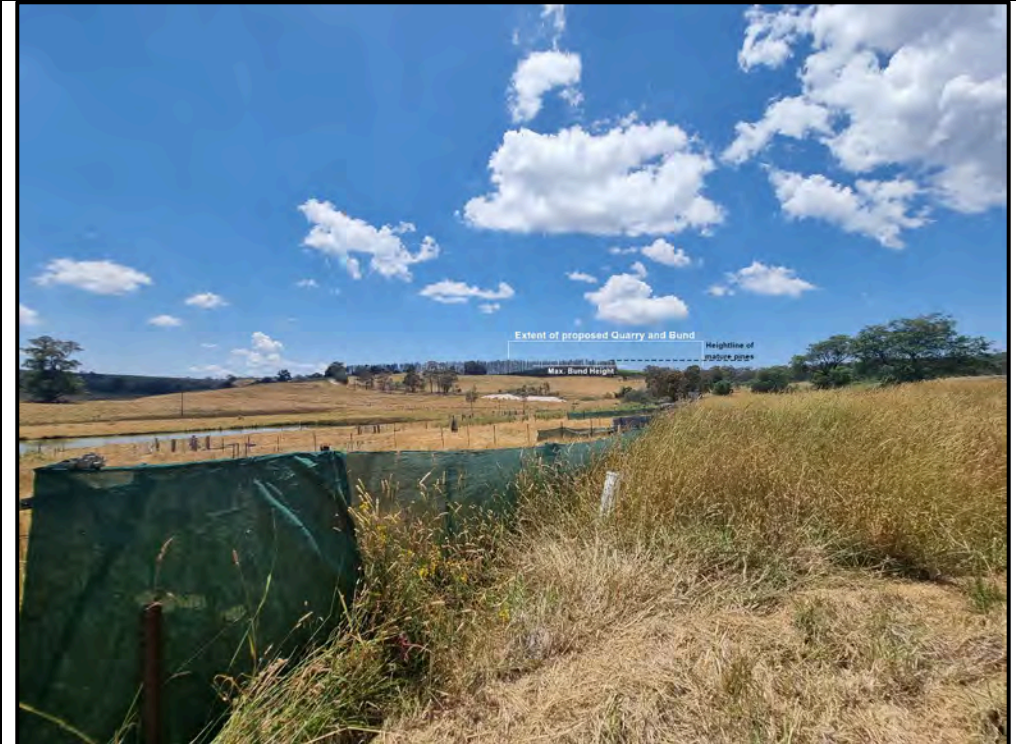
Plate 11: Viewpoint 2 (Razorback Road) when development is in Stage 4 of operations.

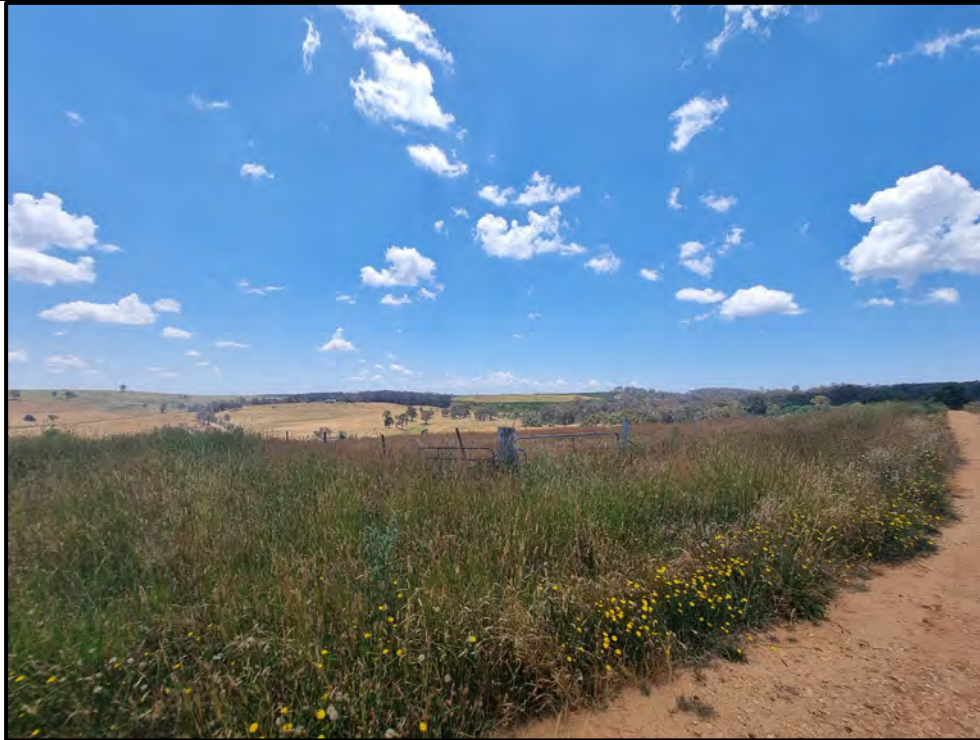
Plate 12: Viewpoint 3 (Berwick Road) as of January 2023.

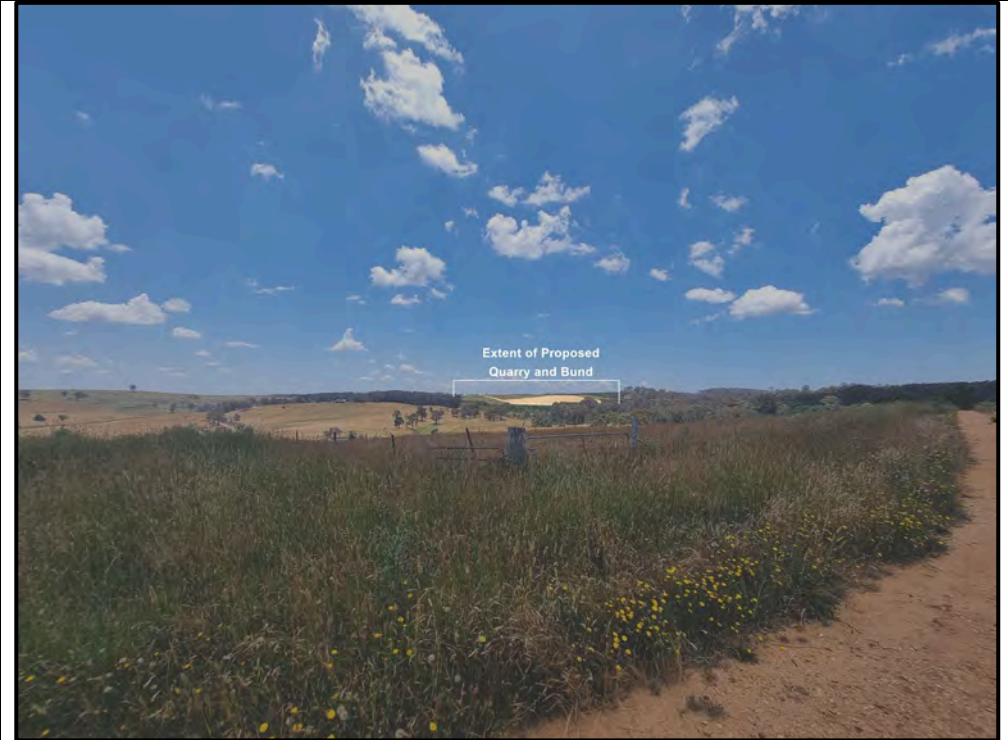
Plate 13: Viewpoint 3 (Berwick Road) when development is in Stage 4 of operations.
