Preliminary Site Investigation
313 Magpie Lane, Galambine NSW 2850

Prepared for: CAM Engineering and Constructions Pty Ltd
EP3386.001 V2 26 February 2024

Preliminary Site Investigation

313 Magpie Lane, Galambine NSW 2850

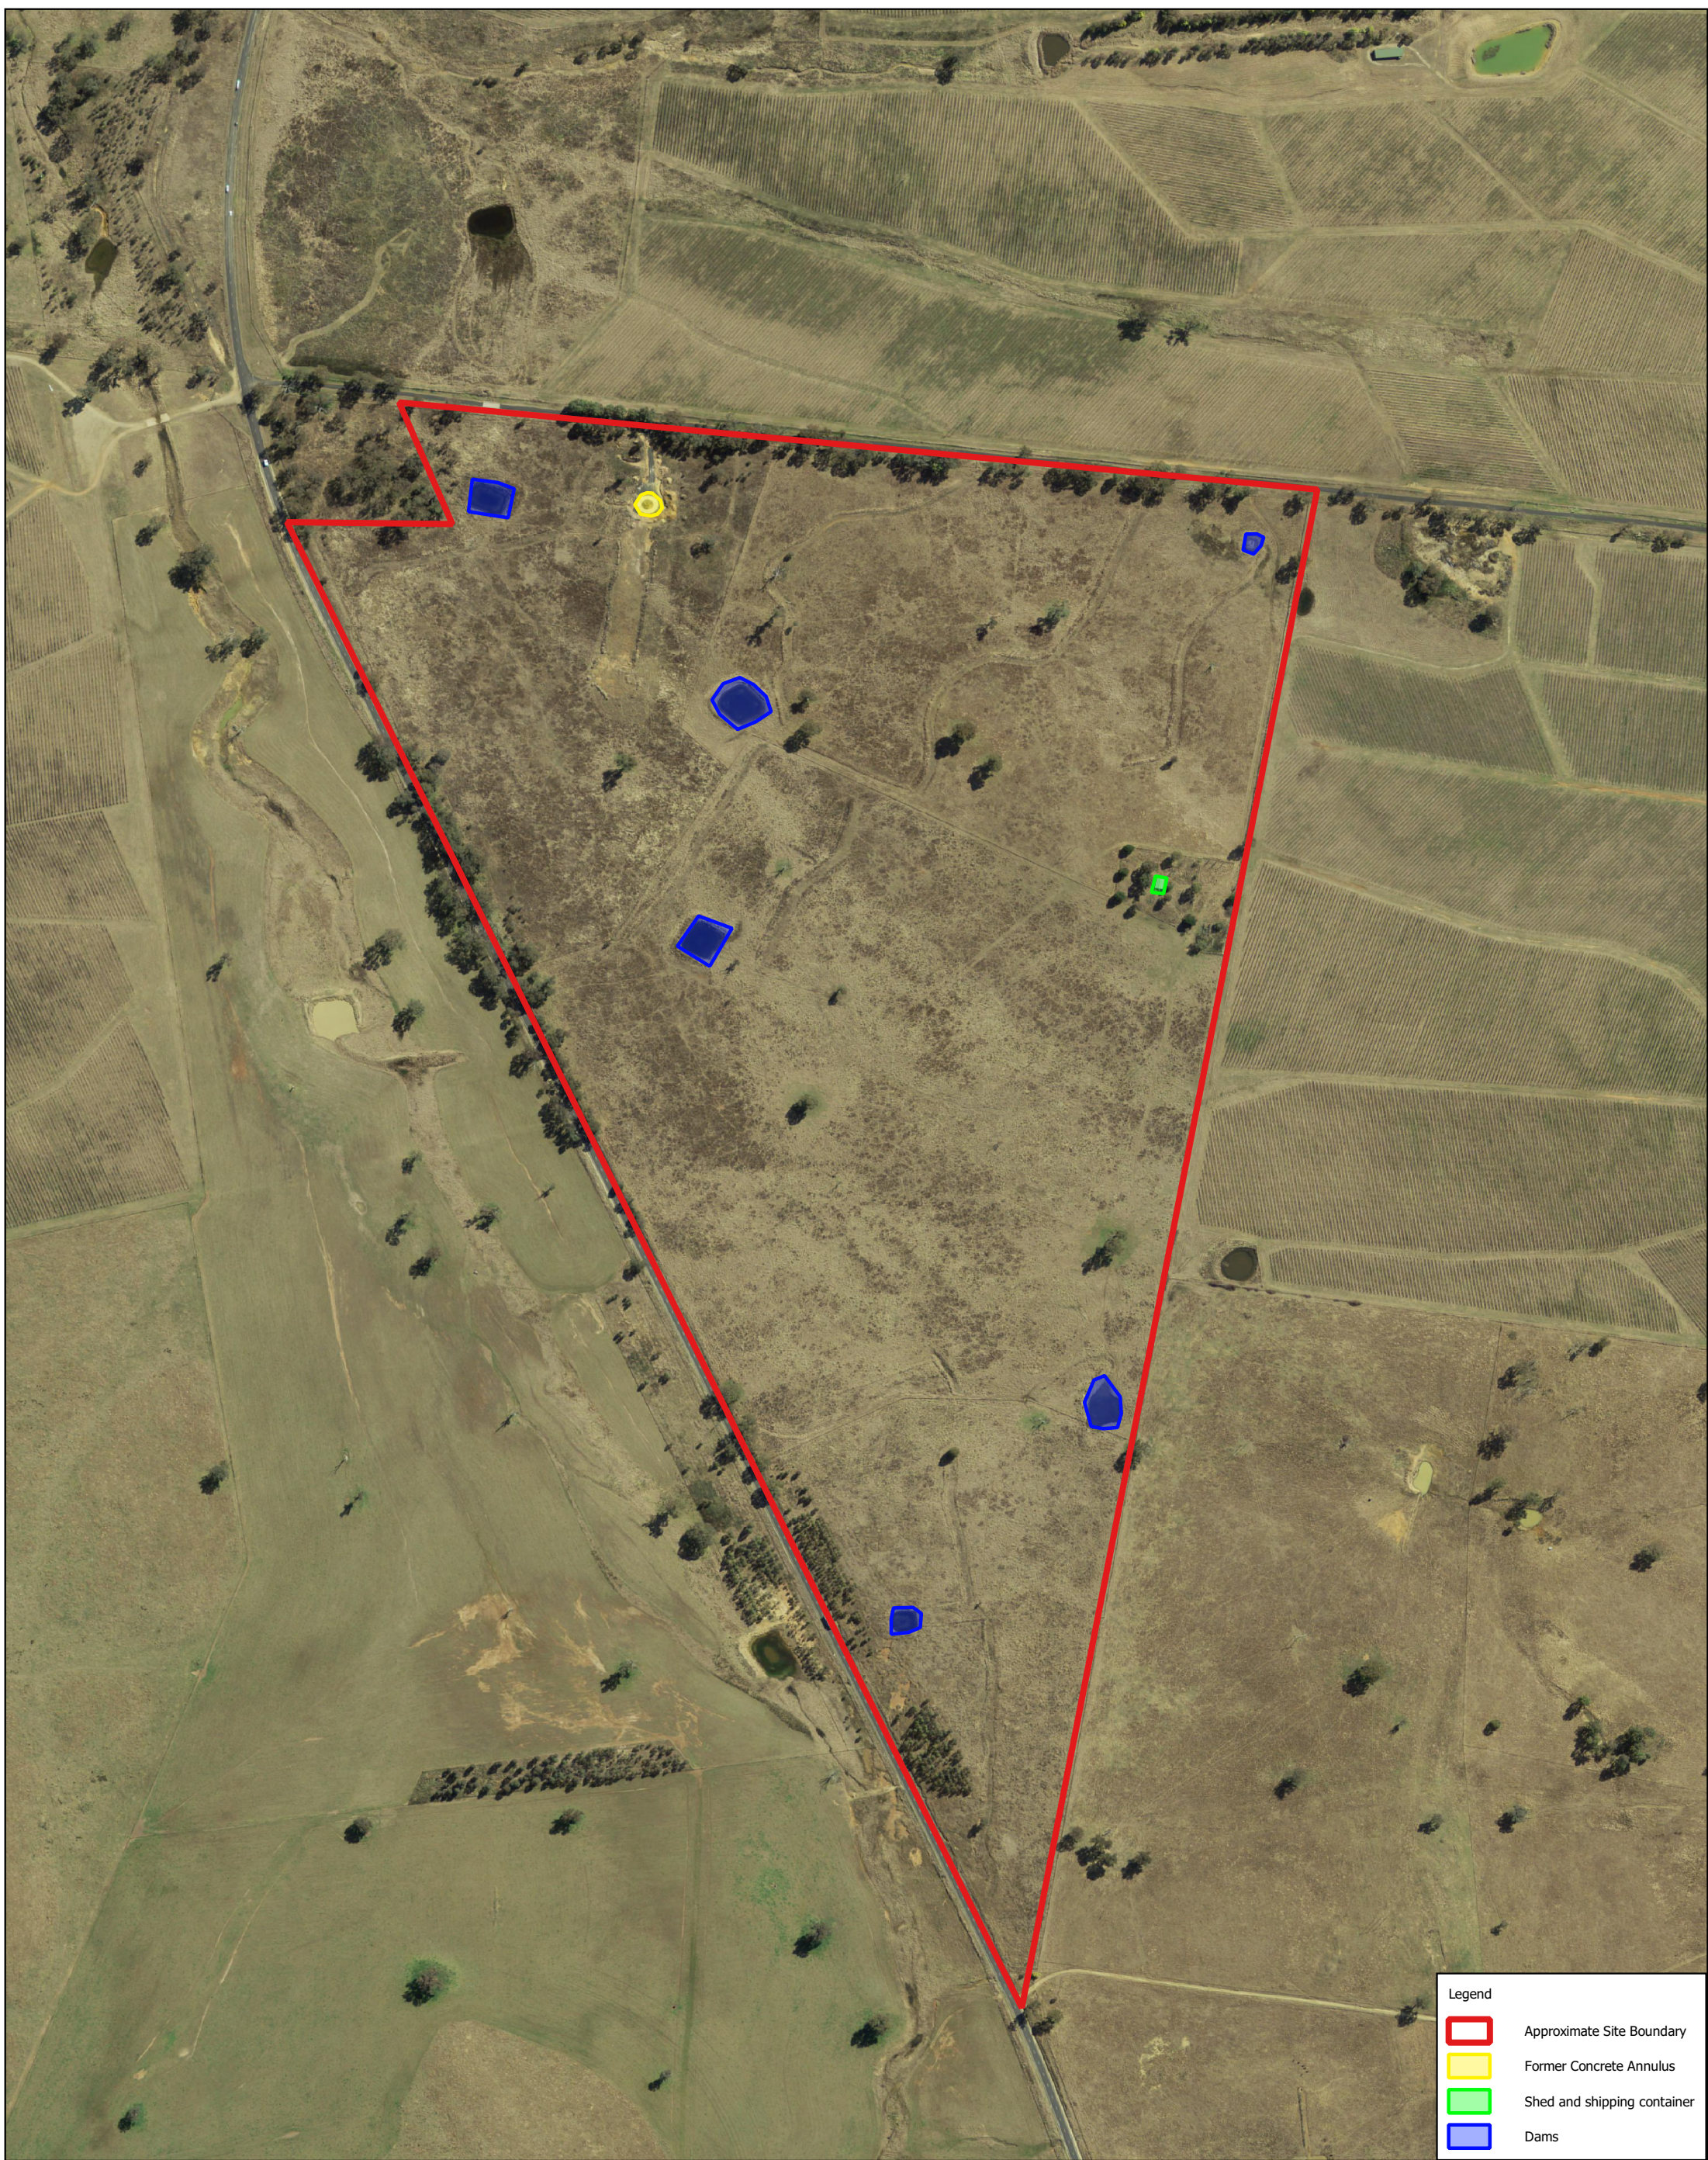
- Approximate Site Boundary
- Former Concrete Annulus
- Shed and shipping container
- Dams

General site features observed consisted of a Shed and shipping container along the eastern boundary of the Site, a partially constructed internal road in the central northern portion of the Site, a concrete annulus for a previously proposed roundabout, approximately six (6) main onsite dams and multiple areas of recontouring of the Site.

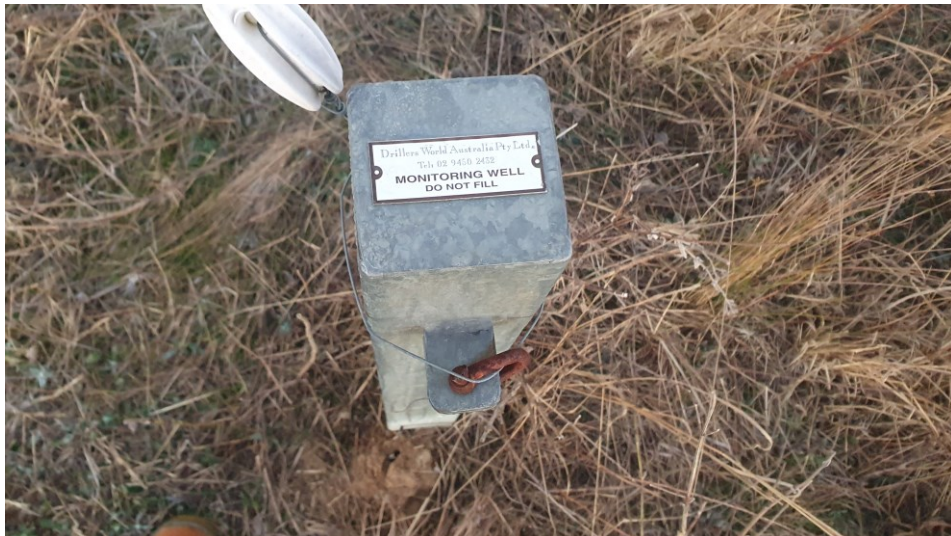
Plate 12

Description:
monitoring well
on site

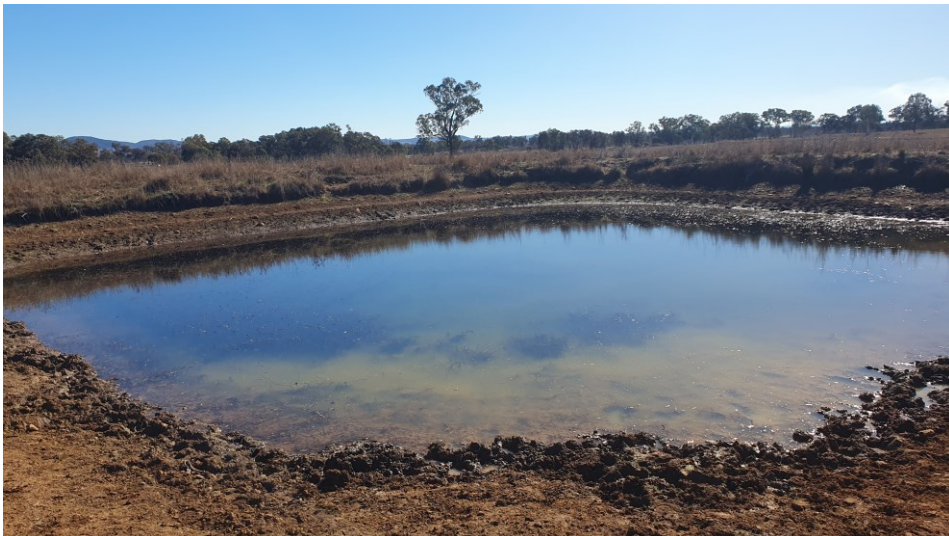
Plate 16

Description:
Dam in the
central area of
the site

The site vegetation consists of short grass with scattered mature trees across the site. Several small dams associated with the primary production activities have been noted on site.

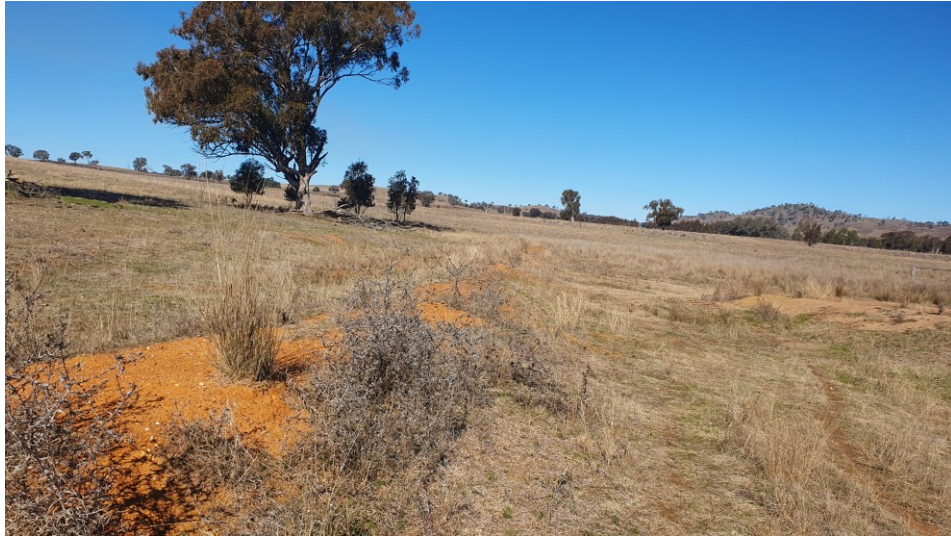
Plate 17

Description: Hill recontouring in the northern section of the site

Recontouring of the hill slopes to reduce the scoring have been observed in the northern section of the site. Two ephemeral water courses run across the site following the contour lines from east to west.

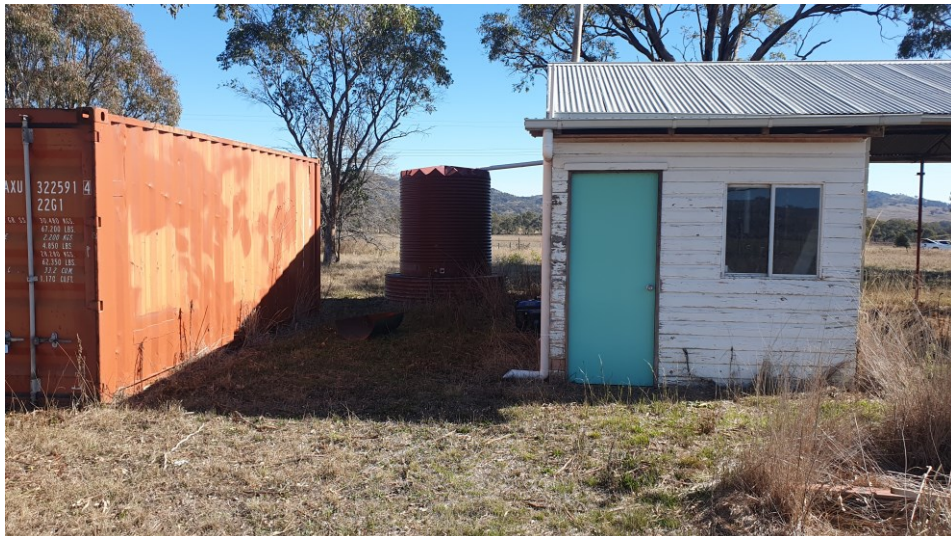
Plate 18

Description: Shed and container on site

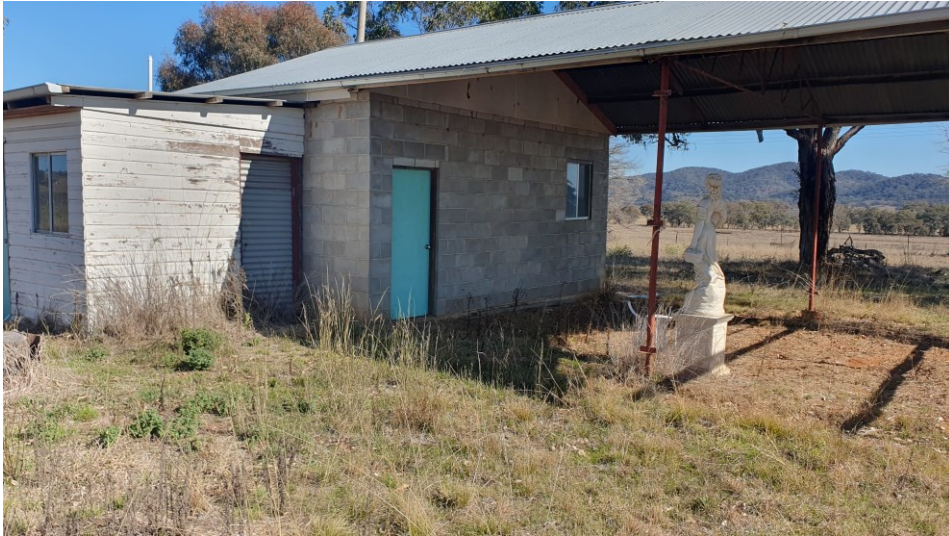
Plate 19

Description:
Shed/structure
identified in the
central eastern
boundary of
the Site.

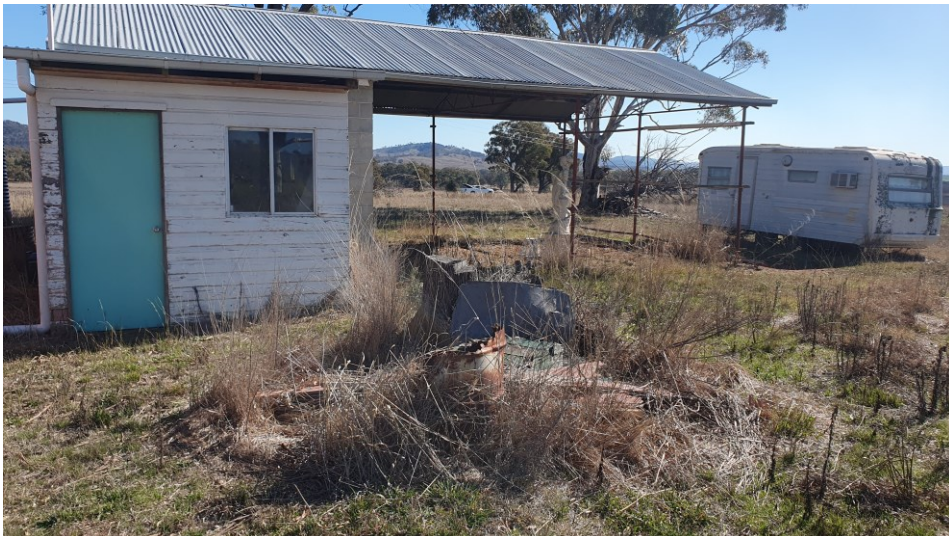
Plate 20

Description:
Shed/structure
identified in the
central eastern
boundary of
the Site.
Potential Septic
tank visible.
