Riparian Assessment Report

Proposed Caravan Park Development at 313 Magpie Lane,
Galambine NSW

Prepared for: ADW Johnson
AEP Ref: 3282
Revision: 00
December 2023

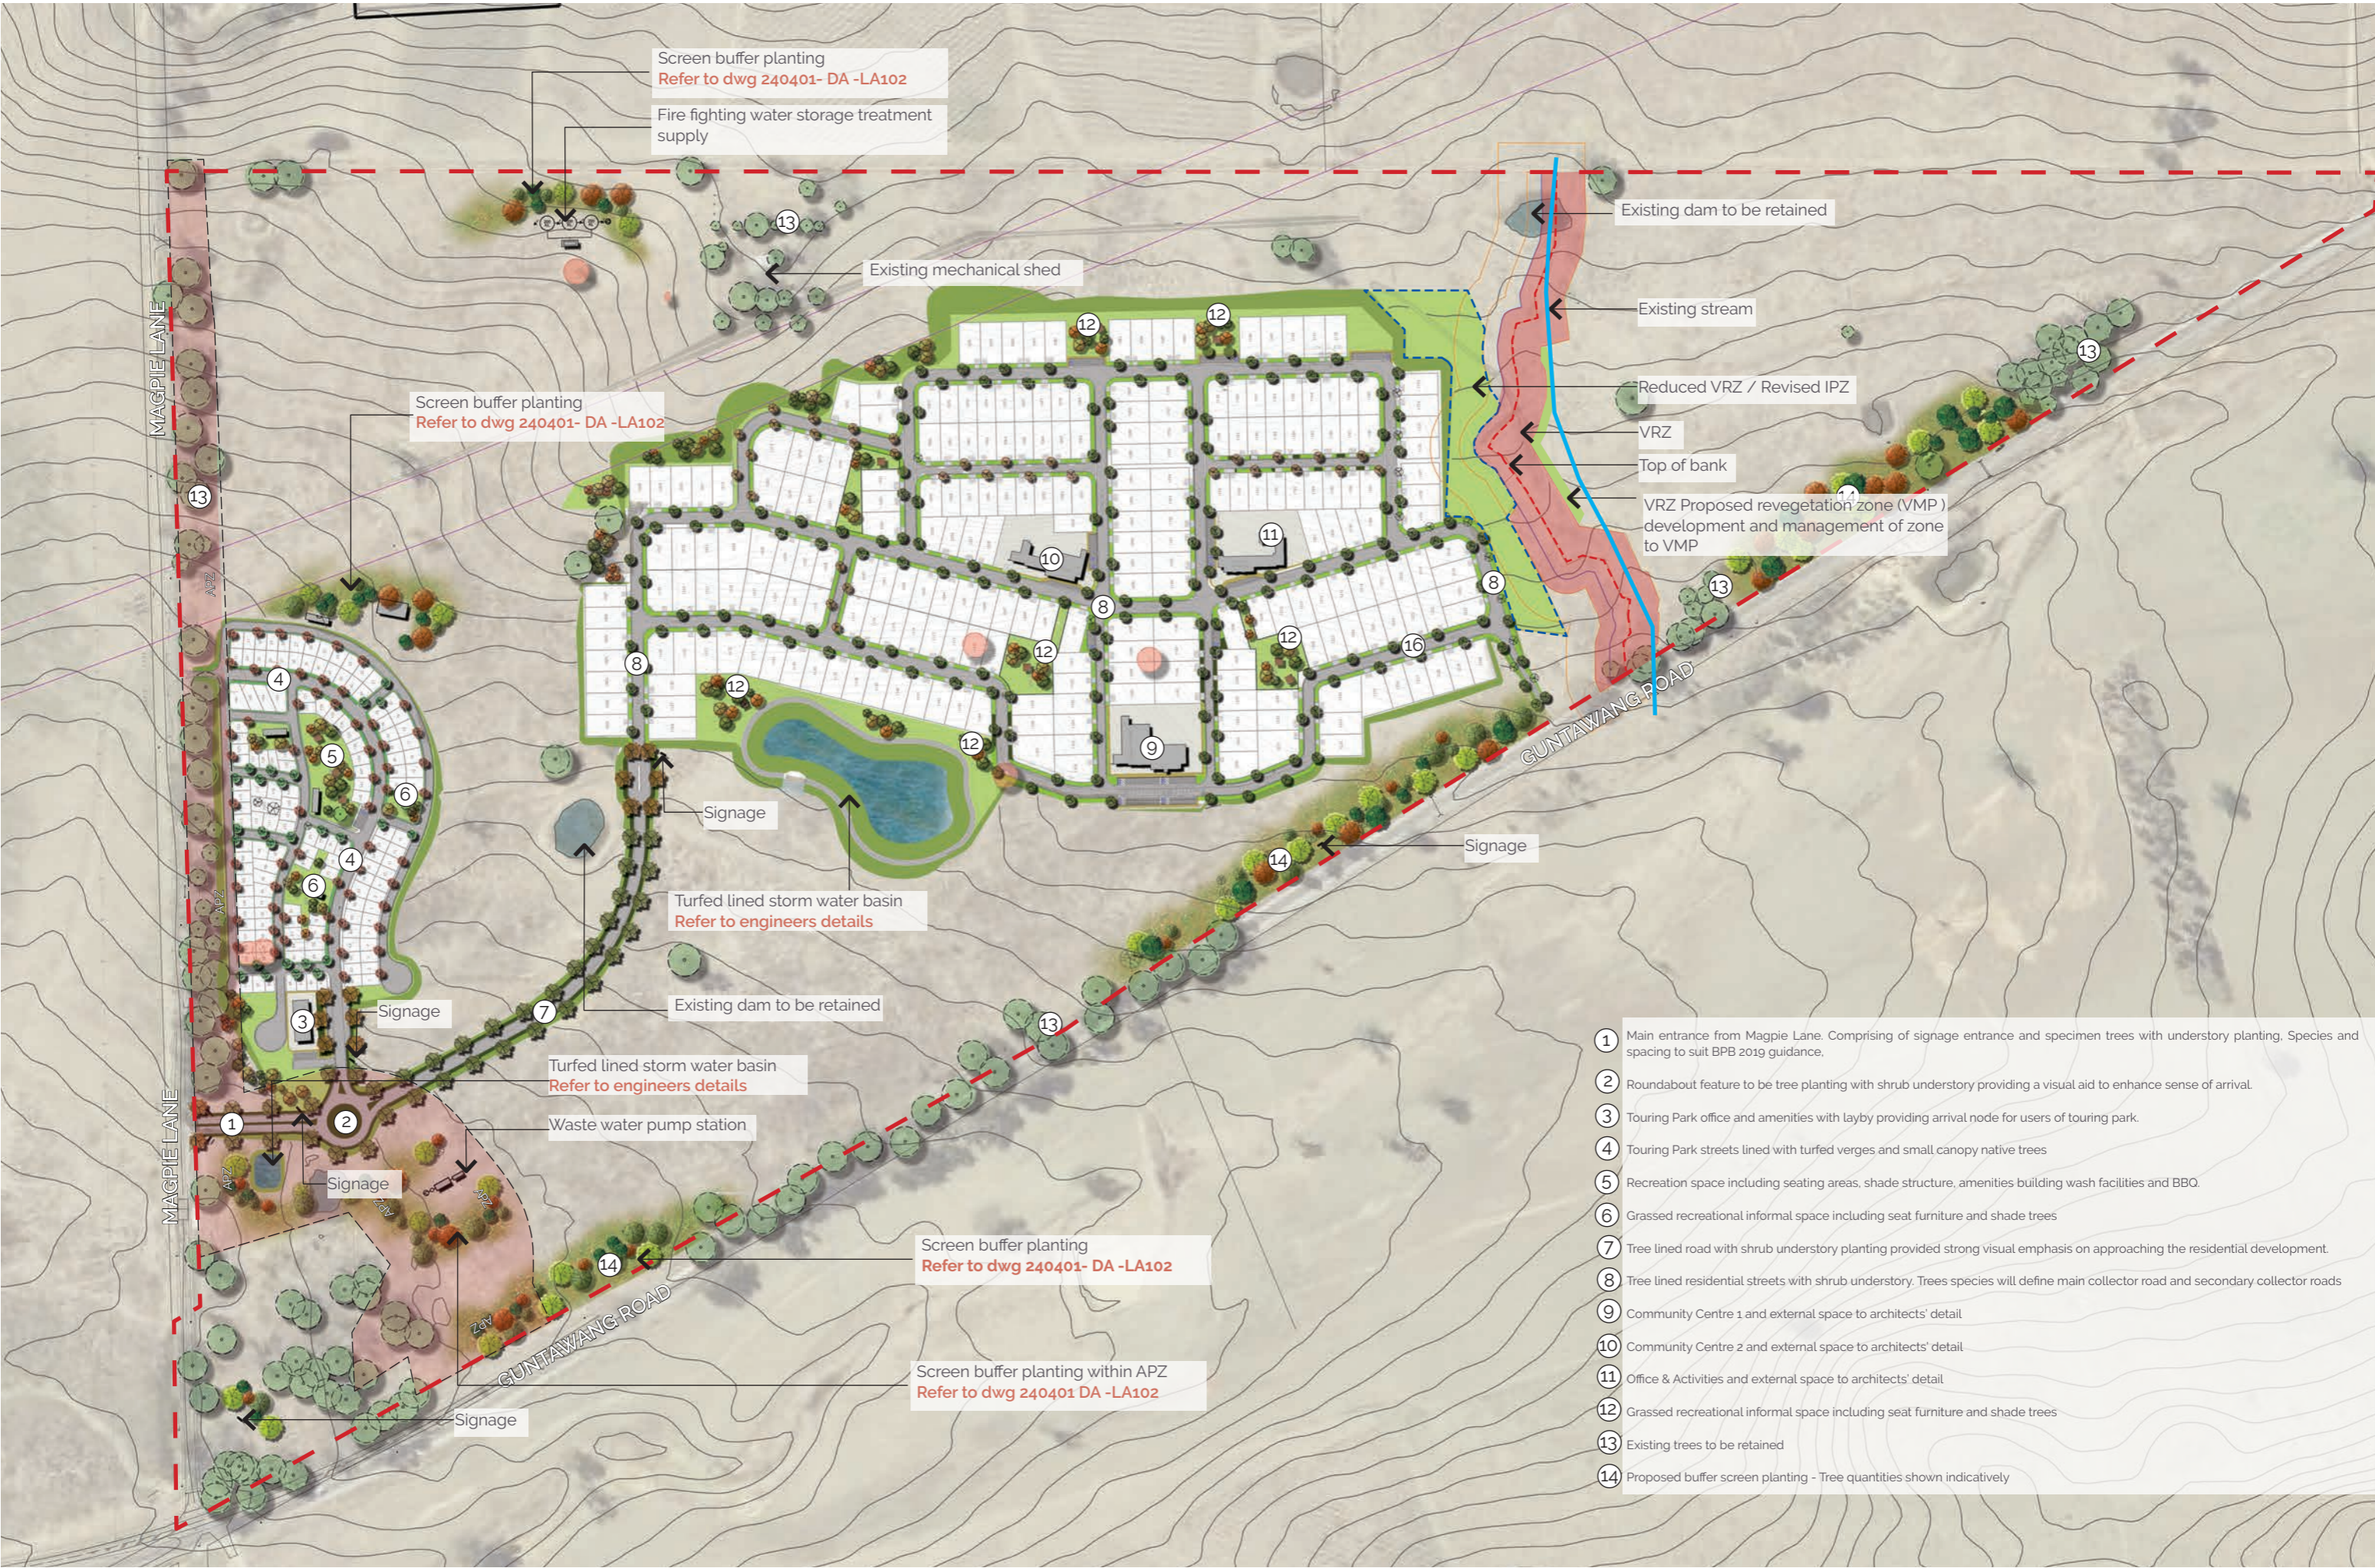
Existing stream

Reduced VRZ / Revised IPZ

VRZ

Top of bank

VRZ Proposed revegetation zone (VMP) development and management of zone to VMP

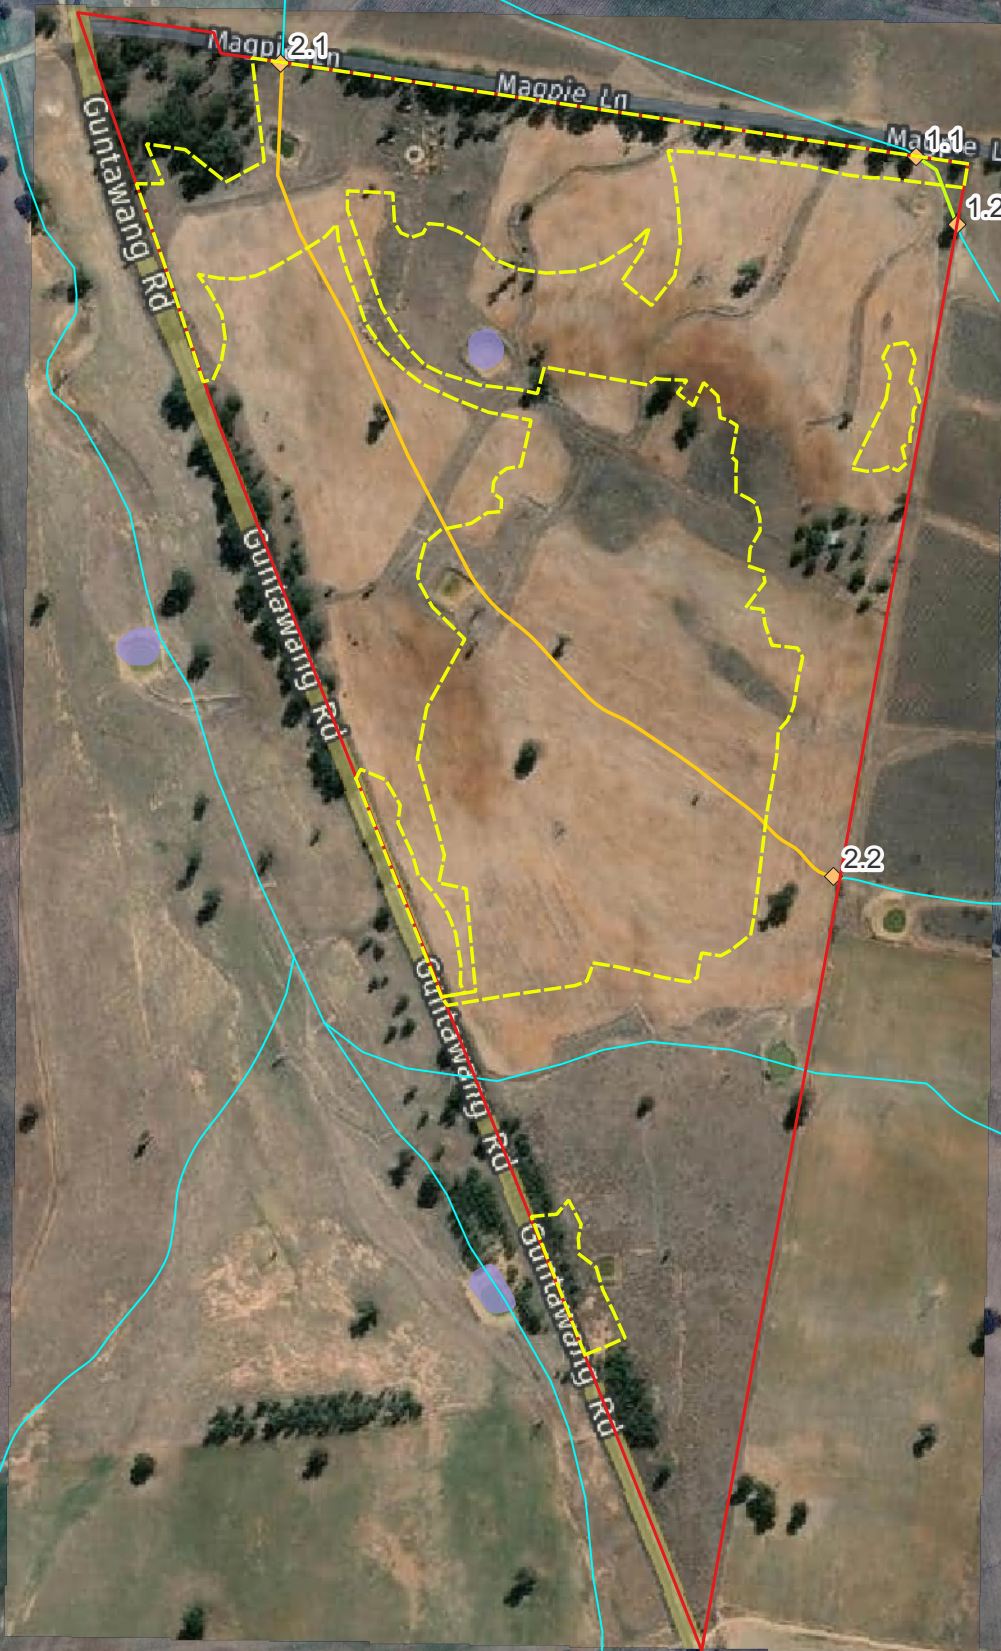
Figure 4 - Survey Identification Number

Site investigations to ground-truth the two (2) 1st order watercourses identified some variation from the mapped hydrolines and stream order, as such two (2) segments were identified and four (4) survey points were investigated (refer to **Tables 2-4**, and **Figures 4** and **5**).

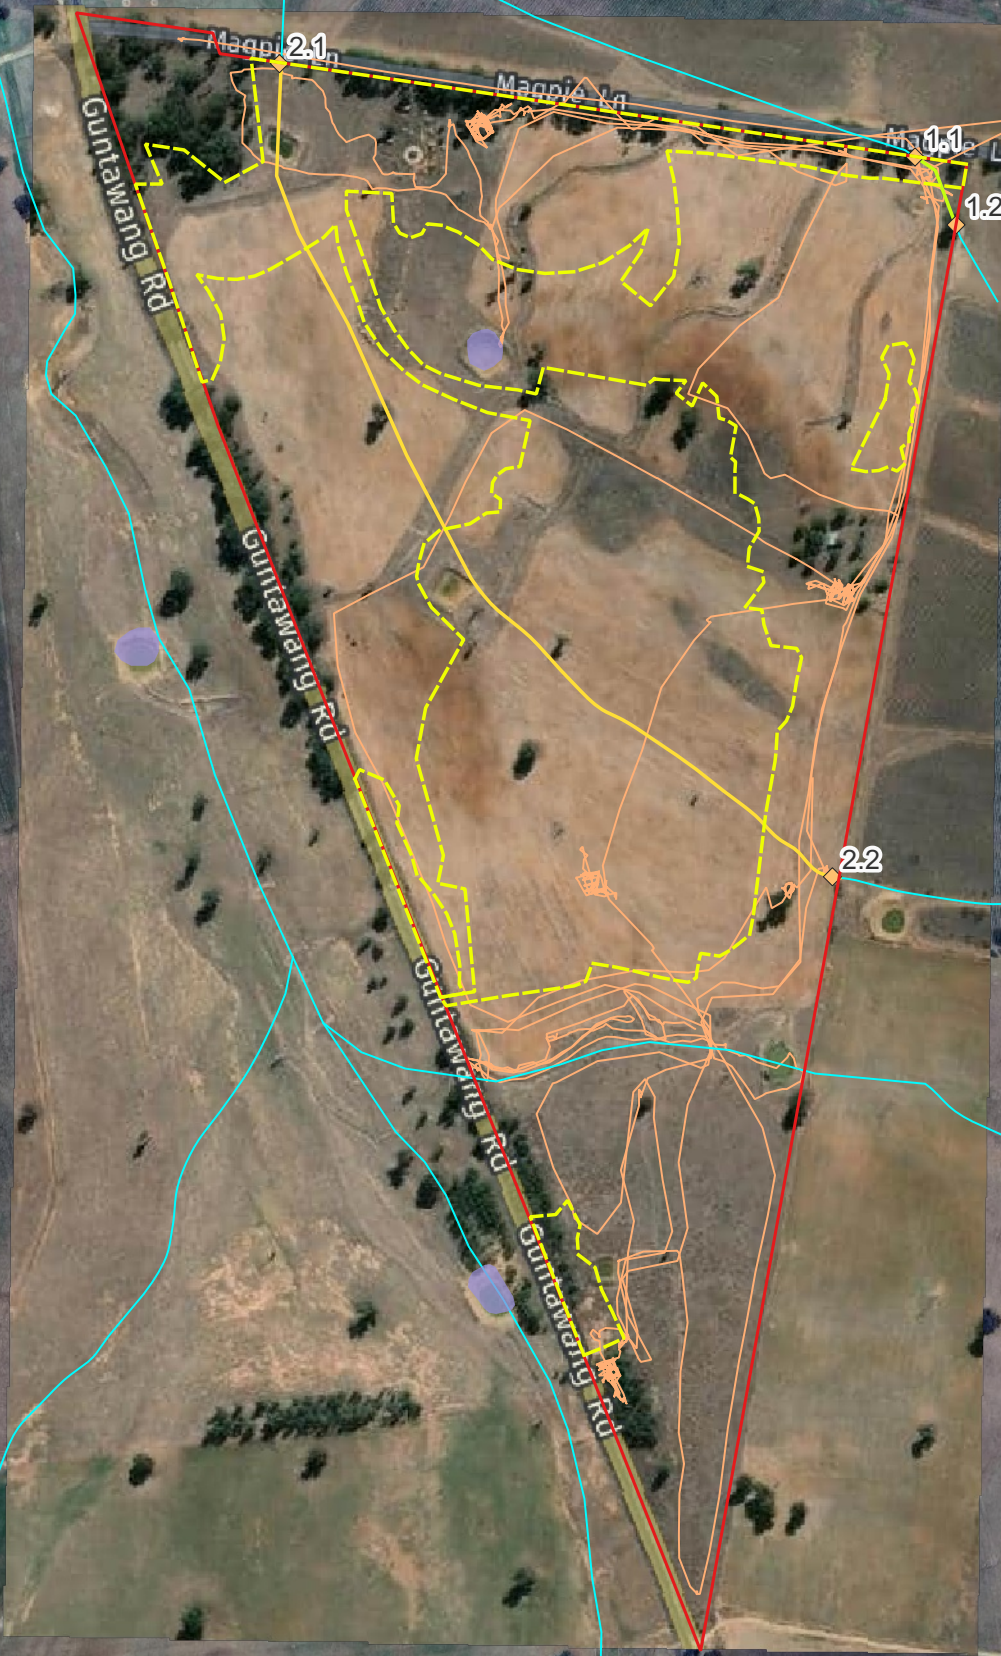
Figure 5 - Survey Effort

General observations outside of the subject site were undertaken to assess the hydrolines in the broader locality (refer **Figure 5** for survey effort).

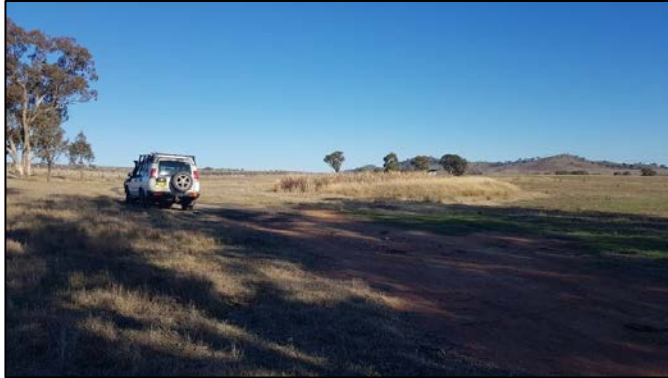
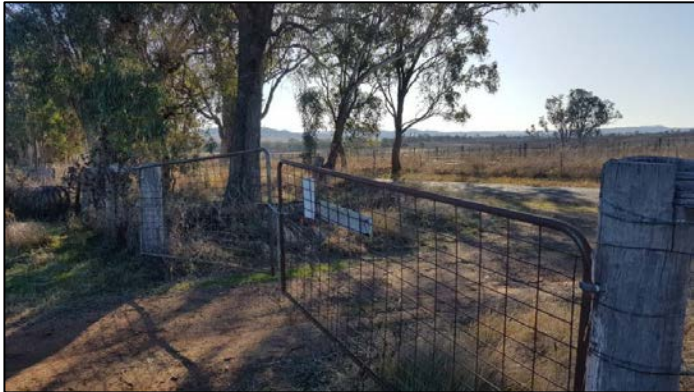
<p>Plate 1: Survey Point 1.1 facing south.</p> <p>Plate 2: Survey Point 1.1 facing north-west.</p>

Ground-truthed Waterfront Land present?	No	The inspection shows no defined bed and bank, or any watercourse features described in Appendix 6 of the Waterfront Land Tool. The 1 st order stream as mapped was not observed and does not constitute waterfront land.	5, 6
Ground-truthed Numbering to Determine VRZ	N/A	No stream present.	-
Controlled Activity Approval Required (Y / N)	No	-	-

Task – Waterland Tool (2020)	Assessment	Comments (provide evidence)	Figure
Vegetated Riparian Zone Required (m)	N/A	No stream present.	-
Comments	The mapped 1 st order stream is not present within the Subject Site.

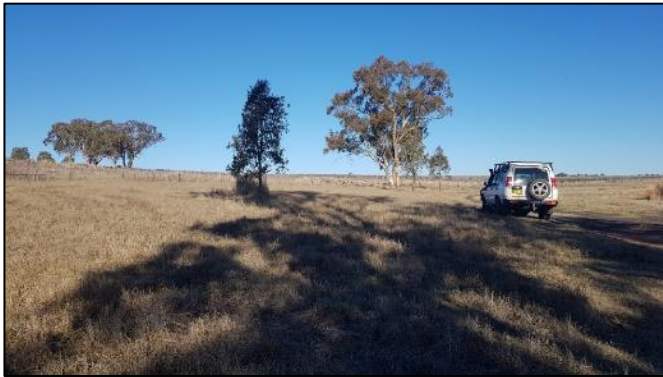
<p>Plate 3: Survey Point 1.1 facing south.</p> <p>Plate 4: Survey Point 1.1 facing north-west.</p>

Task – Waterland Tool (2020)	Assessment	Comments (provide evidence)	Figure
Line Spatial Data Map, what is the stream order of your watercourse?			
Field Assessment – Survey Point 1.2			
Defined Bed and Banks (Yes / No)	No	No defined bed and bank present.	6
Type of Watercourse: Type 1, Type 2, Type 3a, Type 3b, Type 3c, Type 4, Type 5, Type 6, Type 7, None (Refer Appendix 5 - NRAR Guidelines, 2020)	None	No features of a watercourse.	-
Watercourse Feature Present (Pool, Riffle, Erosion and Deposition, None)	No	No water present at the time of survey.	-
Lakes or Wetlands (Appendix 3 - NRAR Guidelines, 2020)	No	None mapped occurring on site.	-
Vegetation Present to Indicate Wetlands (Appendix 7 - NRAR Guidelines, 2020)	No	Vegetation consisted of wet and dry sclerophyll and grassland.	-
High Bank (Appendix 8 - NRAR Guidelines, 2020)	No	No identifiable high bank present.	7
Ground-truthed Waterfront Land present?	No	The inspection shows no defined bed and bank, or any watercourse features described in Appendix 6 of the Waterfront Land Tool. The 1 st order stream as mapped was not observed and does not constitute waterfront land.	5, 6

Ground-truthed Numbering to Determine VRZ	N/A	No stream present.	-
Controlled Activity Approval Required (Y / N)	No	-	-
Vegetated Riparian Zone Required (m)	N/A	No stream present.	-
Comments	The mapped 1 st order stream is not present within the Subject Site.

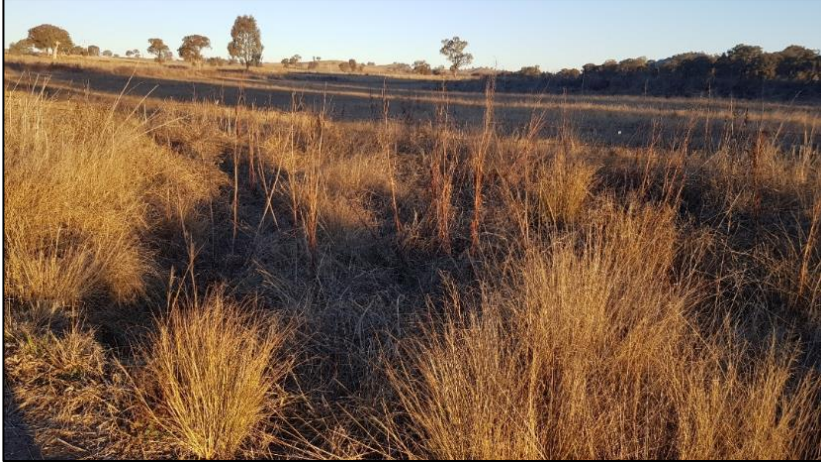
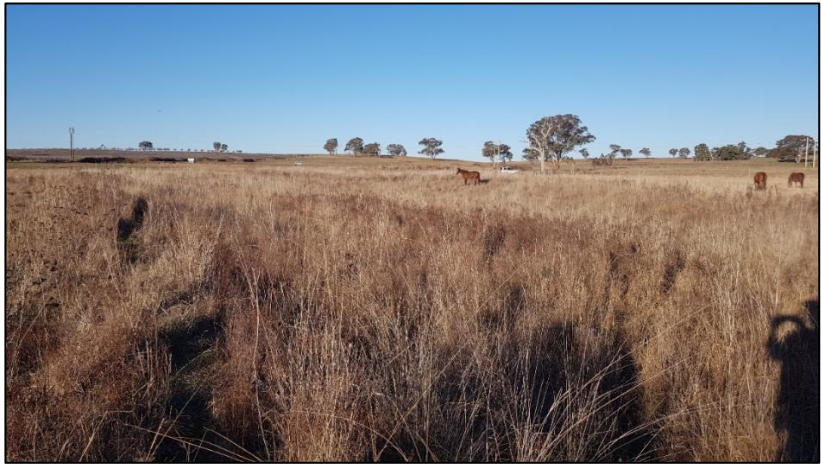
<p>Plate 5: Survey Point 2.1 facing south.</p> <p>Plate 6: Survey Point 2.1 facing north.</p>

Ground-truthed Waterfront Land present?	No	The inspection shows no defined bed and bank, or any watercourse features described in Appendix 6 of the Waterfront Land Tool. The 1 st order stream as mapped was not observed and does not constitute waterfront land.	5, 6, 7
Ground-truthed Numbering to Determine VRZ	N/A	No stream present.	6
Controlled Activity Approval Required (Y / N)	No	-	-

Task – Waterland Tool (2020)	Assessment	Comments (provide evidence)	Figures
Vegetated Riparian Zone Required (m)	N/A	No stream present.	7
Comments	The mapped 1 st order stream is not present within the Subject Site.

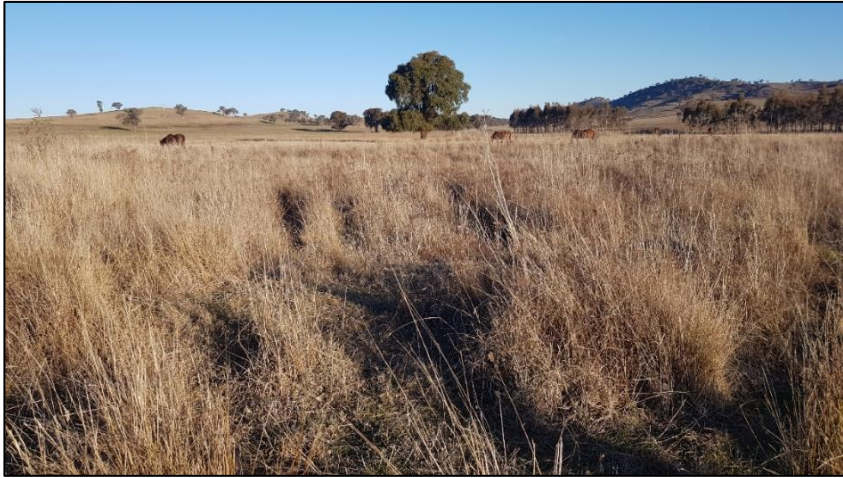
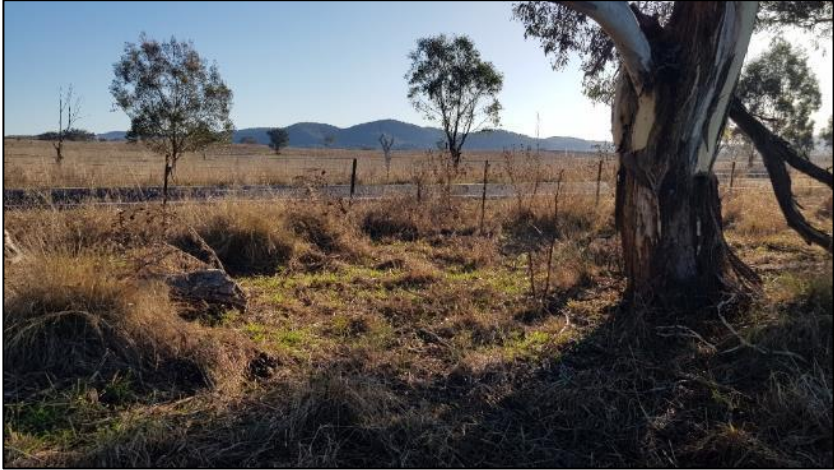
<p data-bbox="576 853 1018 882">Plate 5: Survey Point 2.2 facing north.</p> <p data-bbox="580 896 1013 925">Plate 6: Survey Point 2.2 facing west.</p>

High Bank (Appendix 8 - NRAR Guidelines, 2020)	No	No identifiable high bank present.	7
Ground-truthed Waterfront Land present?	No	The inspection shows no defined bed and bank, or any watercourse features described in Appendix 6 of the Waterfront Land Tool. The 1 st order stream as mapped was not observed and does not constitute waterfront land.	5, 6, 7
Ground-truthed Numbering to Determine VRZ	N/A	No stream present.	6
Controlled Activity Approval Required (Y / N)	No	-	-
Vegetated Riparian Zone Required (m)	N/A	No stream present.	7
Comments	The mapped 1 st order stream is not present within the Subject Site.

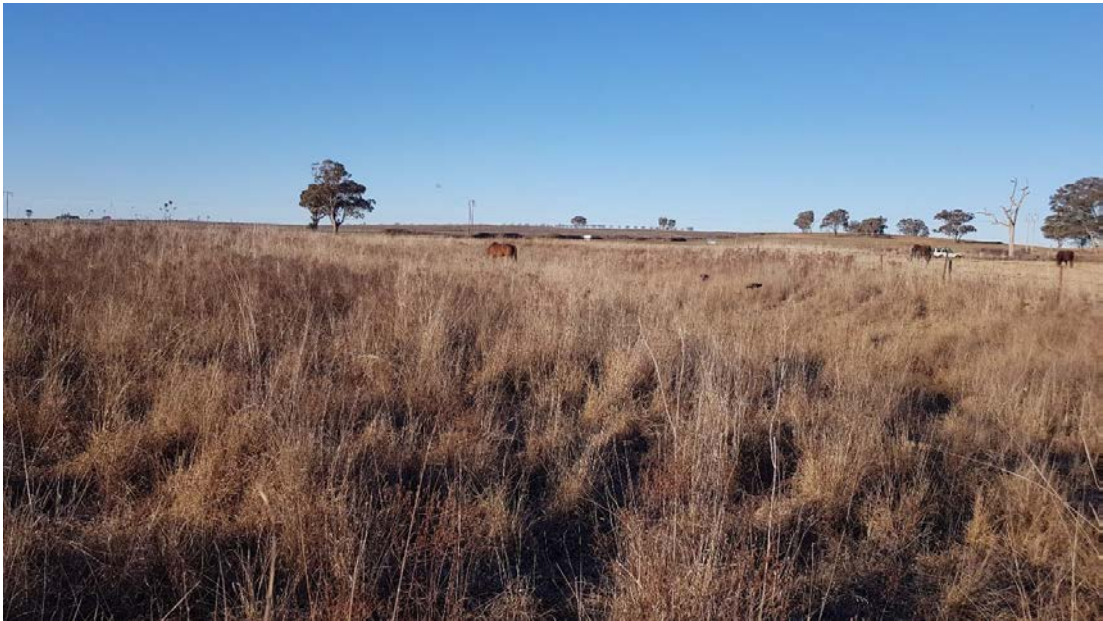
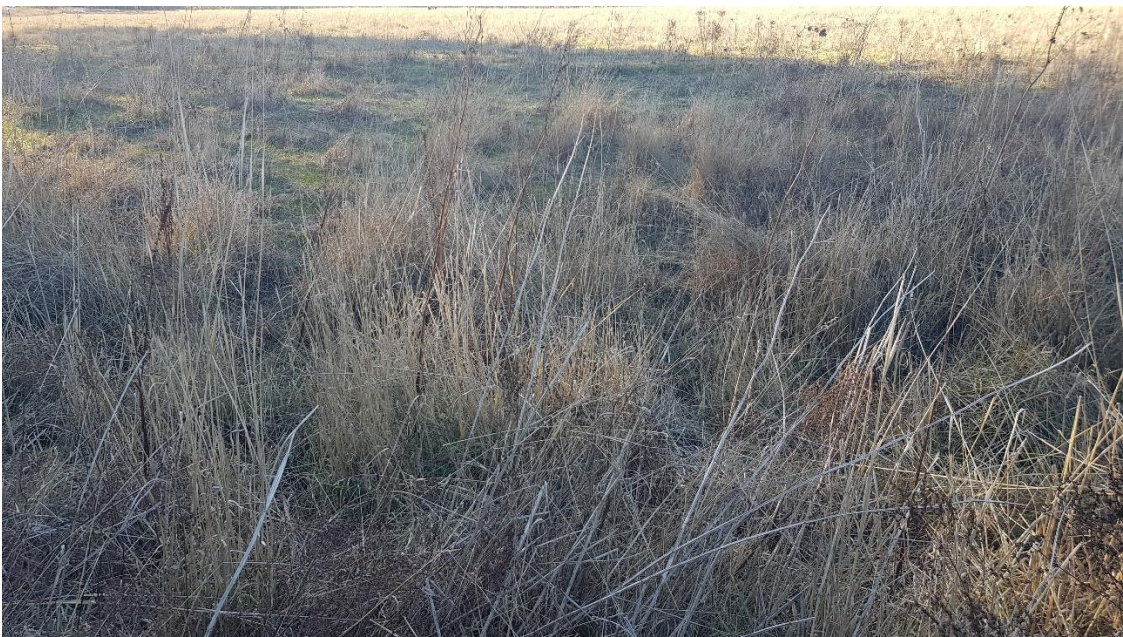
Additional photos were taken along the mapped hydroline location to demonstrate lack of presence on-ground:

Above: Looking south-west.

Below: Example of vegetation along the mapped hydroline. No evidence of a watercourse is present.

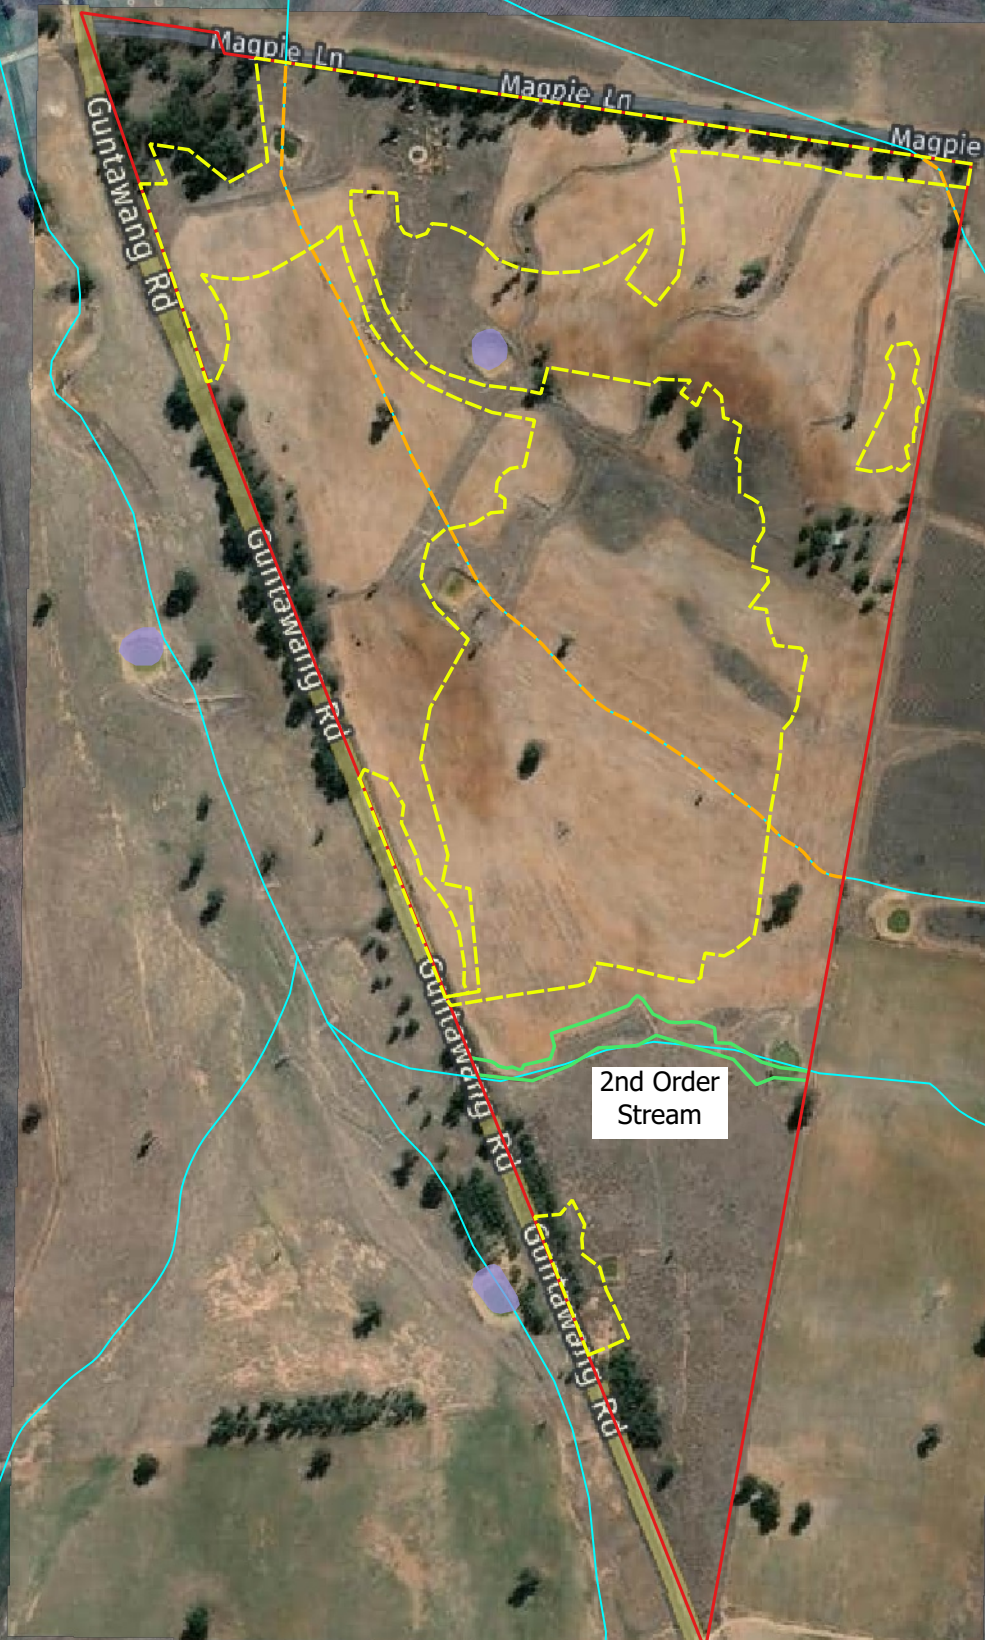
Figure 6 - Ground-truthed SStream Order
Location: 313 Magpie Lane, Galambine, NSW
Client: ADW Johnson

Fieldwork was conducted in July 2023 to ground-truth the stream order of the watercourses within the Subject Site and in the surrounding locality as is mapped in the New South Wales Hydroline Data Set. Desktop investigations determined that two (2) 1st order and one (1) 2nd order streams occur within the Study Area.

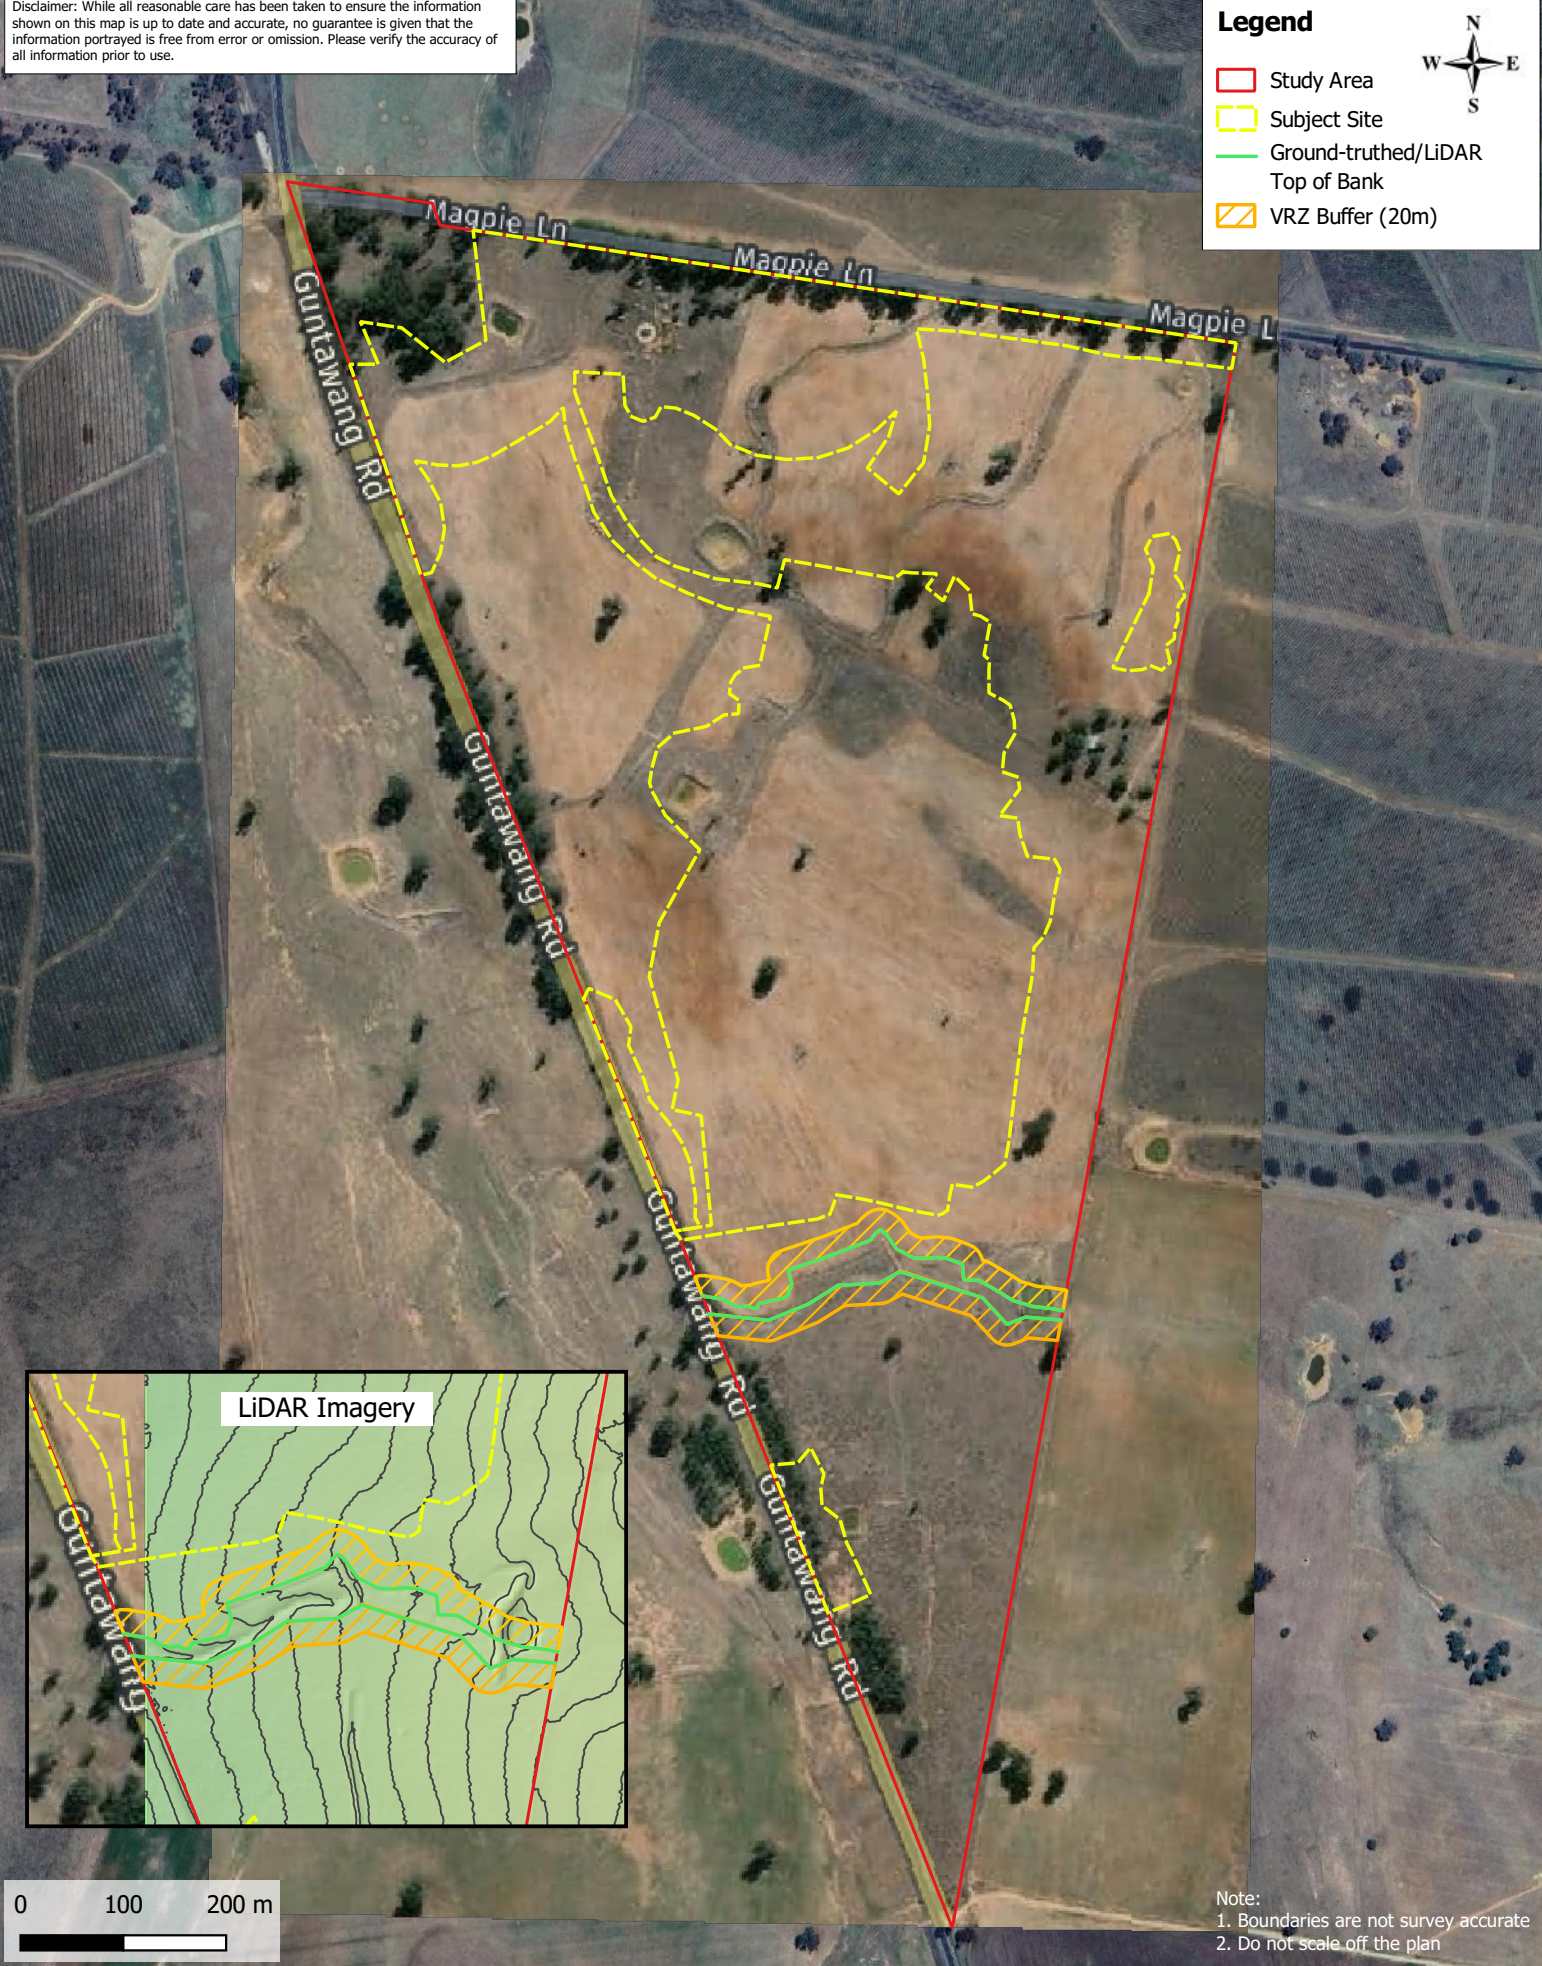
Figure 7 - Top of Bank and VRZ

The 2nd order stream was not included within the watercourse assessment, as it is located south of the proposed development, however, Top of Bank ground-truthing and LiDAR assessment, and a 20m meter VRZ were assessed and are included in **Figure 7**.

The 2nd order stream in the southern portion of the Study Area is assumed present and will require a 20m VRZ (approx. 1.58ha) either side of the high bank. A CAA is required as proposed works will occur within 40m of waterfront land (of the 2nd order stream).

The proposed development will involve encroachment within the VRZ of an unnamed 2nd order stream. It is noted that encroachment can only occur in the outer 50% of the VRZ.

As a requirement of a controlled activity approval, encroachment into the VRZ requires that the area of encroachment be offset at a ratio of 1:1 along the stream within the Study Area. The offset area will also be required to be managed under a Vegetation Management Plan (VMP) to manage and improve the VRZ.
