Site Contamination Investigation

Client: Mid-Western Regional Council

Site Address: 10-12 Burrundulla Avenue,
Mudgee, NSW 2850

9 June 2023

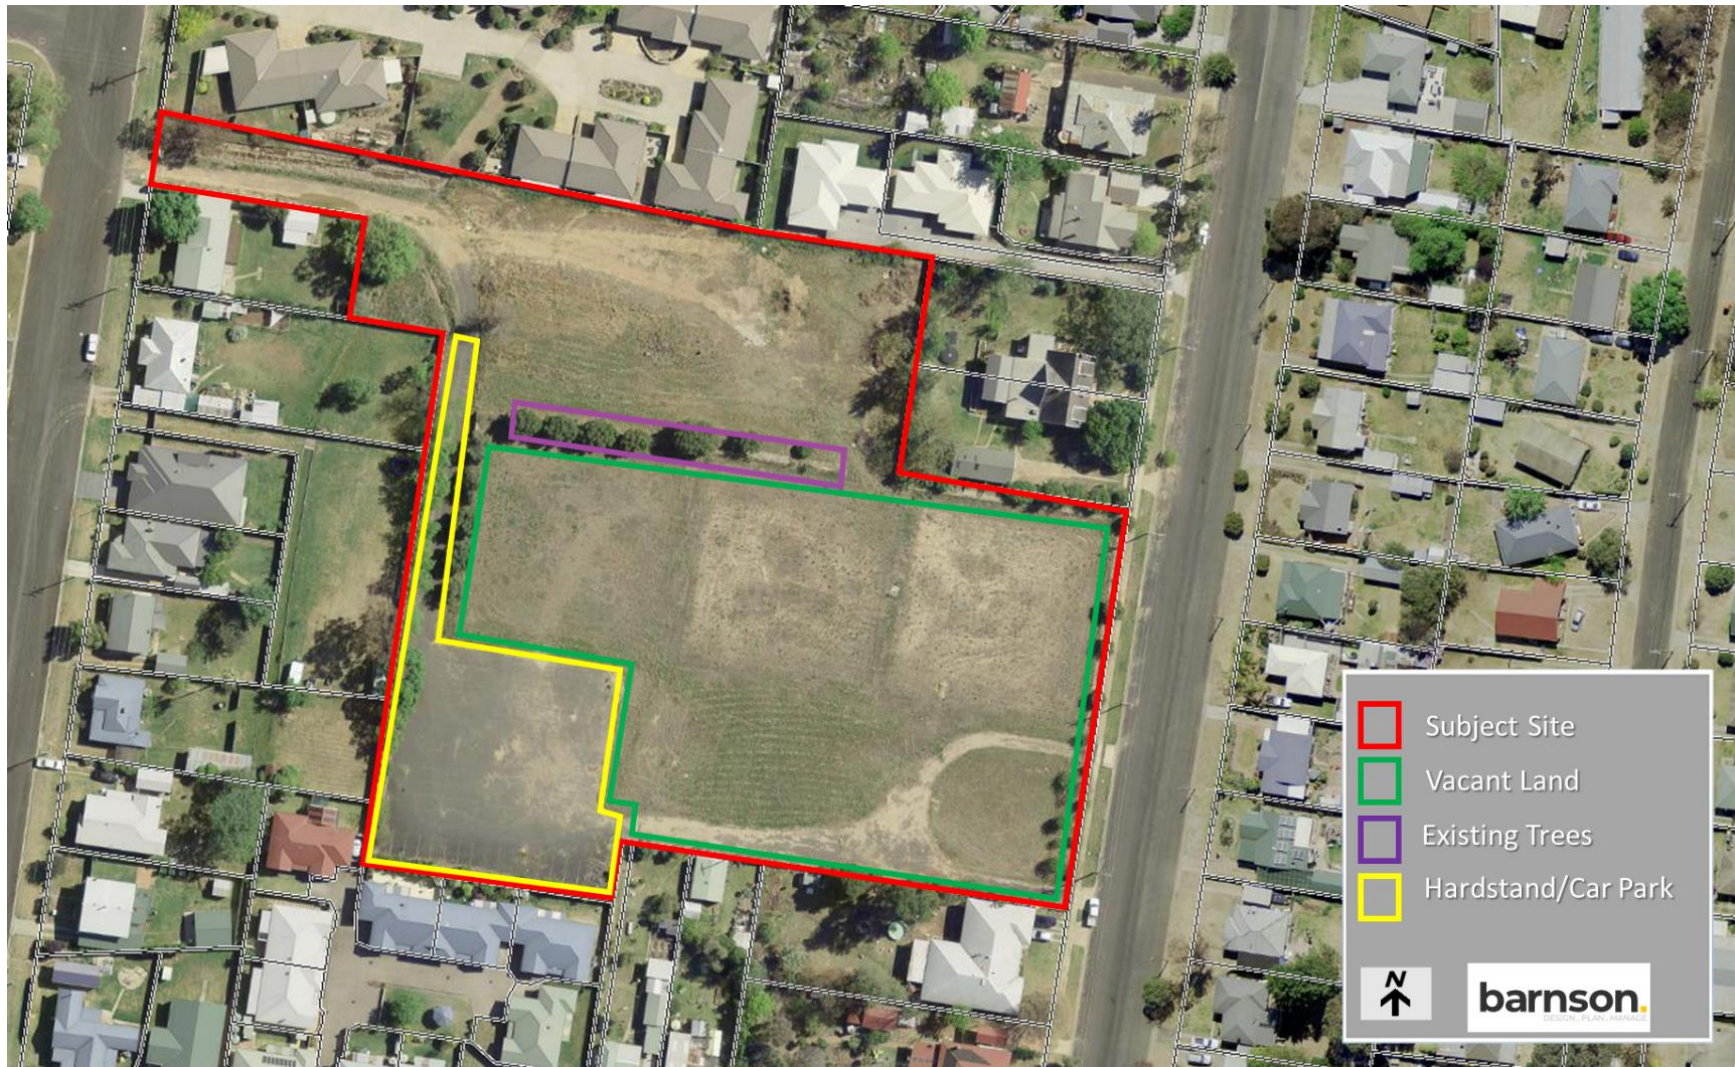
Figure 2.2: Layout of Subject Site.

Figure 2.2 shows an aerial photo of the Subject Site. Features of the Subject Site are indicated as sketch plan overlay on Figure 2.2.

A portion of the site has direct frontage to Burrundulla Avenue to the east, George Street and residential lots to the west, and further residential lots to the north and south. The site is evident to have vehicle tracks and hardstands areas evident on site. The site used to be utilised by the Mudgee Bowling Club.

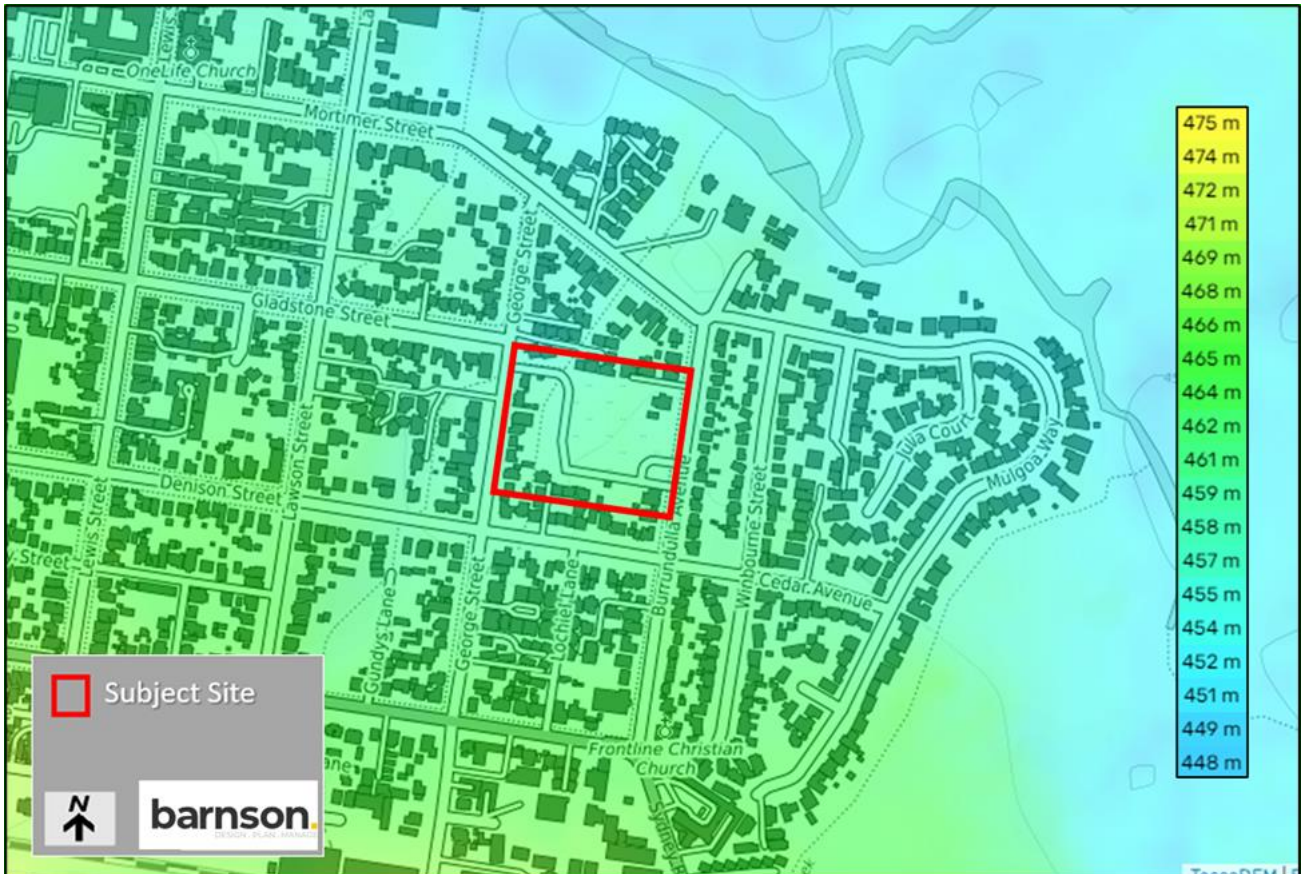
Figure 3.2: Subject Site topography.

Figure 3.2 presents topographical information overlain on a map of the subject site. The presented data shows that the Subject Site is relatively flat throughout. Generally, the site and surrounding locality have an elevation of slight fall to the north.

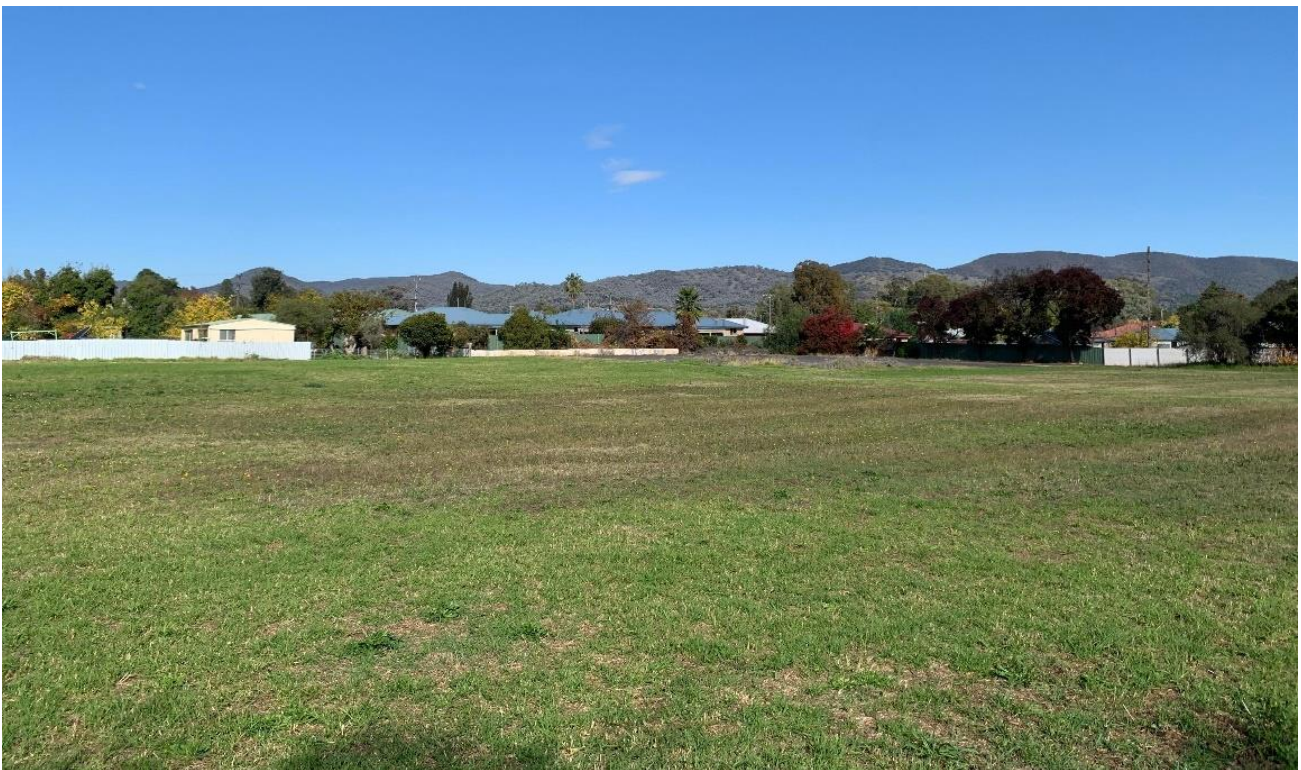
- Vegetation cover of the site was in good condition and appears to be regularly managed (Figure 5.1).

Figure 5.1: Photo of managed vegetation

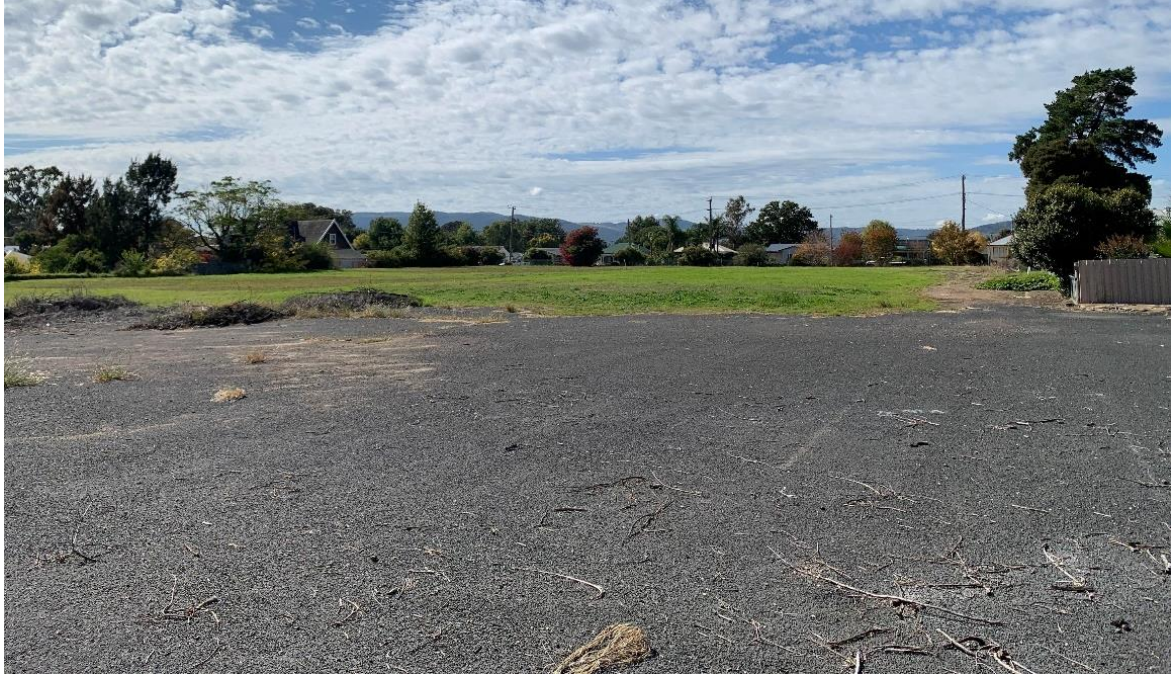
- An area of hardstand, historically utilised for car parking, is located in the southwestern corner of the site (Figure 5.2). Paved driveways link up to the parking area from the north (see Figure 5.3) and east.

Figure 5.2: Hardstand car park

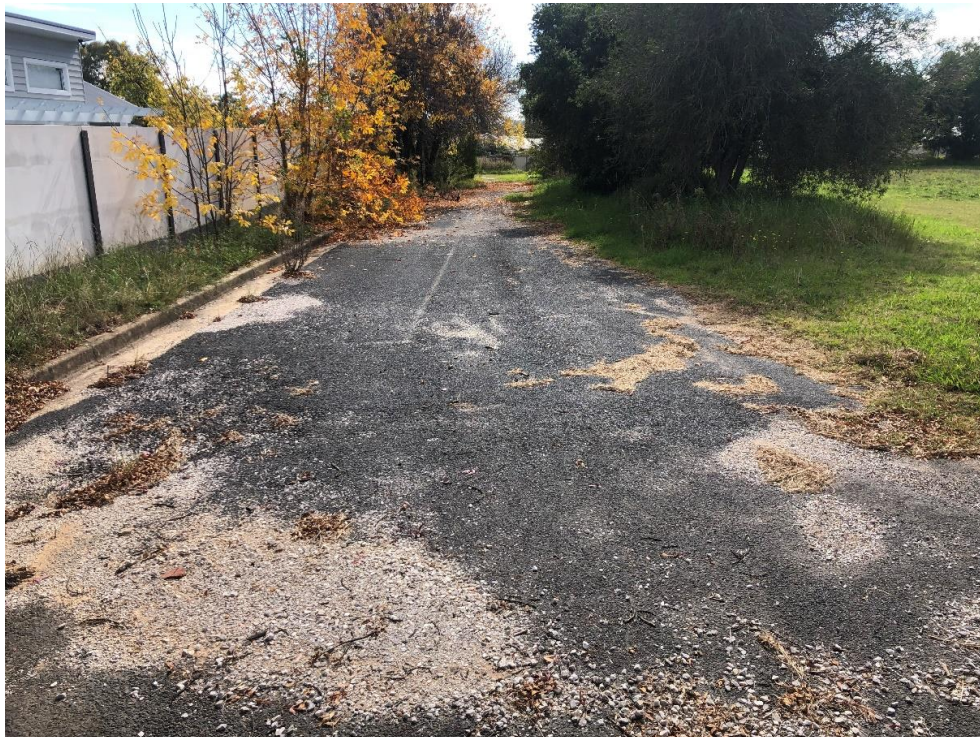
Figure 5.3: Northern driveway providing access from George Street

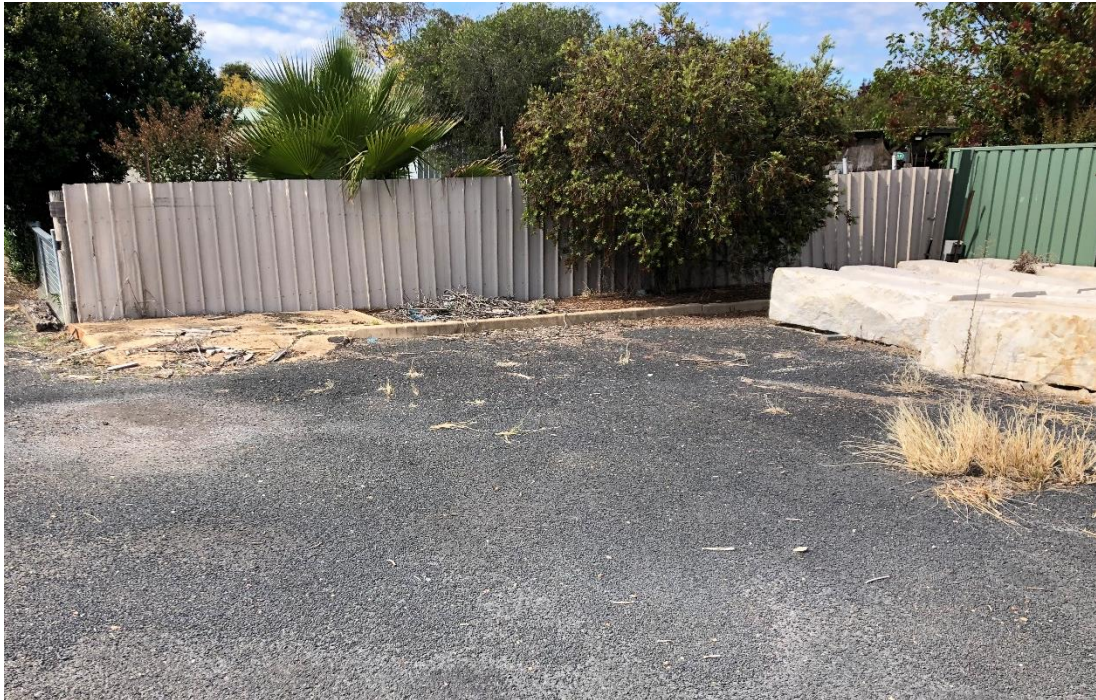
- The former carpark area is used for the storage of large sandstone blocks (Figure 5.4).

Figure 5.4: Sandstone blocks stored at the Subject Site

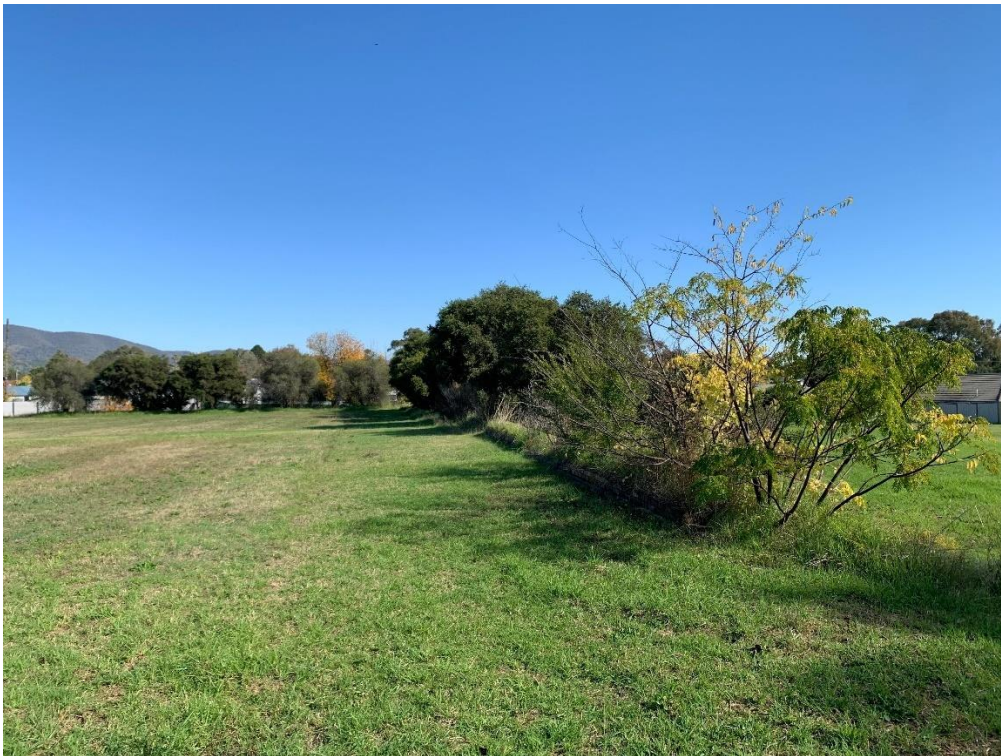
- A retaining wall and a line of trees separate the former bowling greens from an overflow parking area to the north (Figure 5.5).

Figure 5.5: Trees and retaining wall dissecting Subject Site

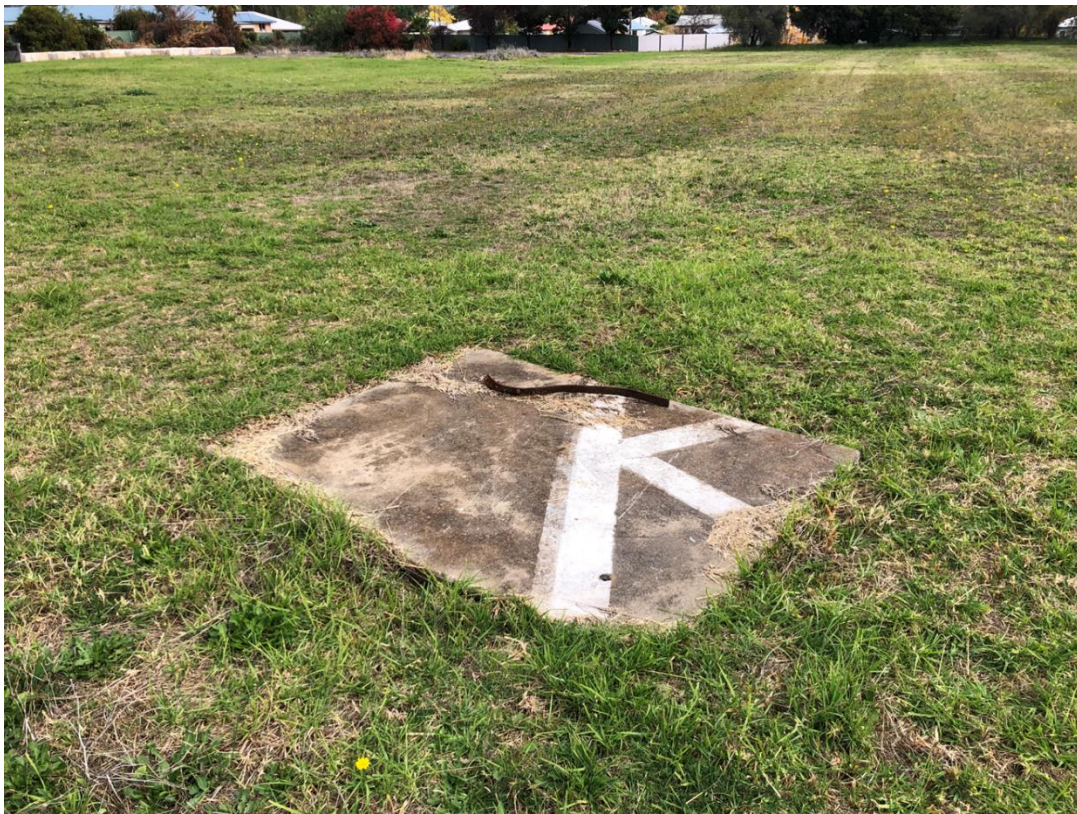
- No visible discoloration or staining of open ground or soil was observed during the site inspection.
- There is evidence of excavations at the corner of the former carpark. This is the area in which the buried asbestos pipe, noted in the previous assessment, was discovered (see Figure 5.2)
- The site is fenced and secured and in general good order without any visible sign of disturbance to the soils or site infrastructure.
- No drainage channels were noted to be present at the site and no surface water was present on the site at the time of inspection. The well noted in the previous assessment was found in the area where the former bowling greens were located but was covered over with concrete (Figure 5.6). The well was not inspected.

Figure 5.6: Covered well in centre of the property.

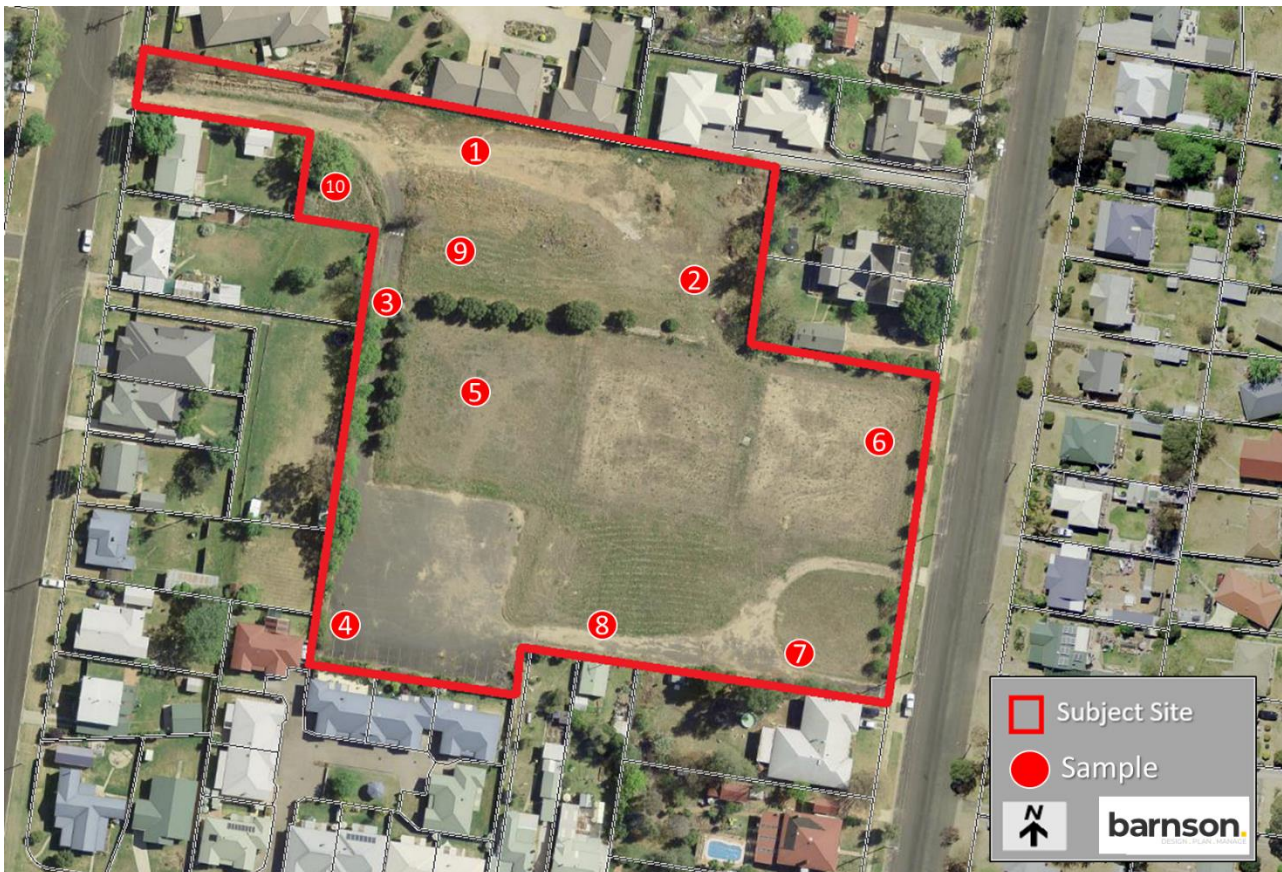
Figure 5.7: Locations of confirmatory surface soil samples.

Figure 5.7 present a map indicating the approximate location of the samples collected. The pattern followed for the sampling can be described as Judgement Sampling, where points are selected on the basis of the investigator’s knowledge of the proposed land use and likely distribution of contaminants at a site. It is an efficient sampling method for confirmatory sampling that utilises knowledge of the site history and field observations to direct sample collection (NSW EPA, 1995).

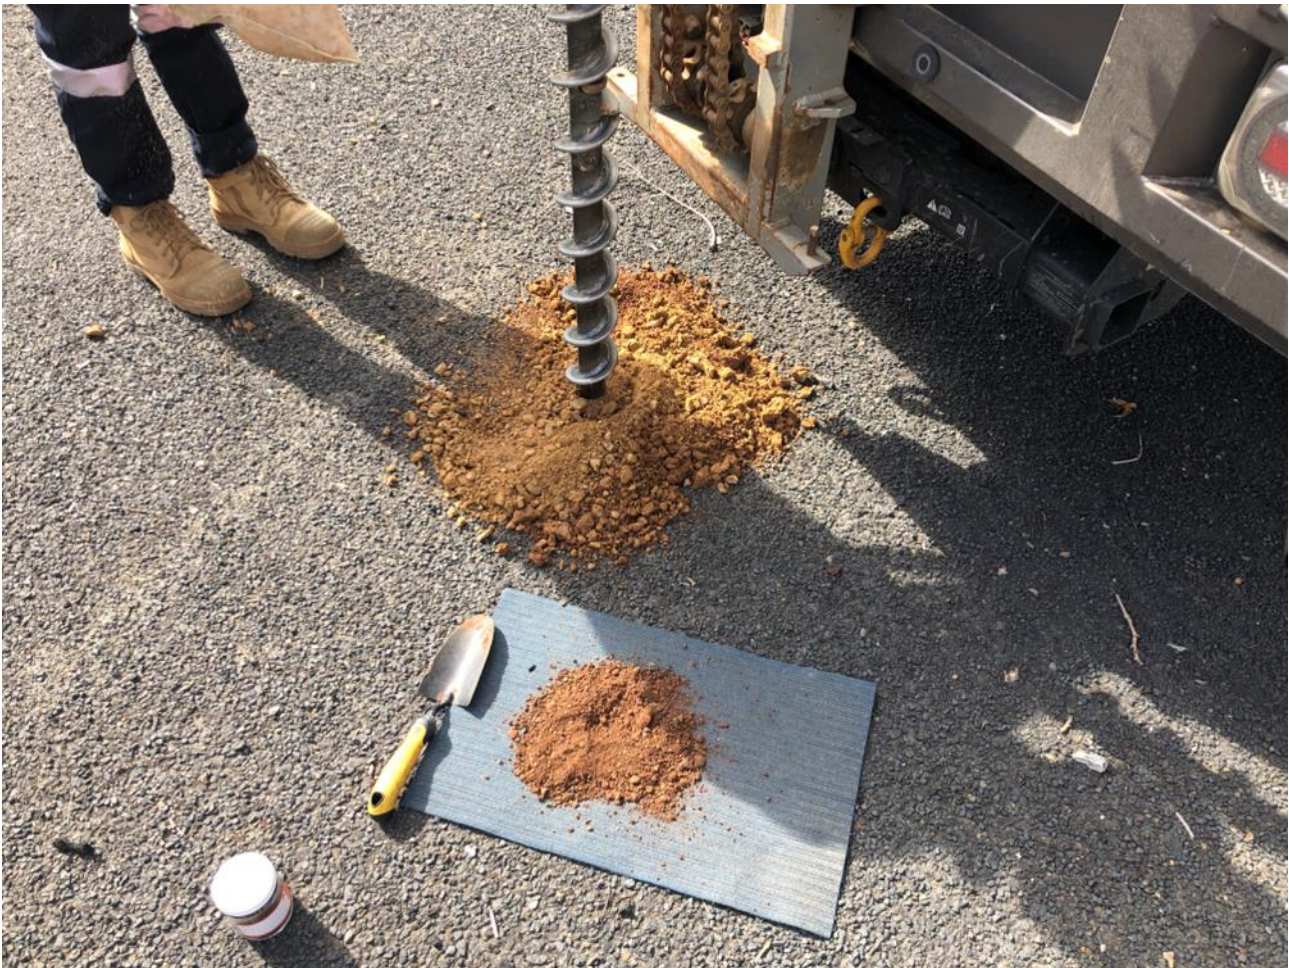
The site investigation was undertaken in conjunction with a geotechnical investigation of the site. Most of the soil samples were therefore collected from geotechnical bores undertaken across the site by means of a vehicle mounted auger drill (Figure 5.8).

Figure 5.8: Geotechnical auger drill bore into hardstand of the former carpark.
