Statement of Environmental Effects

Site Address: 140 Mayne Street, Gulgong

Project Name:	Change of Use to an Office Premises at 140 Mayne Street, Gulgong
Client:	Brodie McGann
Project Number:	45078
Report Reference:	45078-PR01_B
Date:	19 December 2024

Statement of Heritage Impact

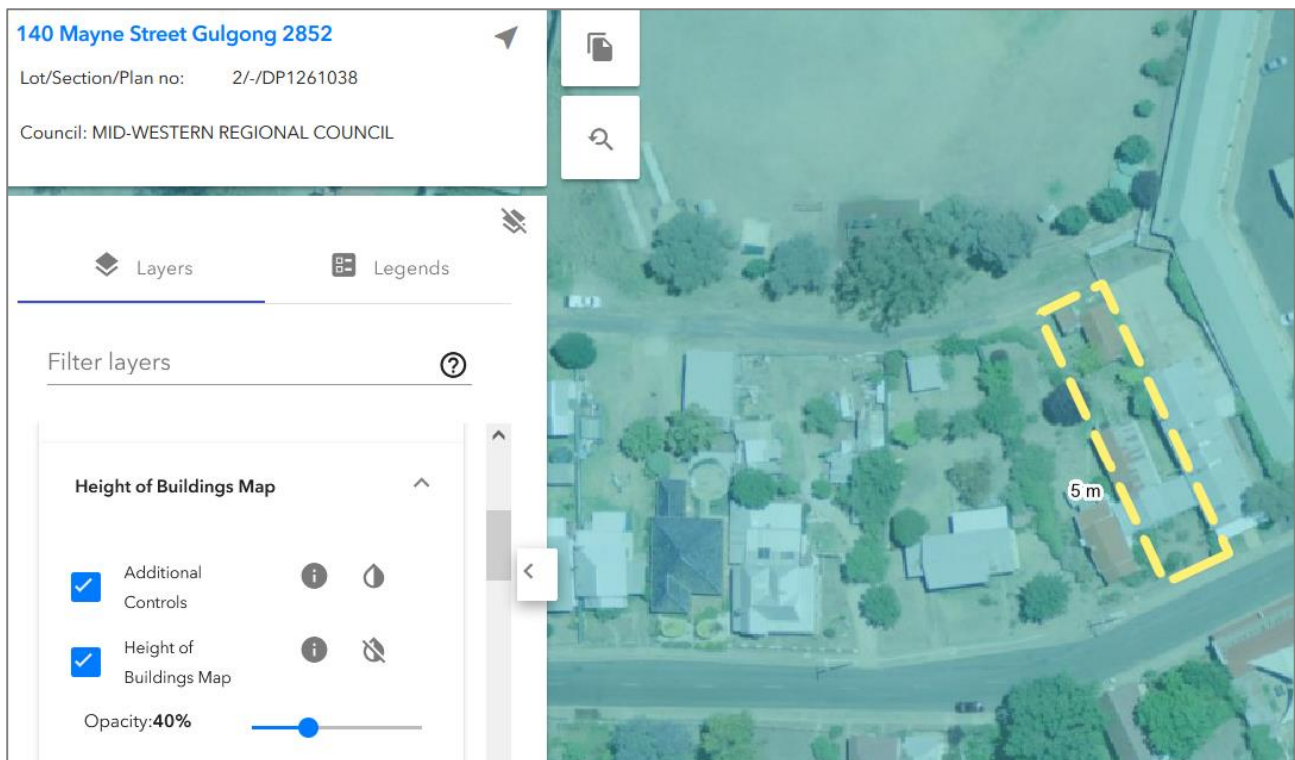
Figure 4 – LEP Height of Buildings Map

Comment: As shown above, the maximum building height applicable to the site is 5.5m, in accordance with Clause 4.3 of the LEP. Clause 4.2(2) states:

Scale form and height	The LEP has a height restriction applicable to the site of 5.5m. As shown on the Development Plans in Appendix C, the height of the structure is less than 5.5m, thereby complying with this part.

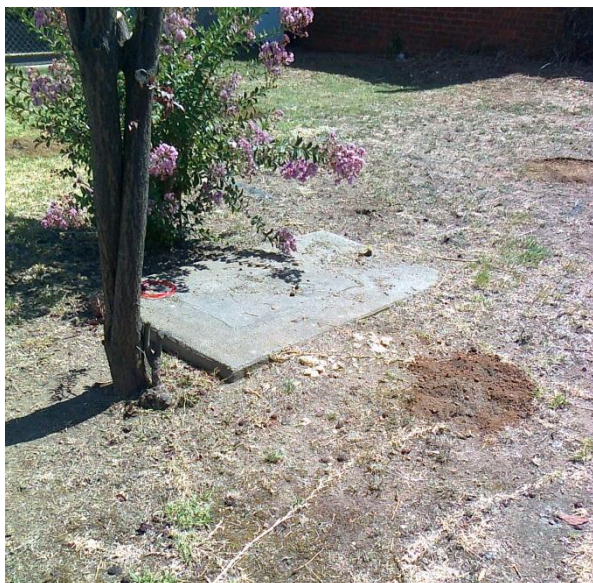
Looking north east over the bowser mount and UST

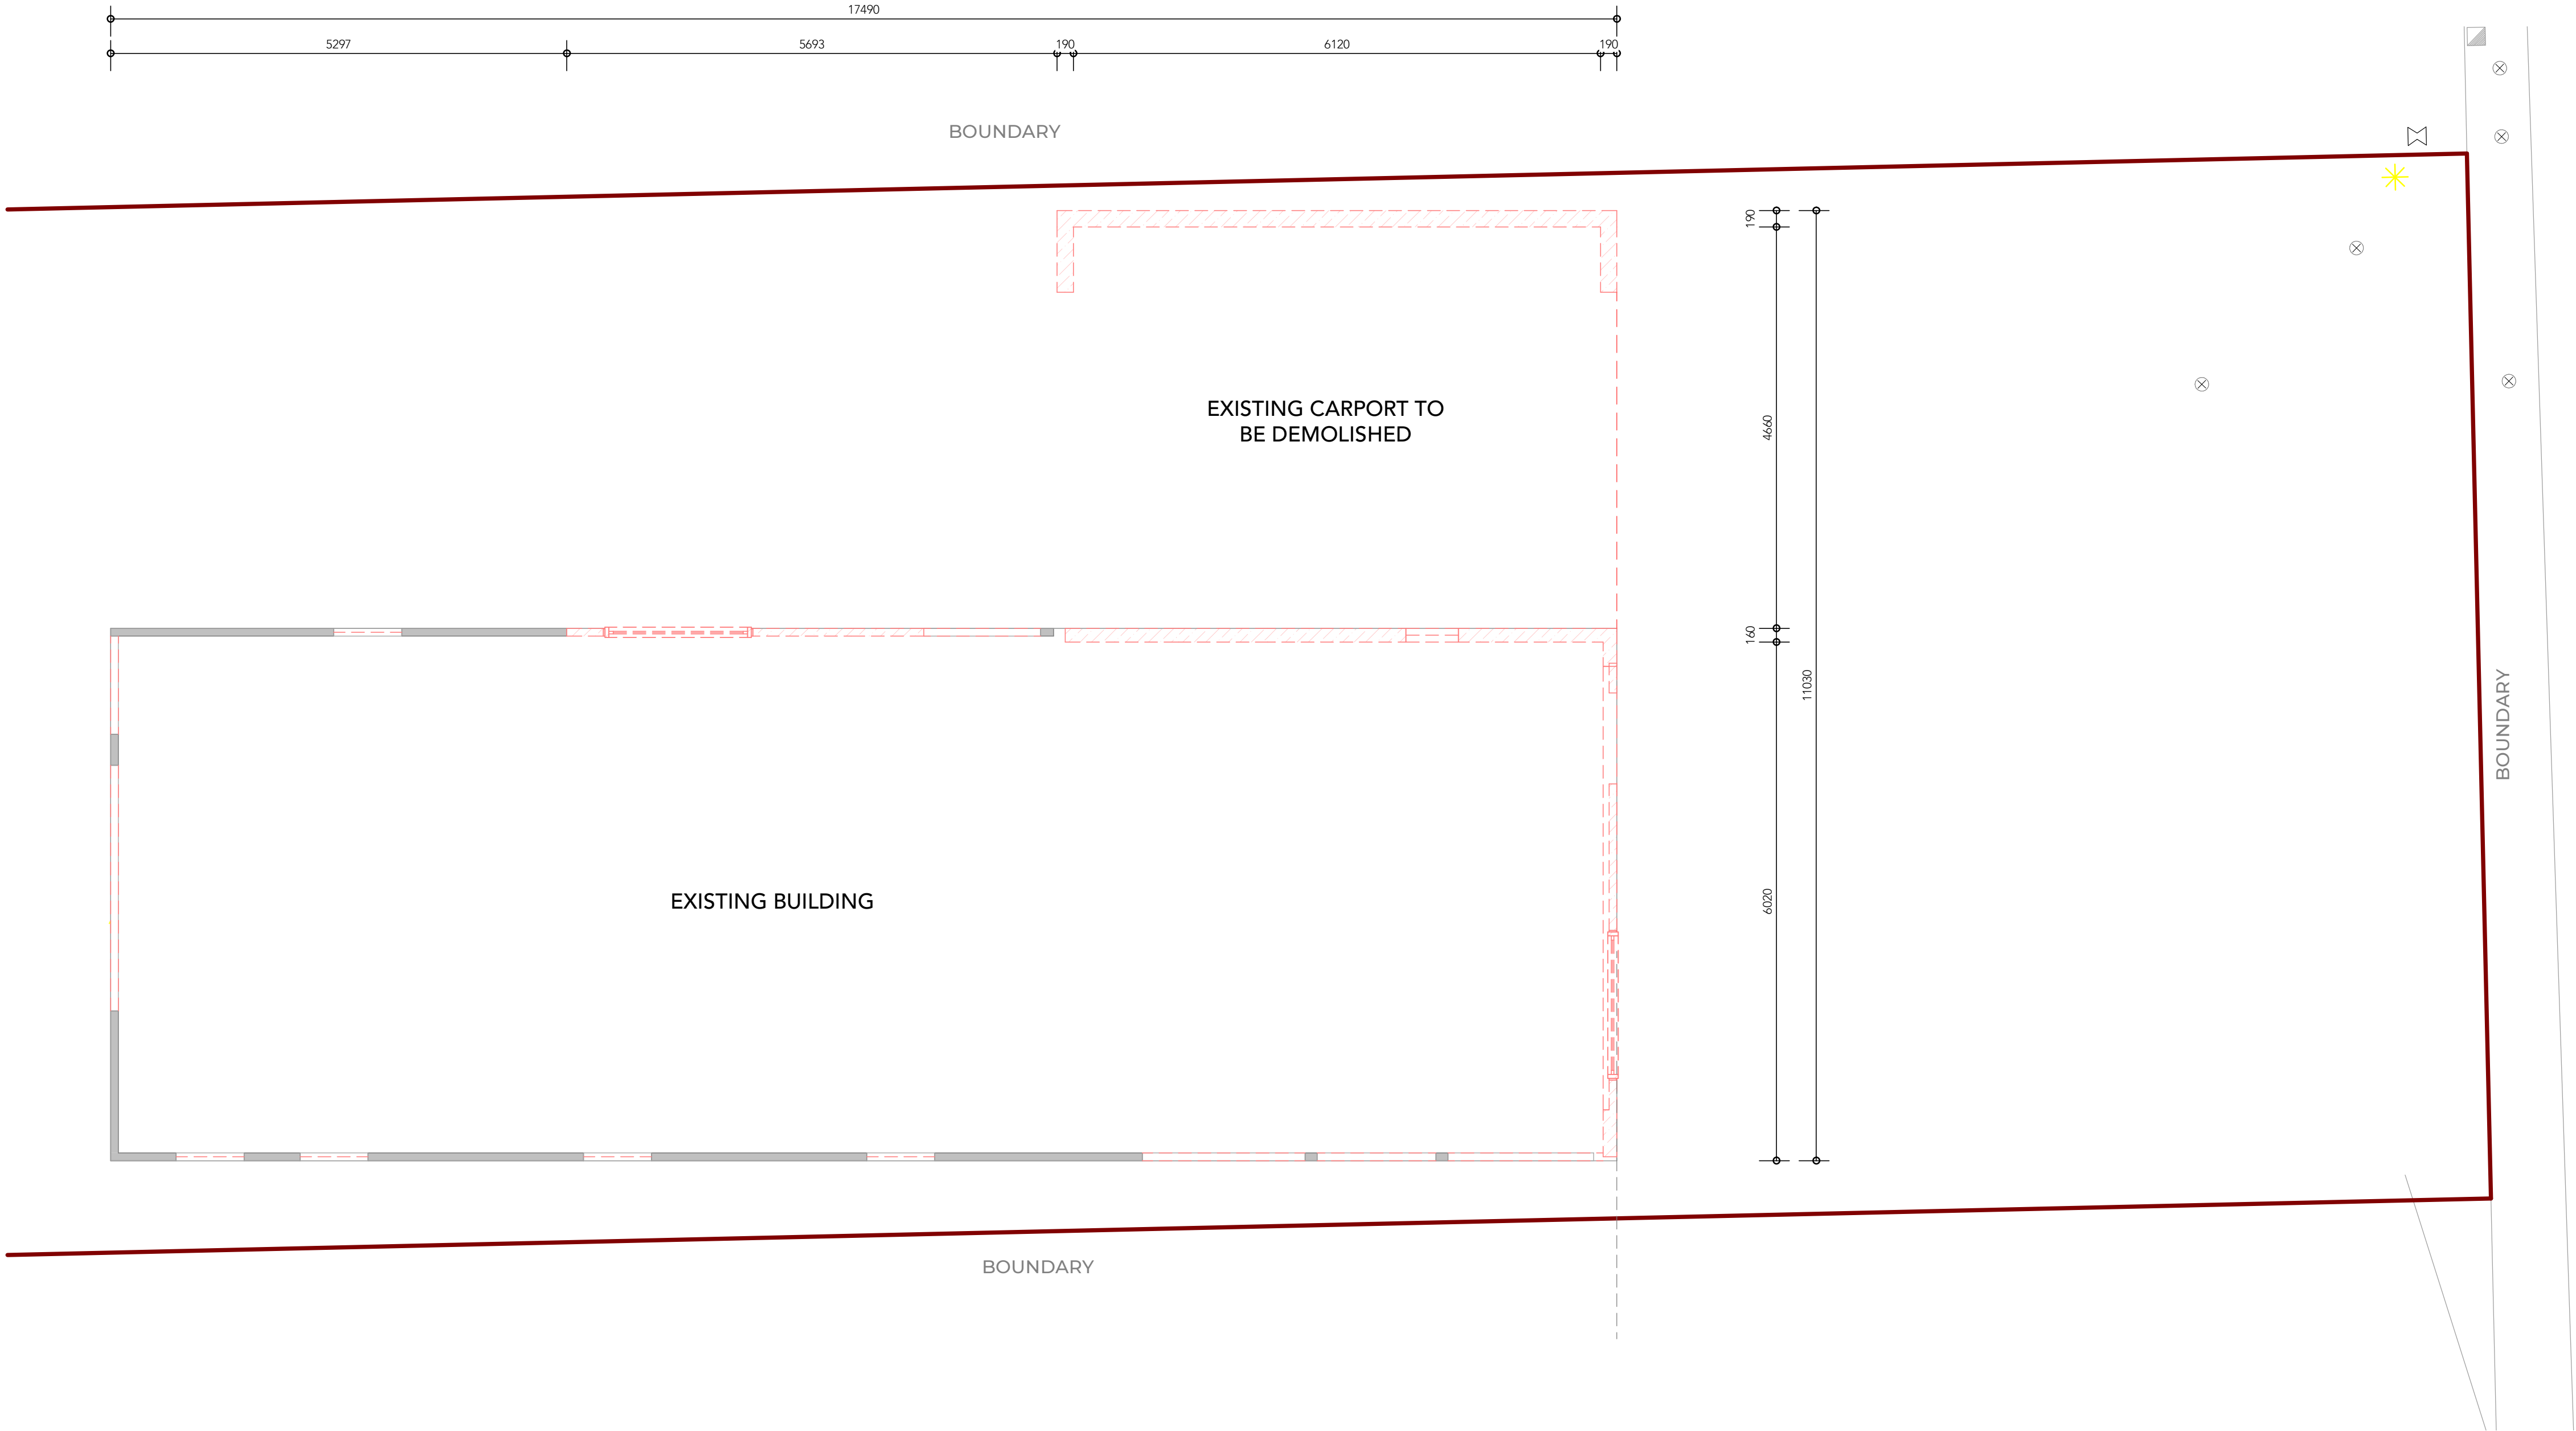
DEMOLITION PLAN

Procedures & method of demolition will be adequate to prevent injury to persons & avoid damage to neighbouring buildings.

No combustible material & rubbish will be left on site as to cause a fire hazard.

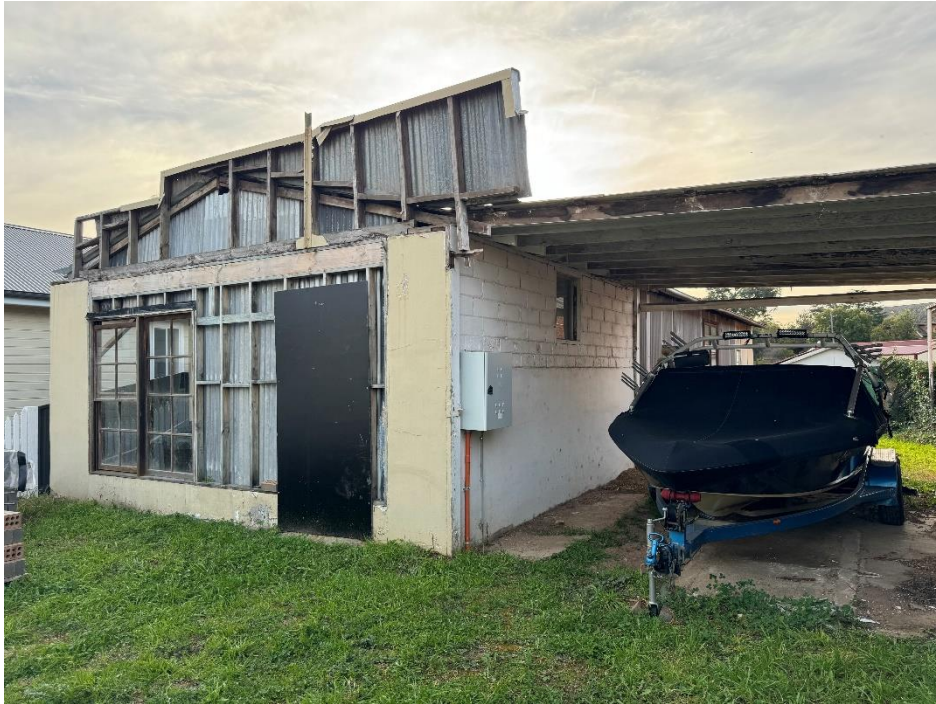
Figure 1: South elevation, block walls to be replaced with double brick, timber framing to be removed

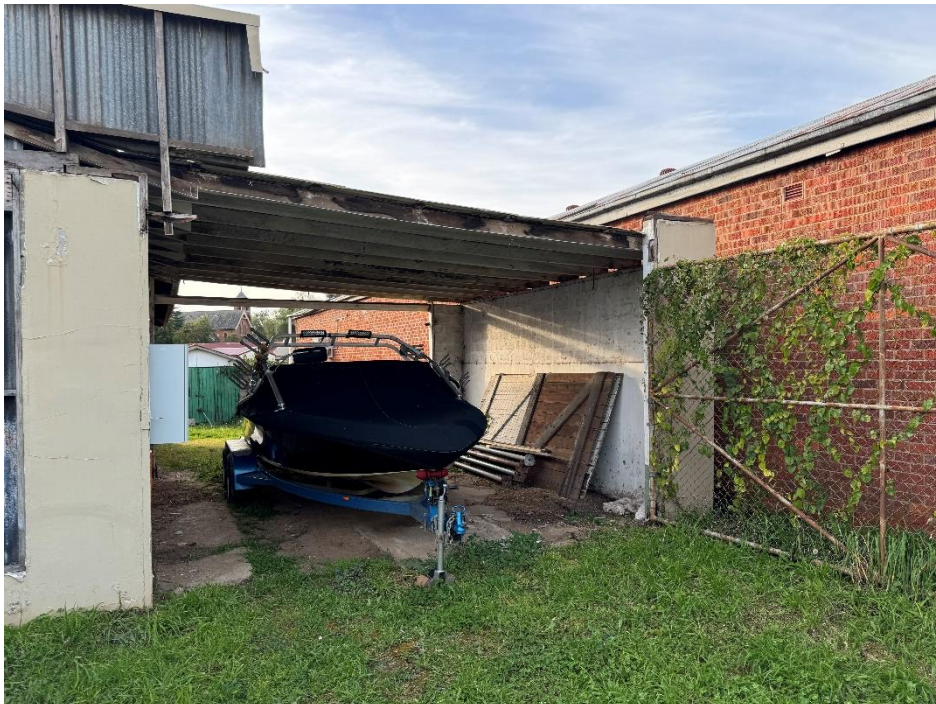
Figure 2: Skillion to be enclosed with double brick walls, existing wall and rafters to be replaced, new slab to be poured

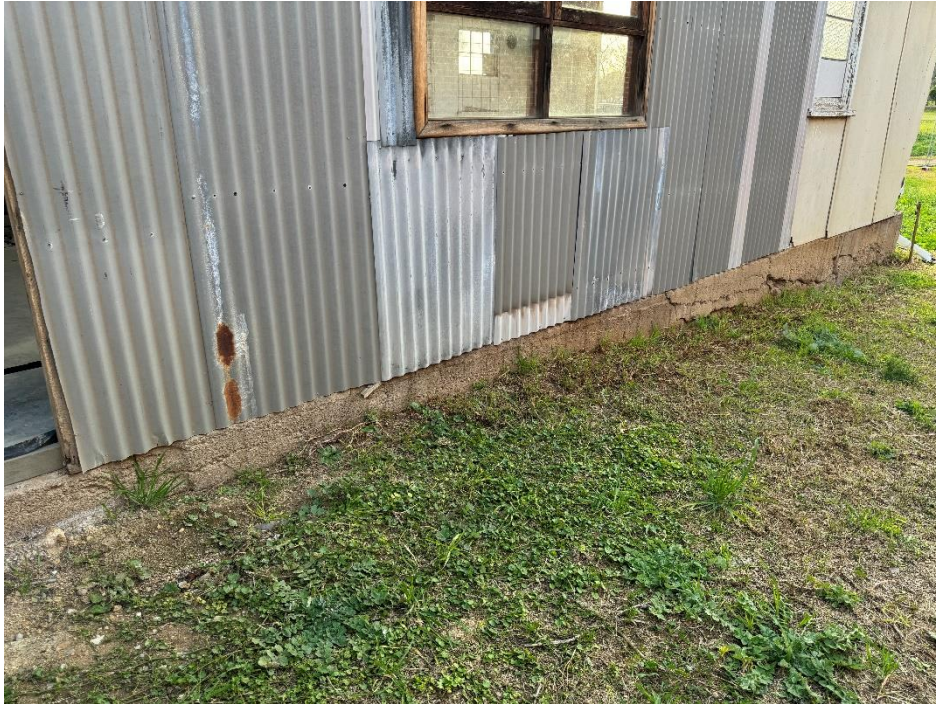
Figure 3: Existing slab, with deep edge beams due to ground slope

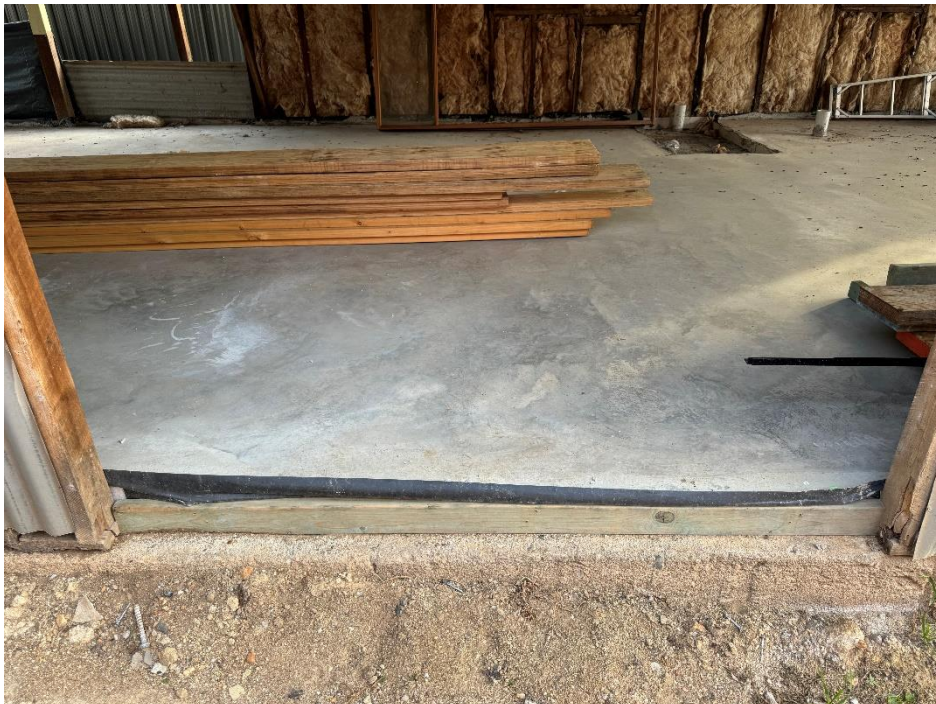
Figure 4: New 100mm topping slab with plastic membrane installed over original slab

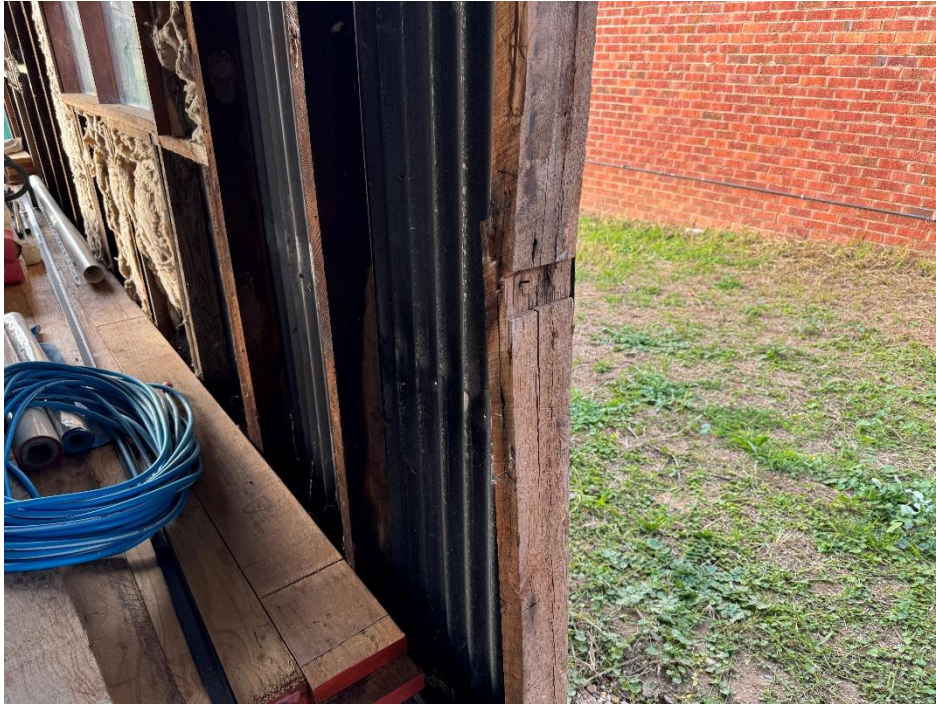
Figure 5: Damaged timber stud requiring repair as part of renovations

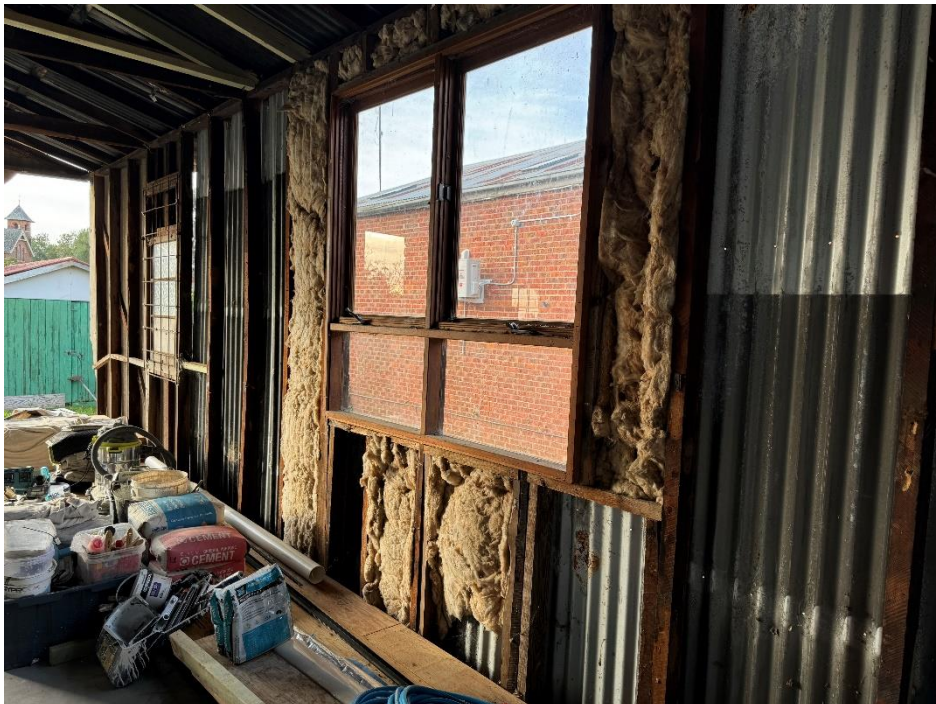
Figure 6: Hardwood wall framing generally in good condition

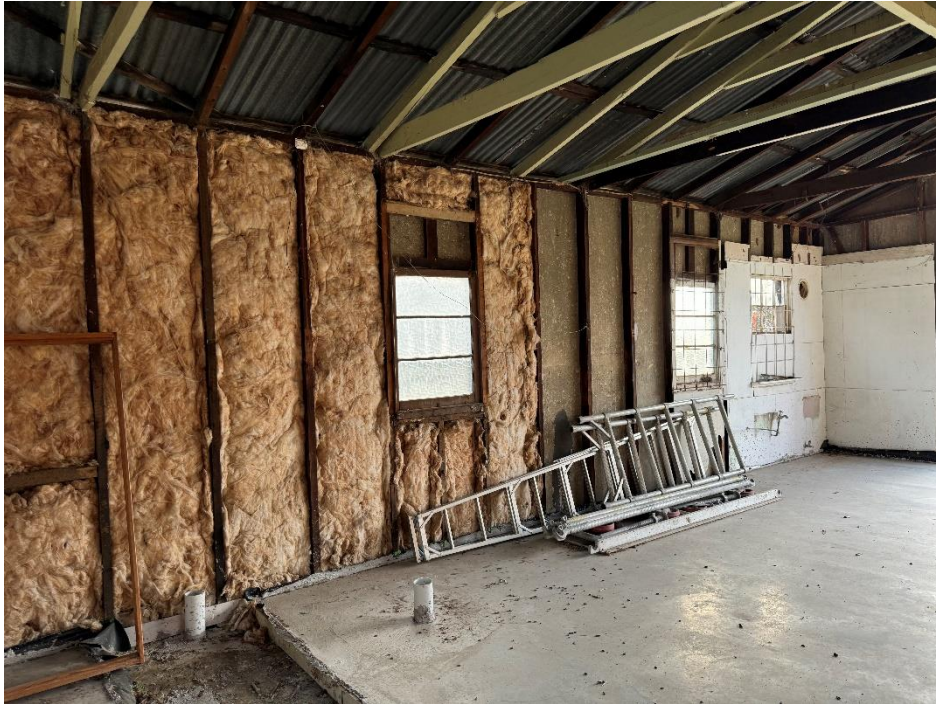
Figure 7: Hardwood wall framing generally in good condition

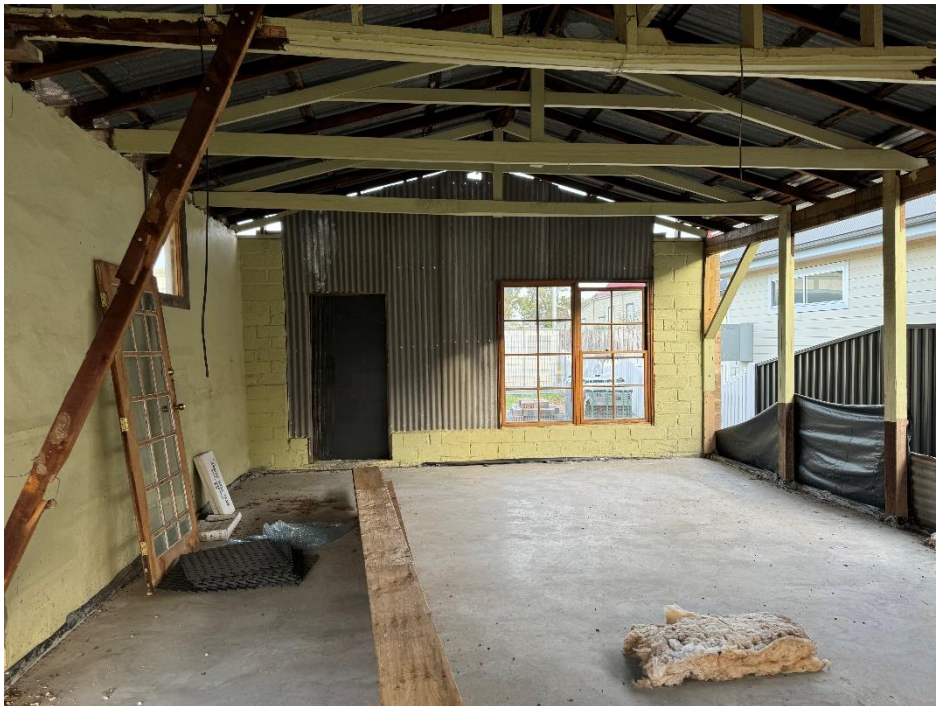
Figure 8: interior of South section, block walls to be replaced, roof framing to be supported on double brick walls

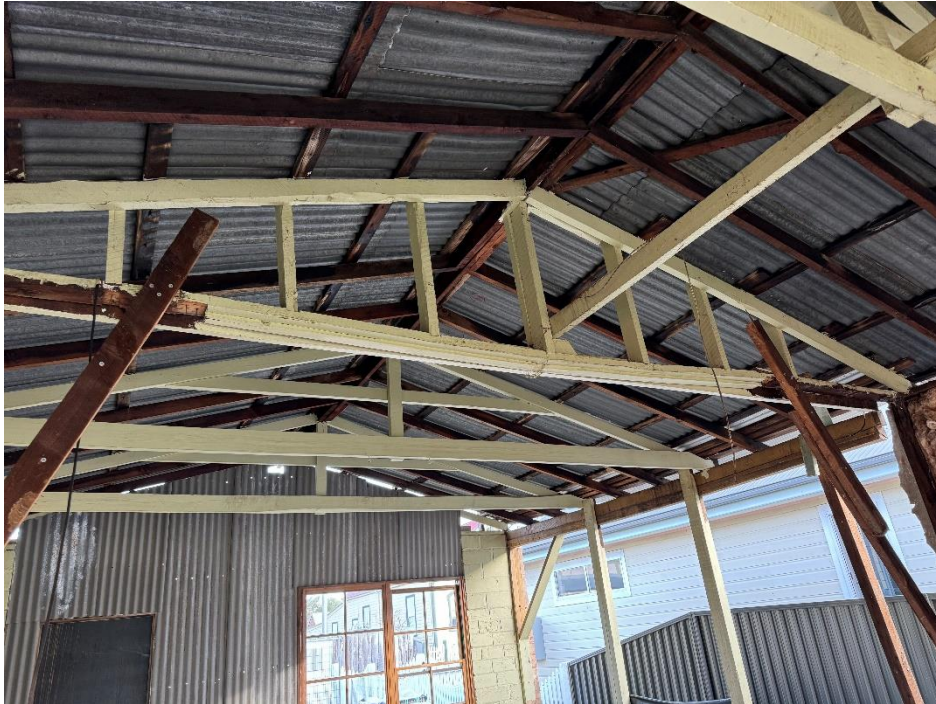
Figure 9: Existing timber roof framing, some damage noted with repairs to be provided as part of renovations

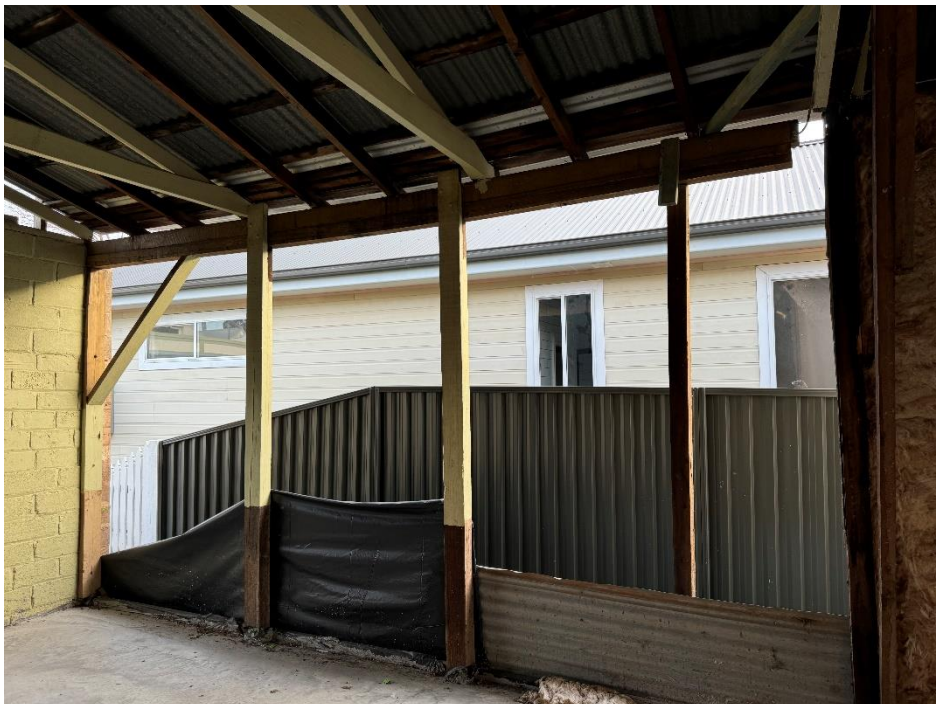
Figure 10: Wall to be enclosed with double brick

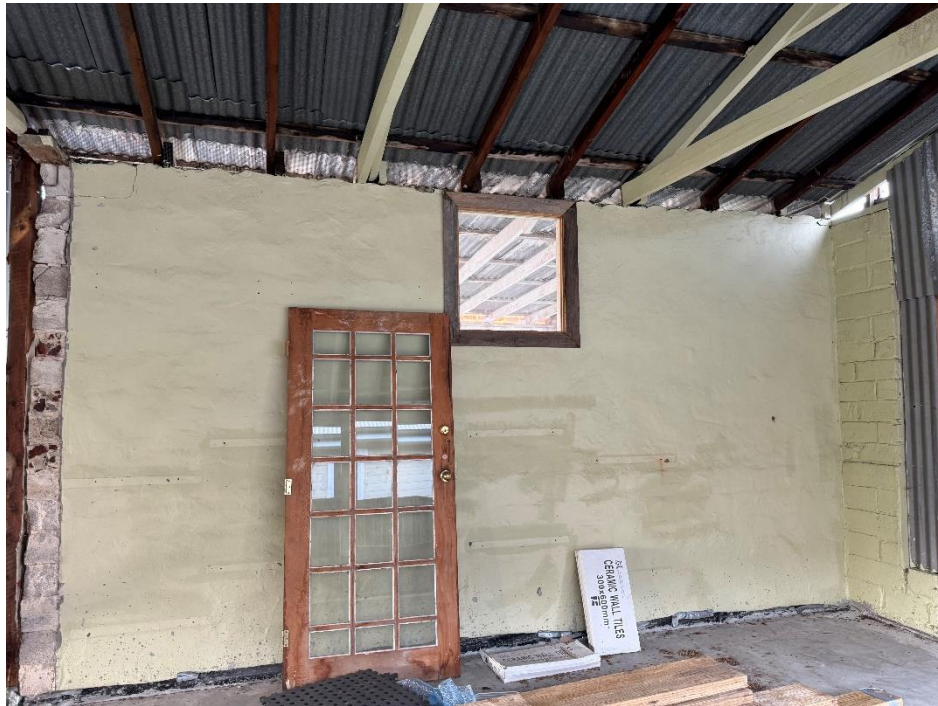
Figure 11: Block wall to be replaced with double brick

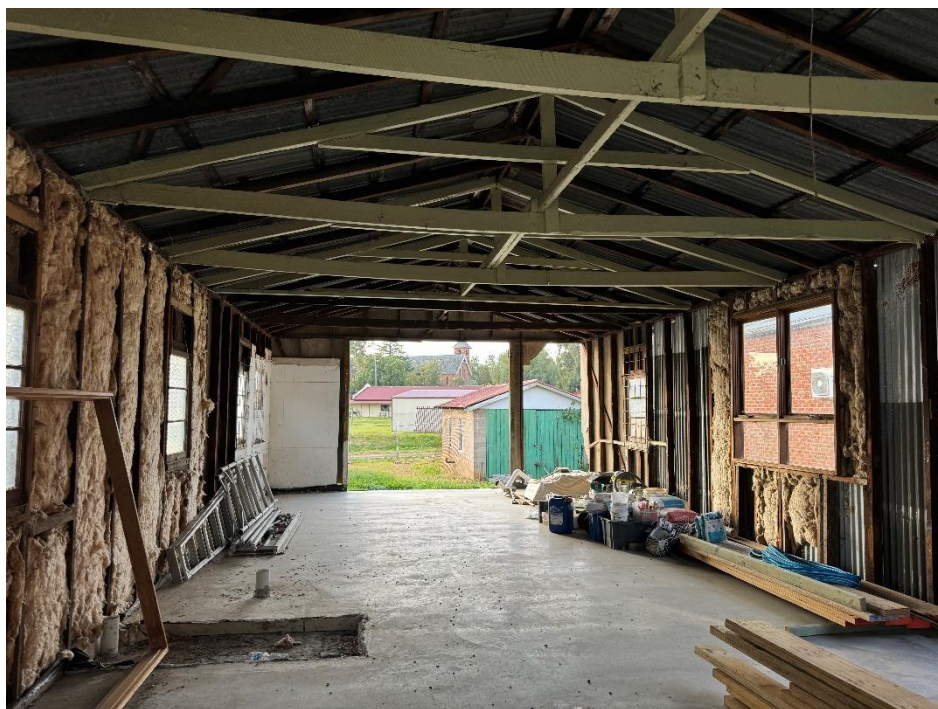
Figure 12: Existing timber roof framing generally in good condition, some repairs required

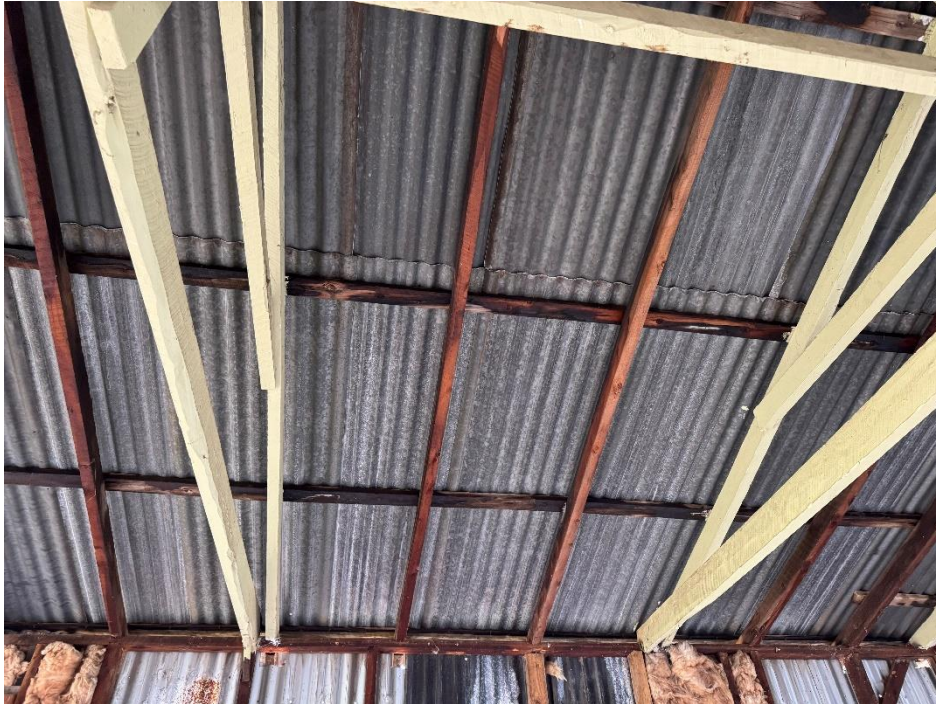
Figure 13: Existing timber roof framing generally in good condition, some repairs required, raked ceiling proposed

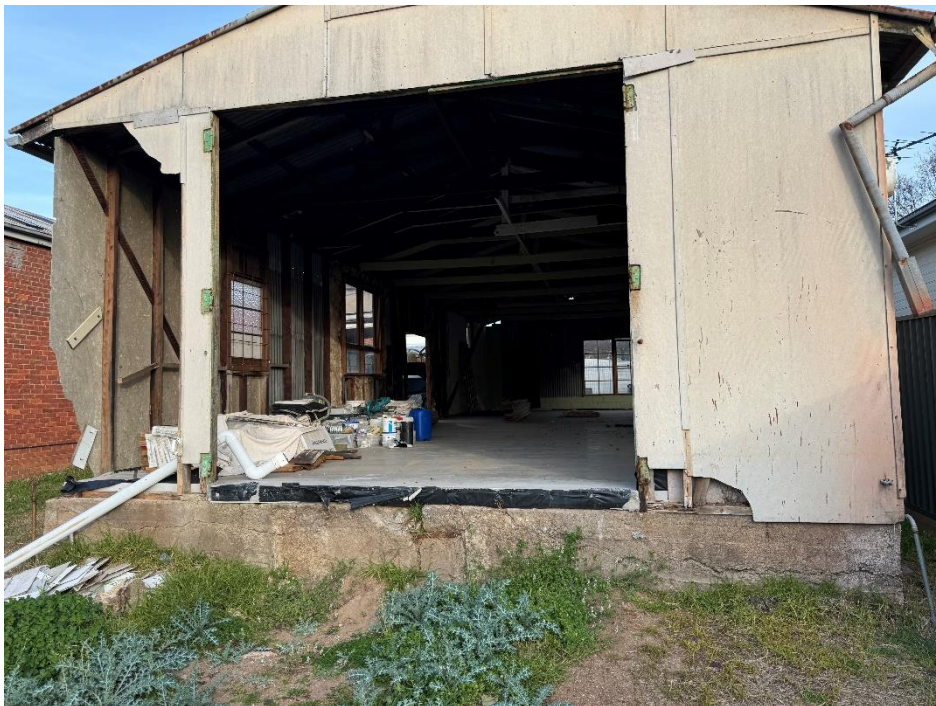
Figure 14: North elevation, cladding to be replaced

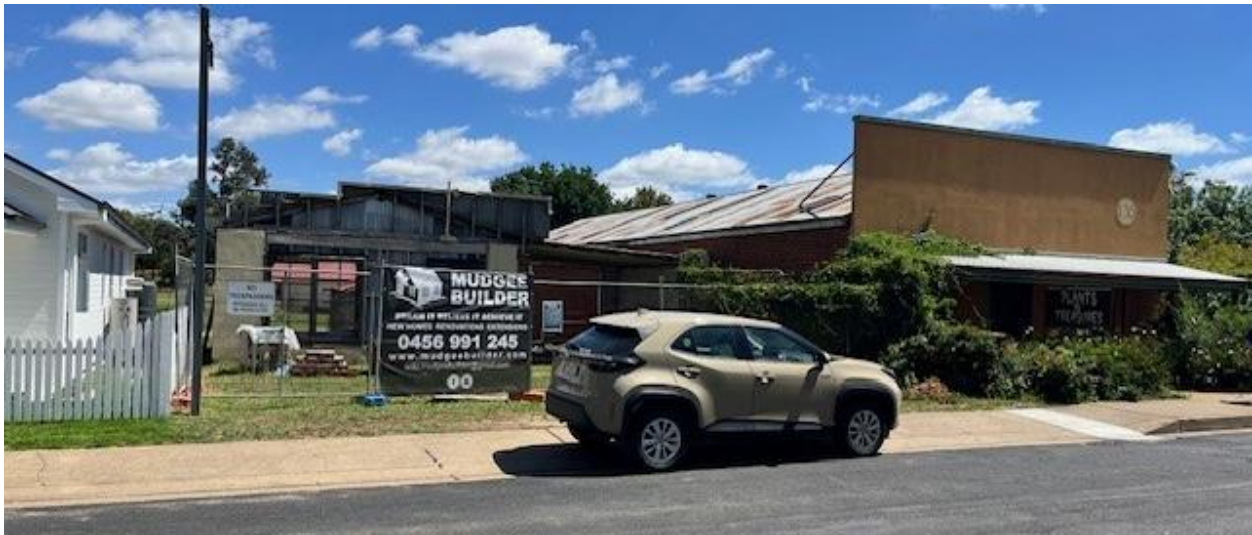
Figure 1 Front Elevation 19 November 2024
