GUNTAWANG STABLE COMPLEX

CONSERVATION MANAGEMENT PLAN

Final 8 July 2025

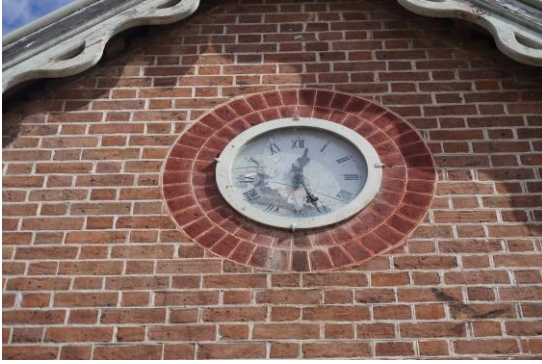
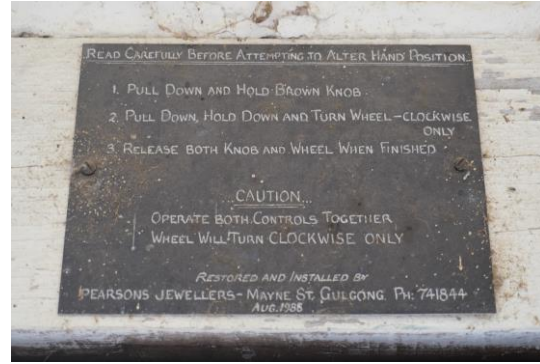
A clock was inserted in the central decorative gable of the stables Area 3. Above the door into Area 3 is a small instruction panel for how to reset the clock in the event of a black out. Chris Pearson, a jeweller in Gulgong, repaired and re-installed this electric clock in 1988. It was probably first installed in the 1950s. There earlier clock had a wind-up mechanism.

Figure 7 Stable clock and plate

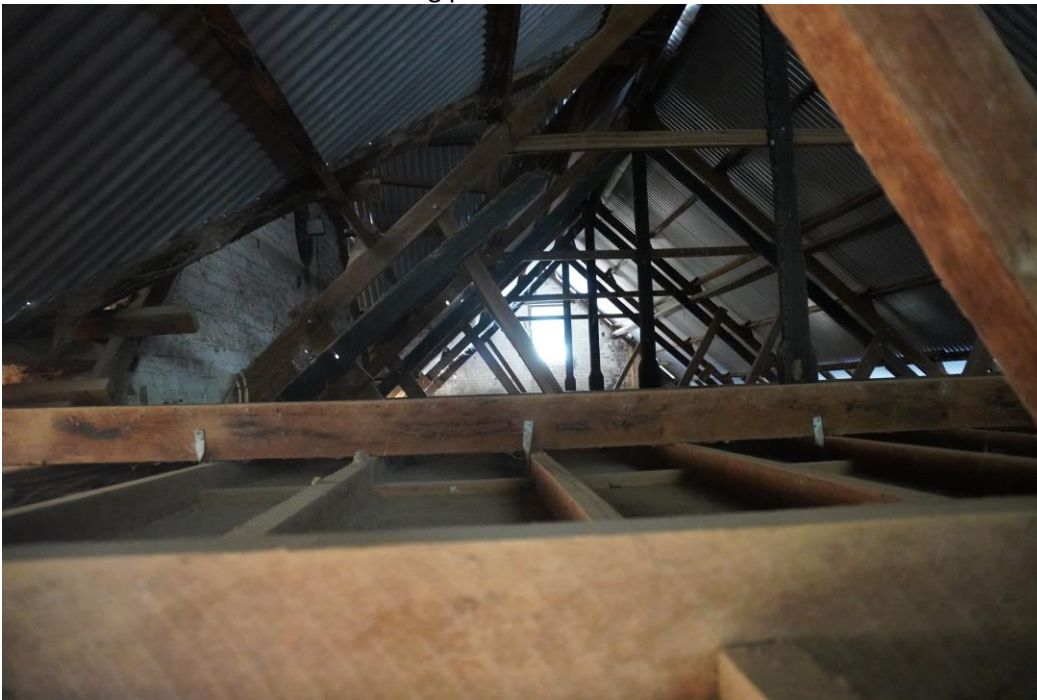
Ceilings have been installed using fc sheet. It may be that there was no ceiling in the main stable, stable complex 3. The roof structure has been repaired from an earlier fire and timber battens installed to support the fc sheet ceiling. Above the stables show king post style trusses with charred rafters and vertical king posts.

Figure 8 South end of roof space showing charred roof members.

It would require structural investigation to decide if the loft level could support a load.

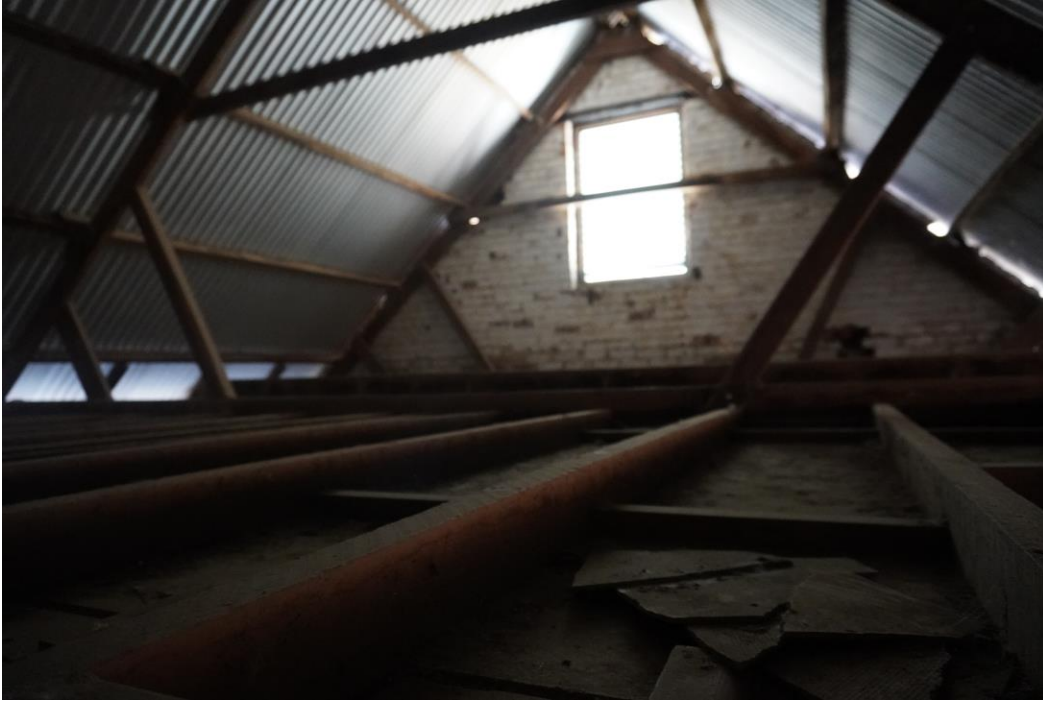
Figure 9 No king posts at the north end.

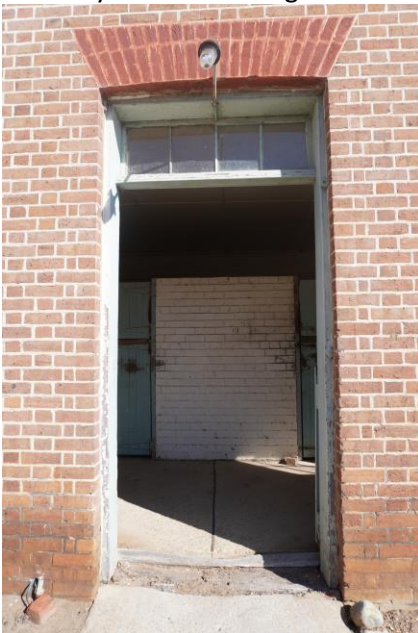
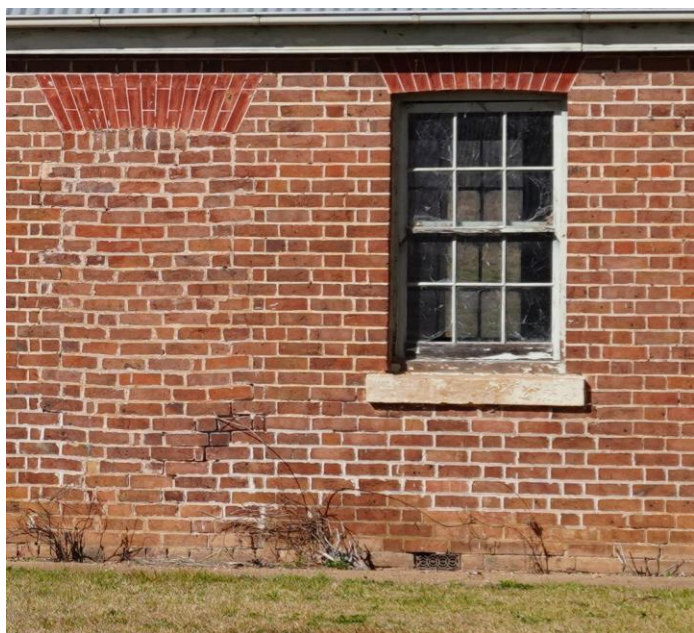
Generally, the heads or lintels of windows and doors are flat arched soldier courses, ochre rubbed, and tuck pointed. Door heads without highlights were set lower. Missing doors are noted by their remaining header courses.

Figure 10 Main entrance door to the main stable wing and missing door to the former stable hands accommodation wing.

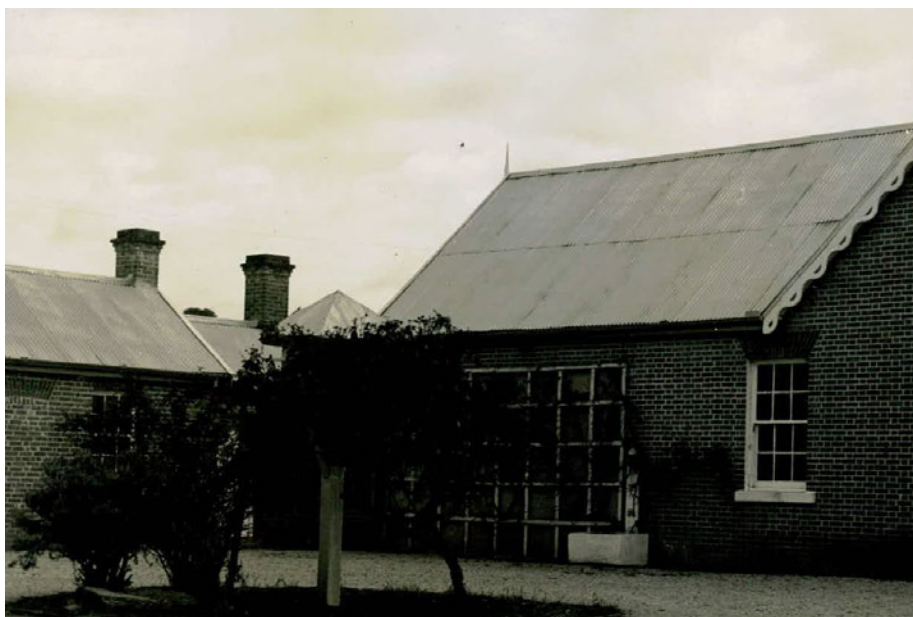
Figure 12: Stable complex image from the National Trust, 1977, showing lattice frame covering the former Harness room wall.

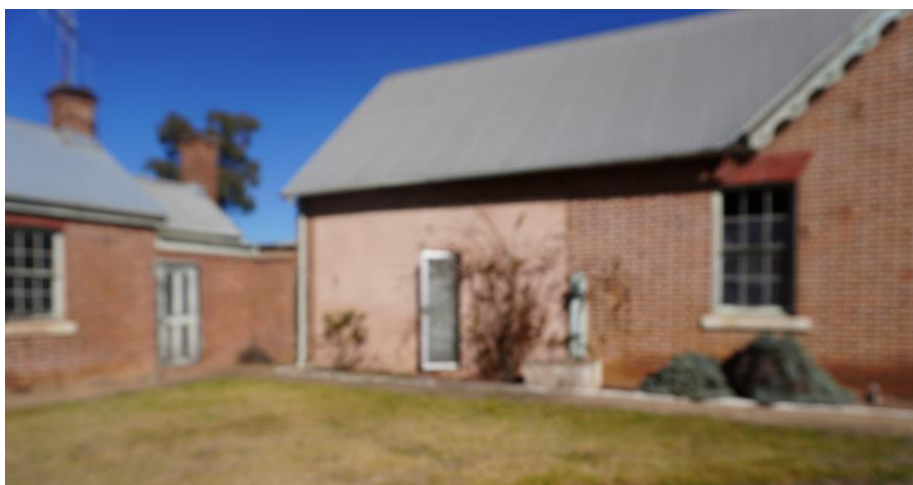
Figure 13 The same corner of the stable complex today. The area that was lattice is now rendered.

It appears likely that the wall of the former Tack & Harness Room was originally enclosed with large doors similar to Greystanes Stables.

- d. When possible, changes to the original heritage fabric of the site should be reversible.
- e. Where a new use permits, concealed or relocated elements of exceptional or high significance should be *restored* to their original or suspected configuration. Eg the external wall of the former Harness Room, missing doors or window.

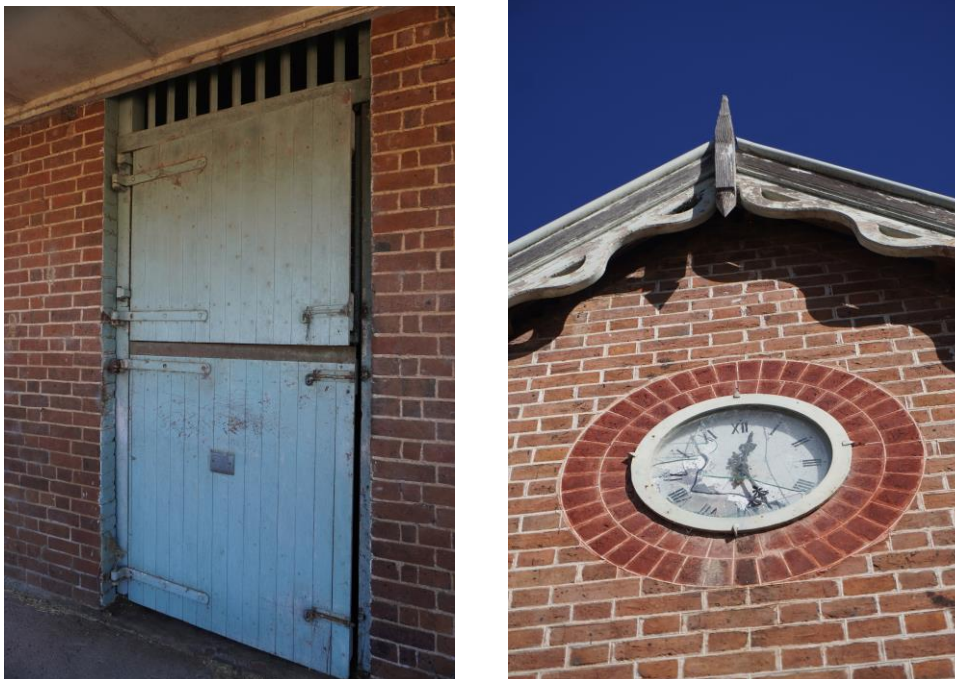
Figure 22 : Original solid timber stable doors with ventilation over; central courtyard clock mounted in the decorative gable and Flemish bond brickwork with hooks to accommodate espalier plants.

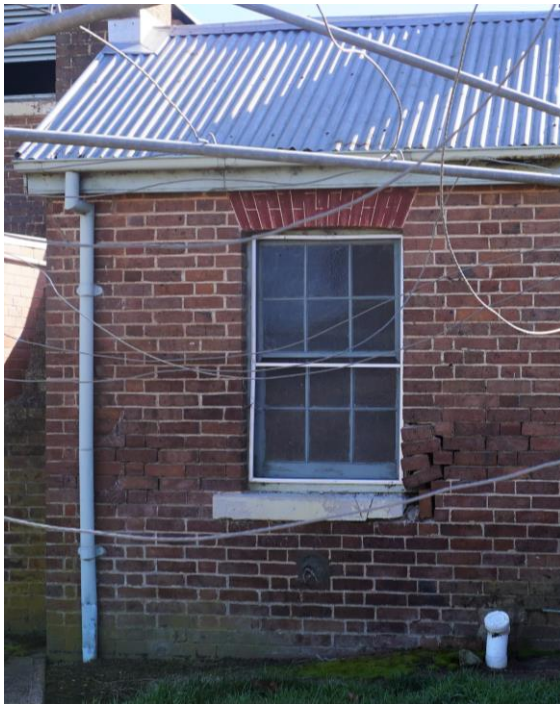
Figure 23 Shower and toilet installed in west room wing showing collapse of wall above the wc cistern.

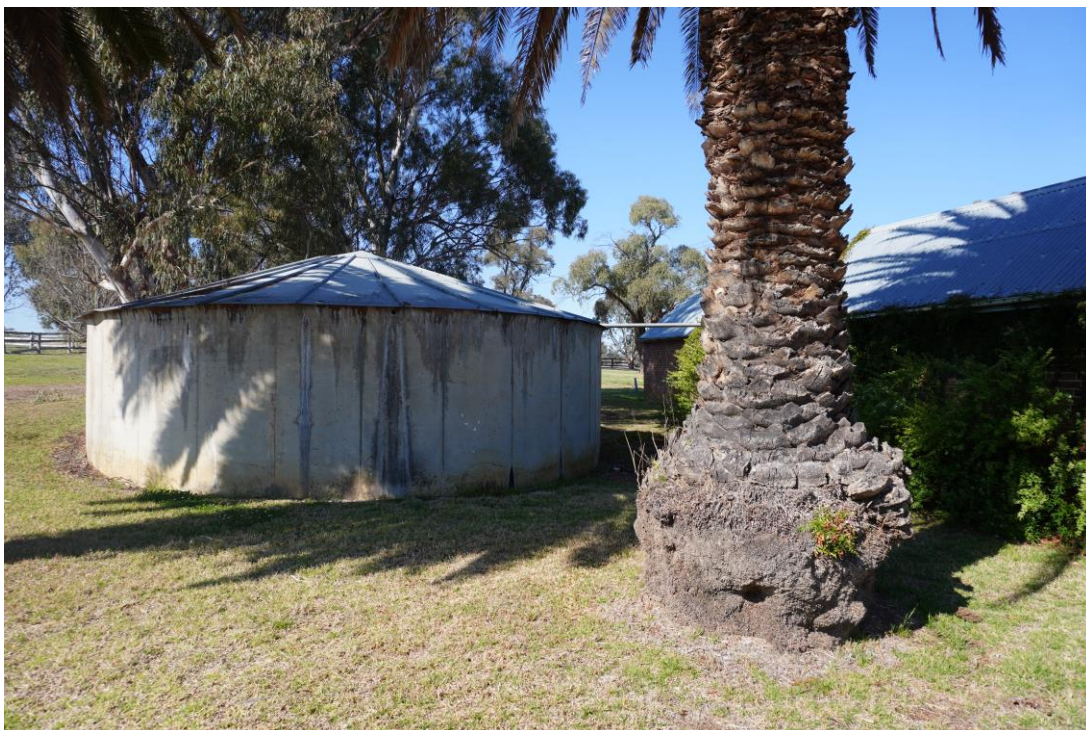
Figure 24 The front approach of the stable complex is impacted by a large surface concrete water tank. Consideration to its relocation or removal should be given.

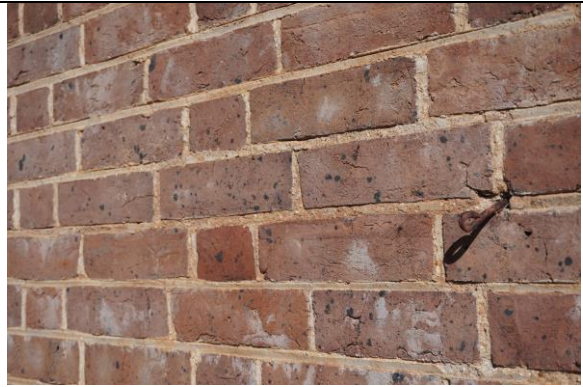
Wire hooks in wall to support espalier plantings

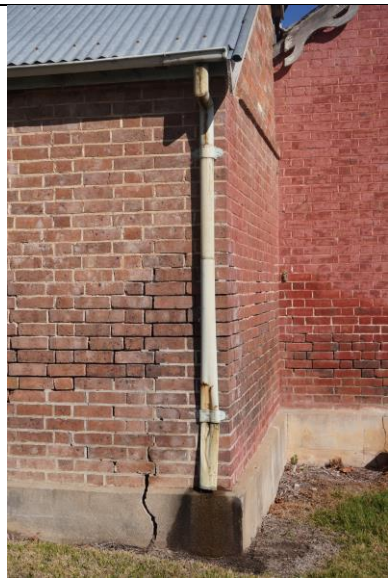
Down pipe unconnected, ground settlement crack.

galvanised roofing system. Lead flashings should only be used with a galvanised roofing system. Guttering should be checked for damage and repaired. Use traditional quad or ogee profiles in repairs to match existing. Downpipes should be checked for connections to the gutters and should be sealed where discharged into the stormwater collection system. Surface discharge should fall away from the stable buildings. Clear obstructions from any subfloor vents.

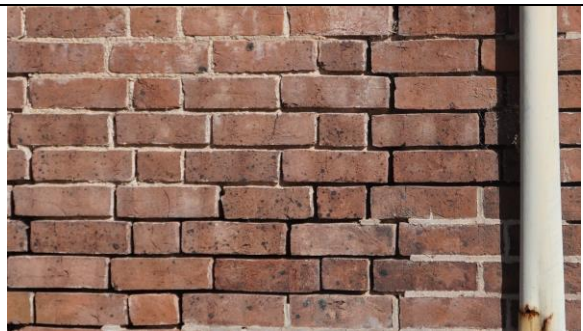
Wall detail – eroded mortar

- d. Brickwork repairs should be carried out by a bricklayer experienced in heritage restoration with the skill to match existing workmanship. Salvaged bricks from the site and corresponding period bricks are preferred to a matching dry pressed brick. Severely damaged brickwork should be repaired by scraping out damaged mortar and repointing using a lime rich mortar. It is preferable to use a 1:3 (Lime: Sand) mortar when the brickwork is soft and porous, and the mortar needs to be less porous than the bricks. Lime mortar has the advantage of low strength which allows some movement without fracturing.

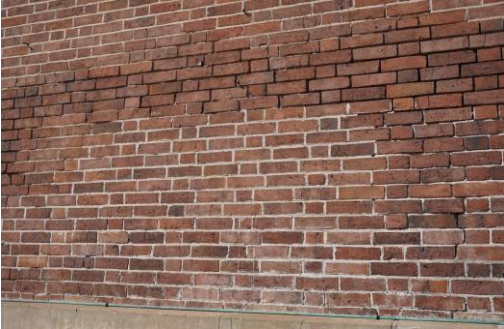
<p>Eroded brickwork in wash bay.</p>
  <p>Inside Horse Stalls room</p>	  <p>courtyard view</p>
	  <p>wash bay</p>

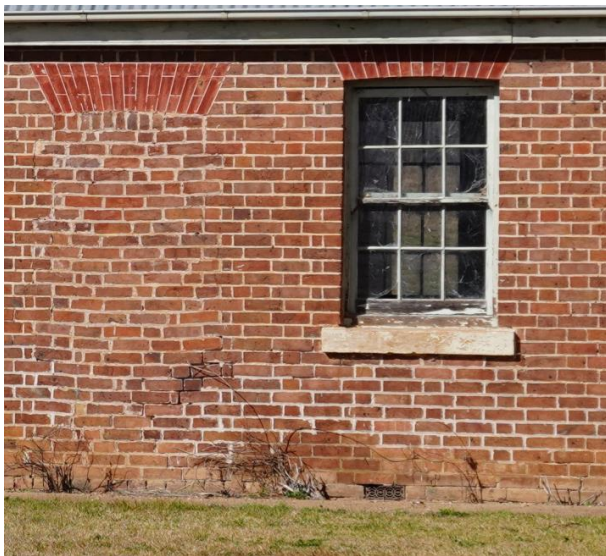
Bricked up original doorway.

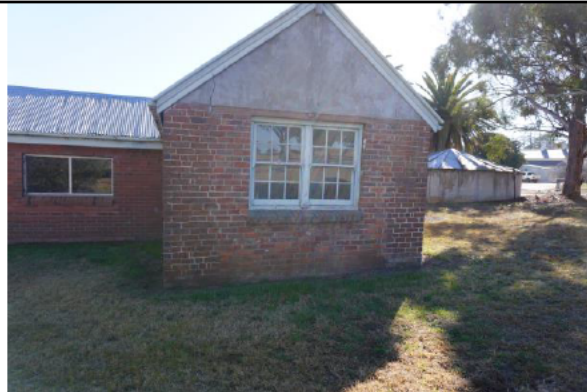
Gable end of Flat area 7. Reconstructed wall.
