CRJ Constructions Pty Ltd
23 Horatio St
MUDGEES NSW 2850
AUSTRALIA

Re: 31 Court St Mudgee NSW 2850

Thank you for the opportunity to inspect 31 Court St Mudgee in April 2021.

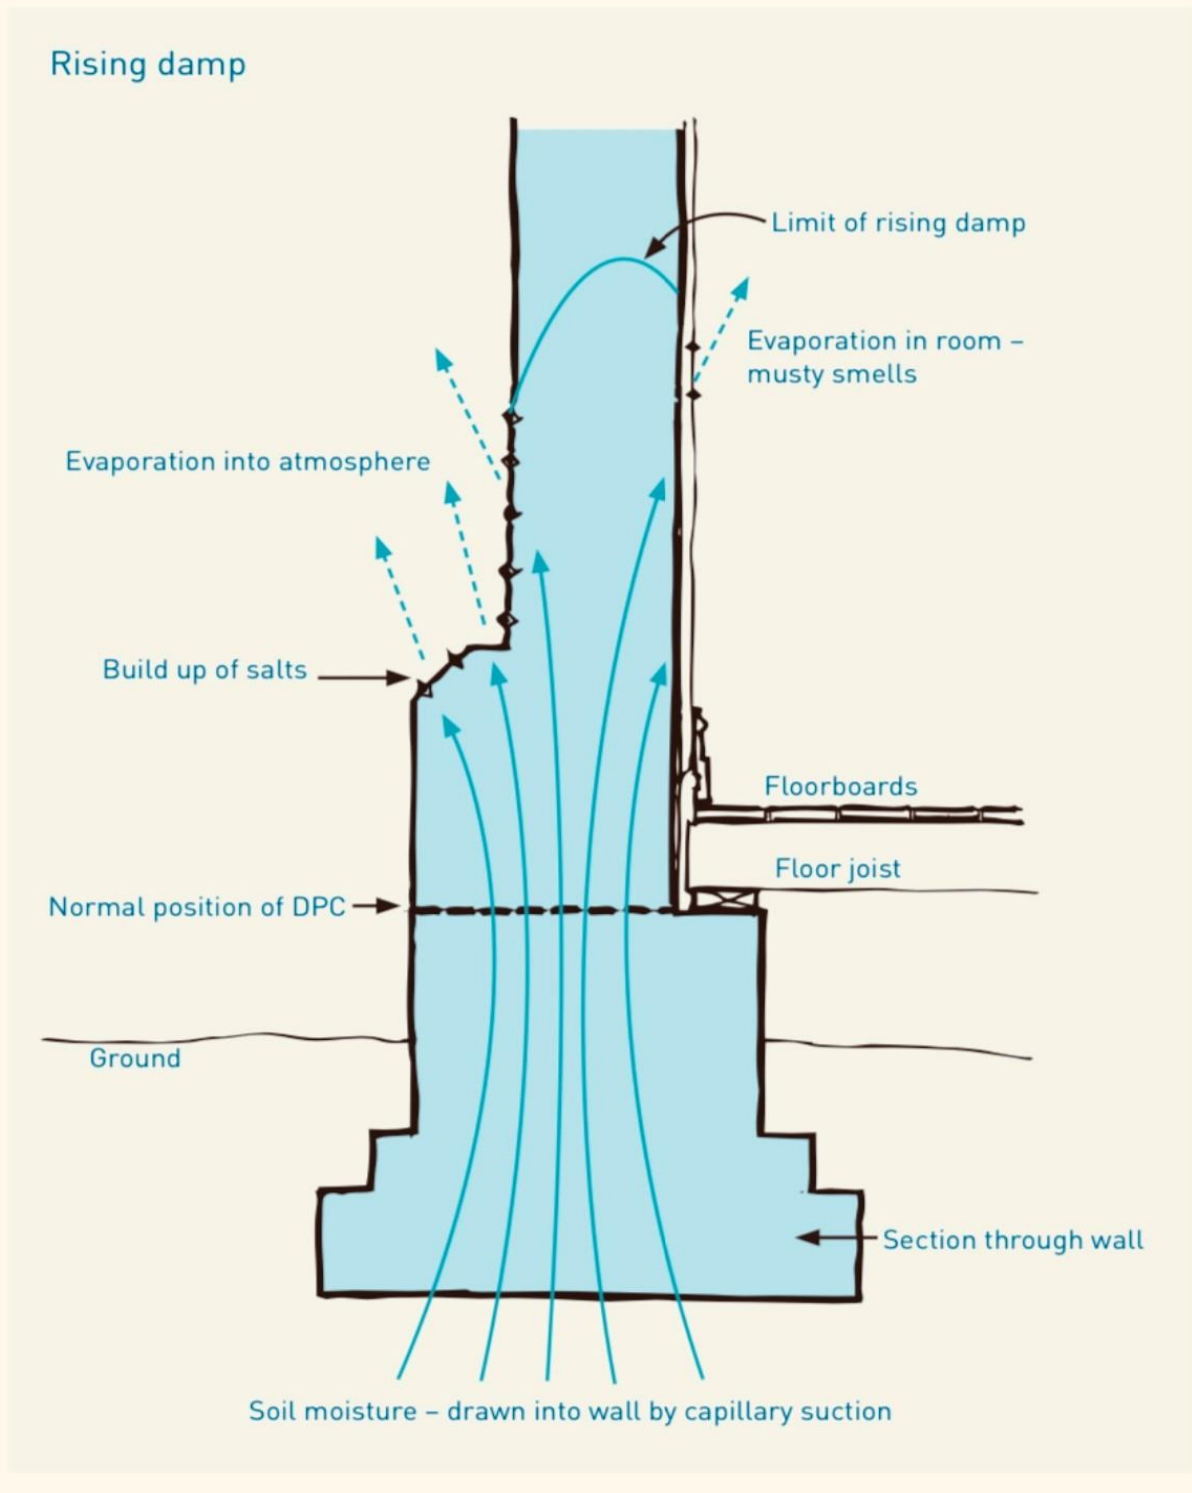
Attachment 4.

A normal internal brick inside a house reads no moisture or next to no moisture. Now if you look at attachment 4 it shows how moisture enters this type of building with brick footings.

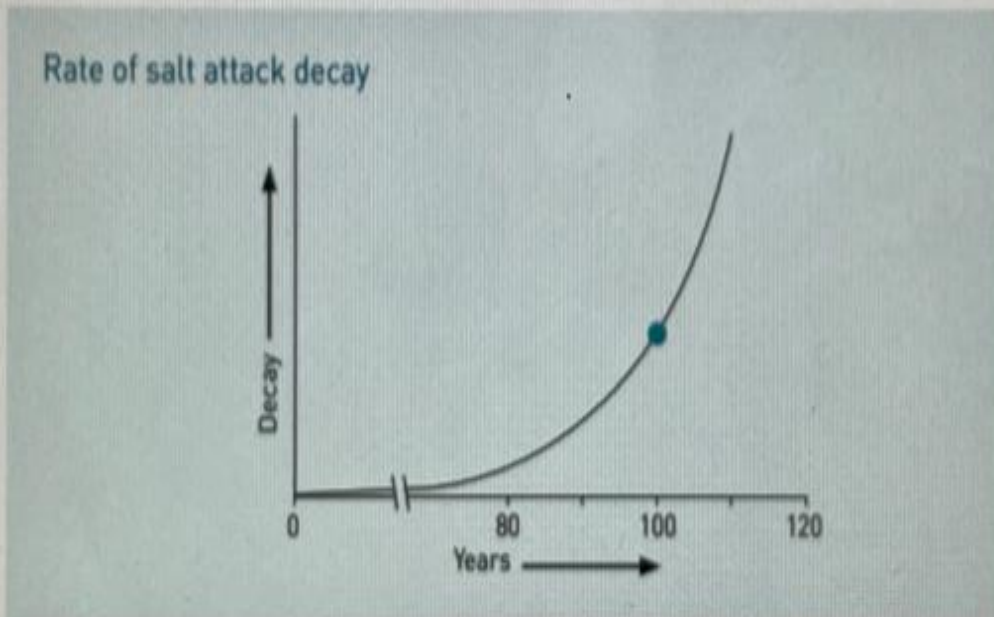
Attachment 5.

If you look at attachment 5 it shows you the pace in which deterioration will occur if left alone and the life cycle or jevity of the building remaining. If damp cure is injected too late the rate of decay will increase but the result will still be the same in the end the building will succumb to salt attack and will have to be removed along with the contaminated soil.

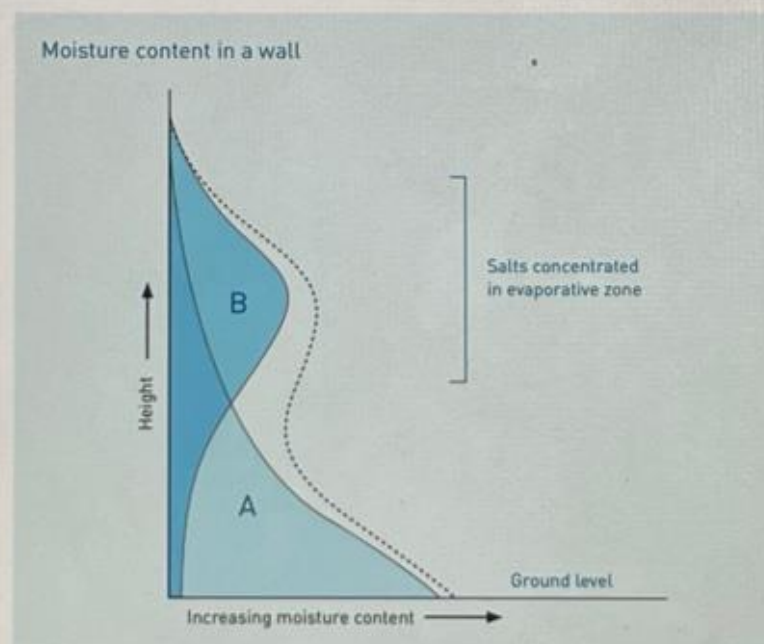
Figure 12 Moisture content in a masonry wall due to A, capillary action (rising damp) and B, hygroscopic salts. The total moisture content is shown by the dashed line and is the sum of A and B. The relative contributions of A and B to the total will depend on the amount and nature of the salts in the soils beneath, on the climate (humidity, temperature and wind speed) and on time (the older the wall the longer it will have had to accumulate salt).
