ACM VISUAL SURFACE SOILS CLEARANCE REPORT

Capstone Developments Pty Ltd – 127 Gladstone St Mudgee

Report: CLR1706R01

Date: 18/05/2024

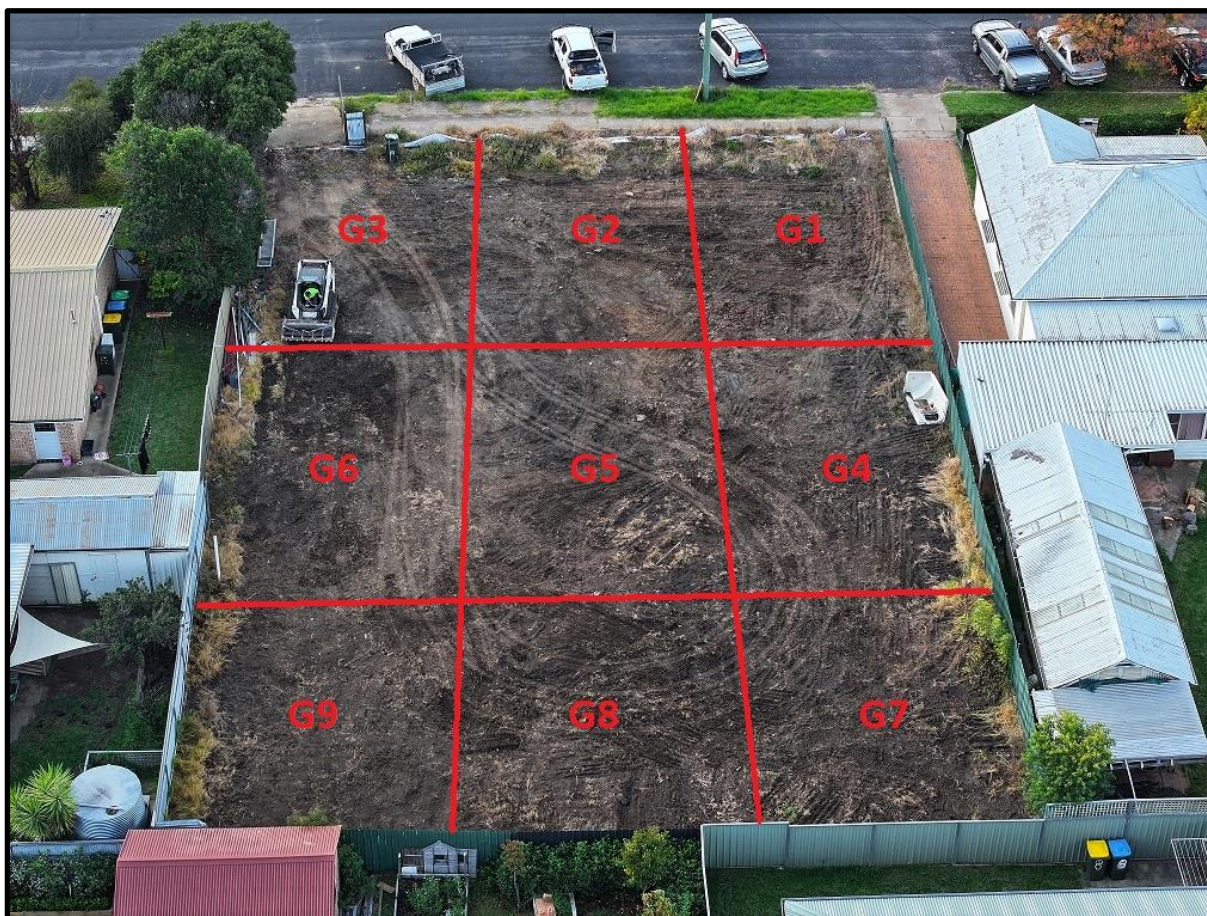
Appendix A Grid Locations & Orientation

The site is a vacant parcel of land approximately 1000m². The area has been divided into nine (9) grids, approximately 8m x 13m, for the purpose of this survey. Each grid has been visually assessed where practicable by walking in an east/west direction, followed by walking in a north/south direction. Please refer to Appendix A, for the grid locations and orientation.
