## AS2870-2011 SITE CLASSIFICATION

Hibbard Homes

Lot 16 Saleyards Lane Mudgee NSW

**Class H1**

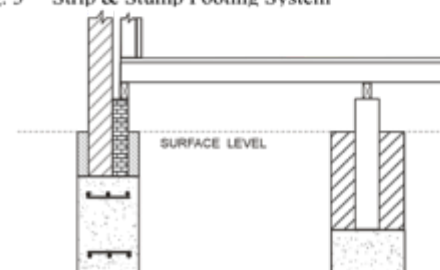
Fig. 3 Strip & Stump Footing System

**Footings** (often incorrectly called foundations) are the "members" that support the building. They are commonly concrete slabs or timber floors supported by strips and stumps. (Fig 1, 2 & 3).

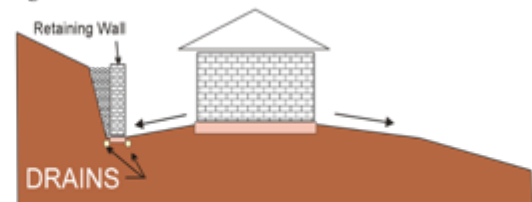
Fig. 5 Well Drained Sites

- Constructing sheds or outdoor roofed areas without connecting the roof drainage to storm water lines.
- Constructing paving around the building without sufficient slope away from the building. (In sandy soils and low and moderate "reactivity" clays, a slope of 1:40 up to 1 metre away from the building is adequate. In highly reactive clays a slope of 1:20 works better. In large paved areas a drain and collection pit may be necessary). (Fig. 5 & 18)

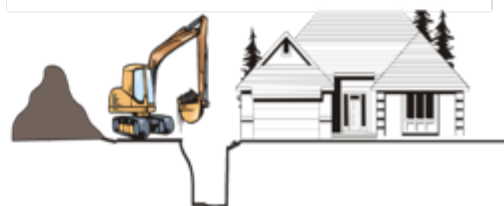
Fig. 11 De-stabilizing house foundations

- Ensuring that excavations are well supported or are dug to avoid collapses. (Fig. 11)
- Constructing well-compacted and retained 'soil aprons' around the building to stop erosion.

- Special considerations if any excavations are to be dug near adjoining structures.(Fig. 11)
- Sloping the soil and paths away from the building by the minimum amount required by the building regulations to prevent water flowing towards the building foundations. (Fig. 10 & 18)

- Running machinery over shallow drain pipes may break them causing leaks and subsequent foundation movements.
- Any excavations close to building footings can cause them to sink by disturbing the foundation material or by drying the foundation clay. (Fig 11)
