Site Classification for Lot 33 in DP1273458, 29 Peru Lane Gulgong NSW 2852

Prepared For: Manor Homes

Reference: SGC21-266 Rev B

Date: 3rd September 2021

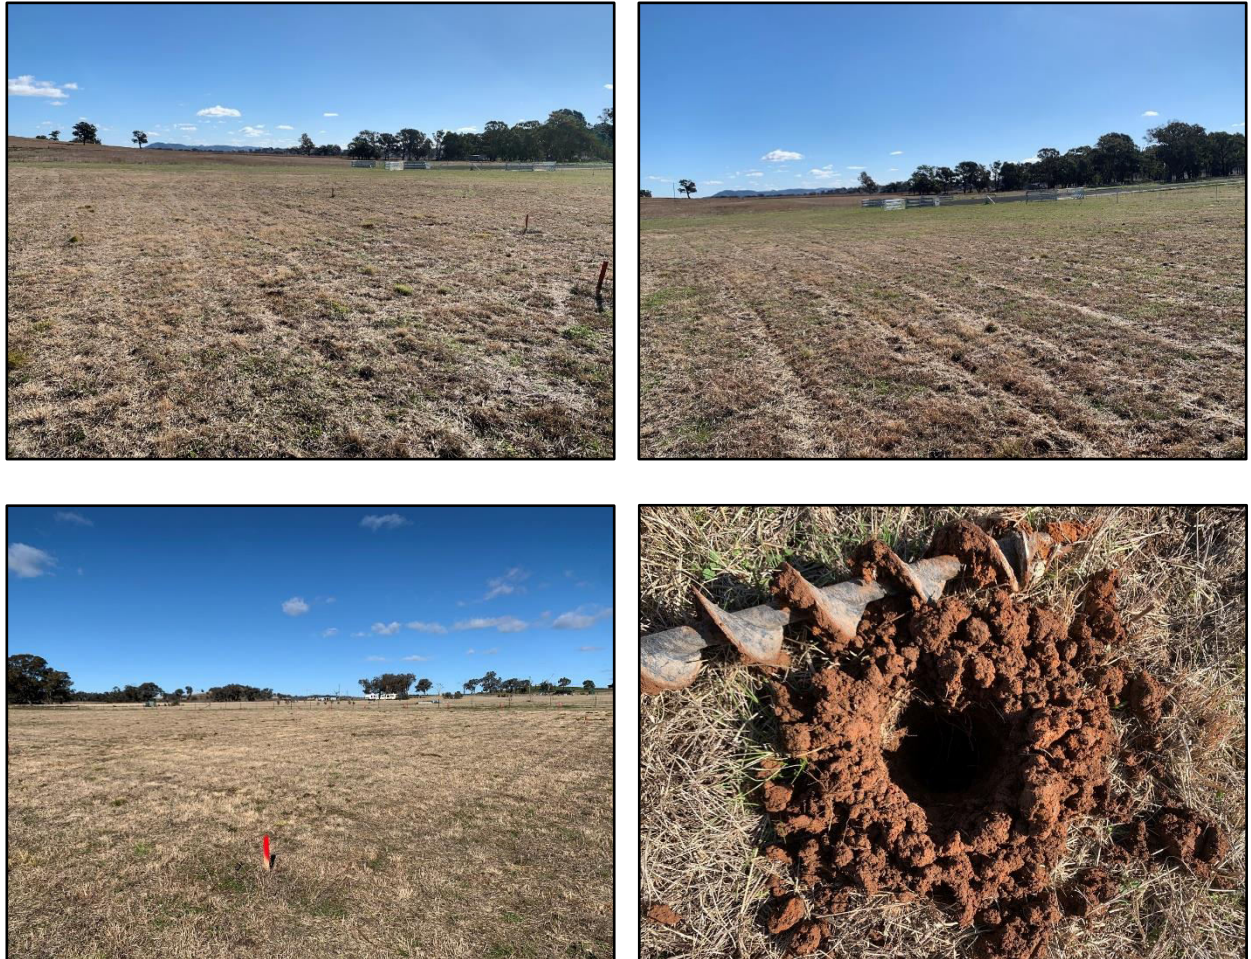
Figure 1 Existing Site

The site was located at Lot 33 in DP1273458, 29 Peru Lane Gulgong NSW 2852. The investigation area is displayed in Figure 1 below. The site is accessed by an access road via Peru Lane Road to the north.
