37147-GR01\_B

## Soil Reactivity Test for Proposed House Site at 17 Glenrock Lane, Kains Flat NSW

# Material Test Report

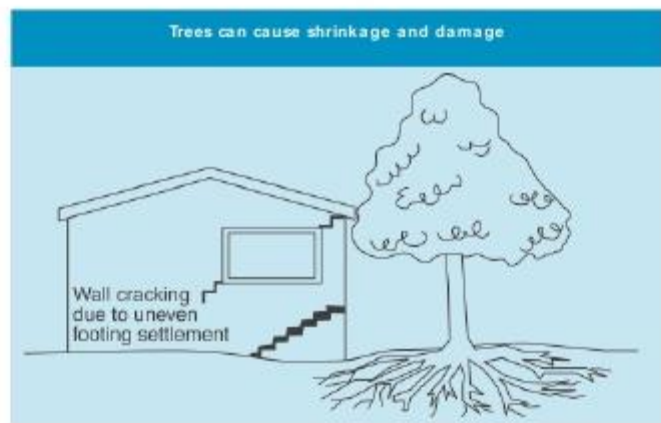
As the moisture absorption process completes its journey to the innermost areas of the building, the internal footings will rise. If the spread of moisture is roughly even, it may be that the symptoms will temporarily disappear, but it is more likely that swelling will be uneven, creating a difference rather than a disappearance in symptoms. In buildings with timber flooring supported by bearers and joists, the isolated piers will rise more easily than the strip footings or piers under walls, creating noticeable doming of flooring.

As the weather pattern changes and the soil begins to dry out, the external footings will be first affected, beginning with the locations where the sun's effect is strongest. This has the effect of lowering the external footings. The doming is accentuated and cracking reduces or disappears where it occurred because of dishing, but other cracks open up. The roof lines may become convex.
