Soil Reactivity Test Report

842 Ridge Road, Cooks Gap
NSW

Soil Reactivity Test for Proposed House Site at 842 Ridge Road, Cooks Gap NSW

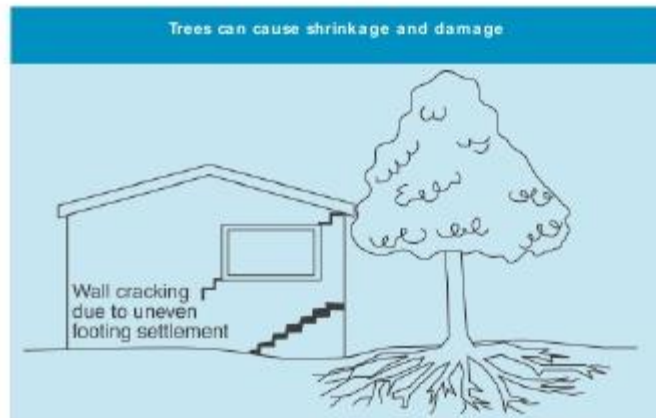
As the moisture absorption process completes its journey to the innermost areas of the building, the internal footings will rise. If the spread of moisture is roughly even, it may be that the symptoms will temporarily disappear, but it is more likely that swelling will be uneven, creating a difference rather than a disappearance in symptoms. In buildings with timber flooring supported by bearers and joists, the isolated piers will rise more easily than the strip footings or piers under walls, creating noticeable doming of flooring.

As the weather pattern changes and the soil begins to dry out, the external footings will be first affected, beginning with the locations where the sun's effect is strongest. This has the effect of lowering the external footings. The doming is accentuated and cracking reduces or disappears where it occurred because of dishing, but other cracks open up. The roof lines may become convex.
