Site Classification for Lot 1 in DP577917, 1928 Goolma Road, Two Mile Flat NSW 2852

Prepared For: Manor Homes

Reference: SGC22-614

Date: 22nd October 2022

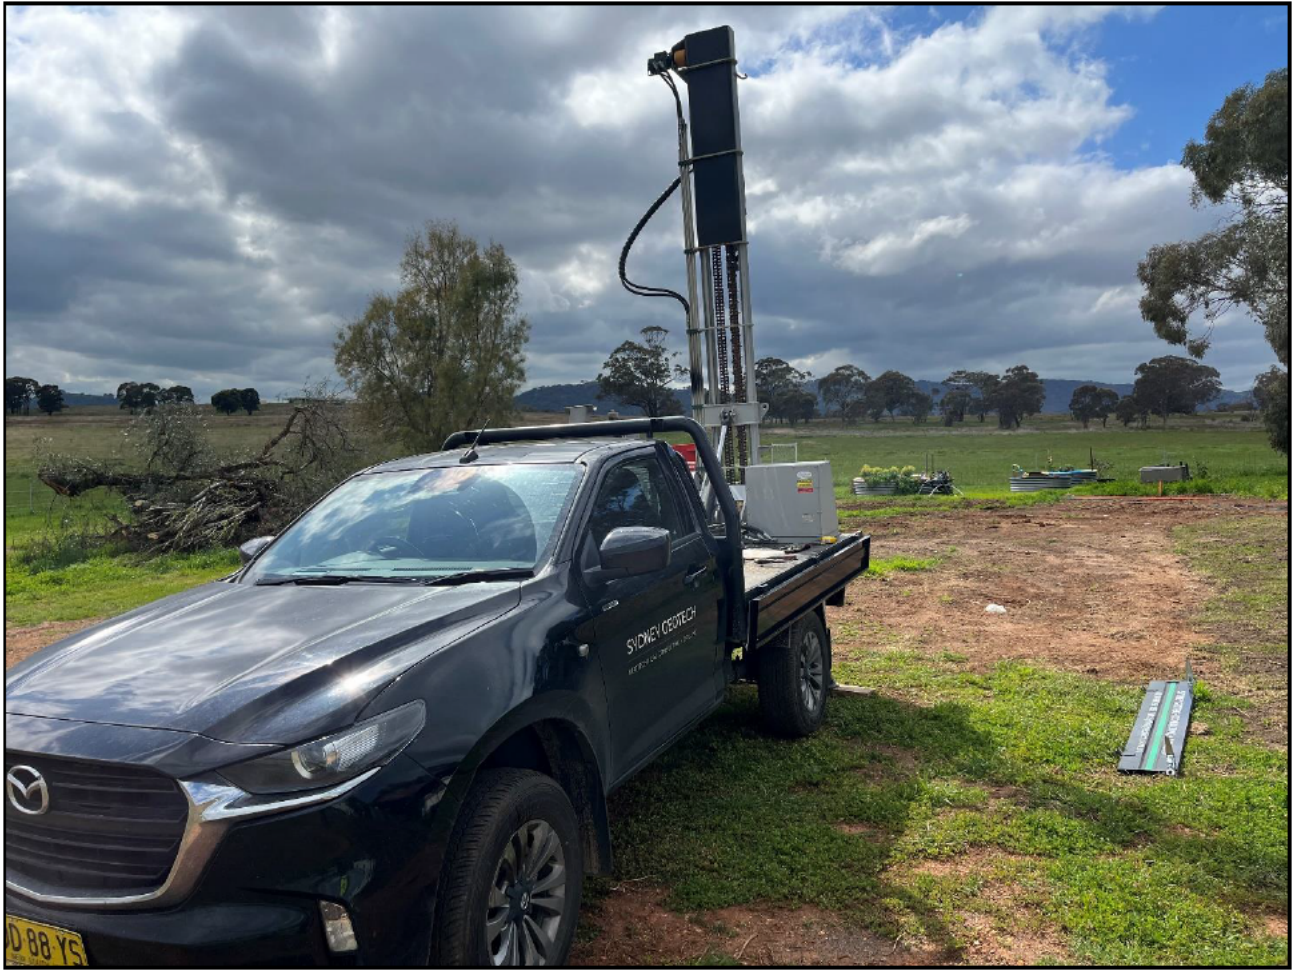
Figure 1 4WD Ute Mounted Drilling Rig

A site visit was made on Monday 17th October 2022 by an engineering geologist from SGC. A preliminary walkover of the site was conducted during the site visit. The fieldwork consisted of the drilling of two (2) boreholes up to 1.50 m (met with refusal) within the footprint of the proposed development area. The drilling was undertaken utilising a 4WD Ute Mounted Drill Rig with 90mm solid flight auger attachments (Figure 1).

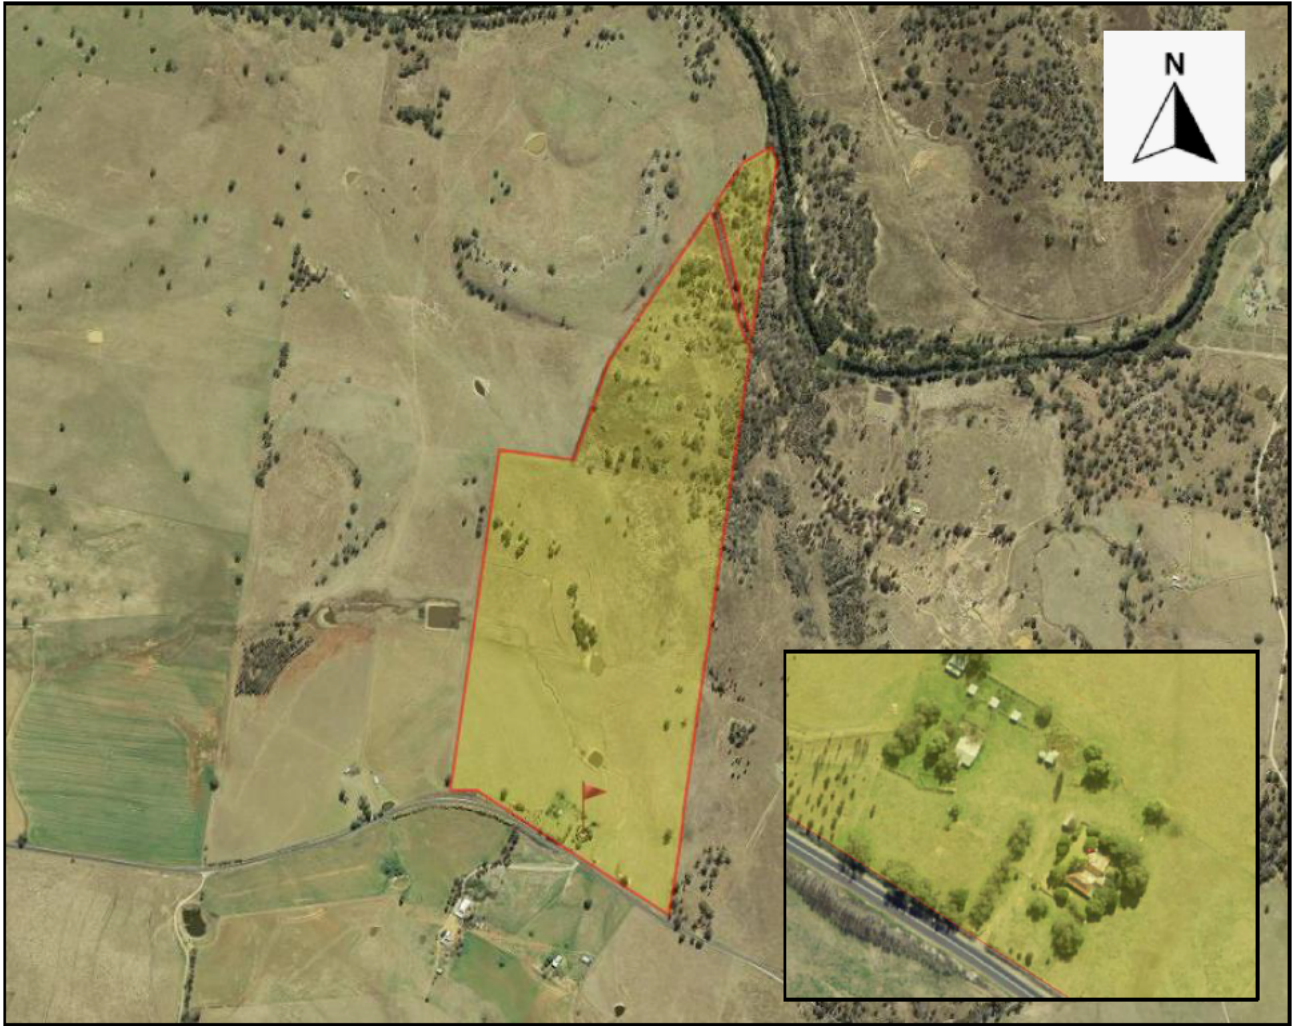
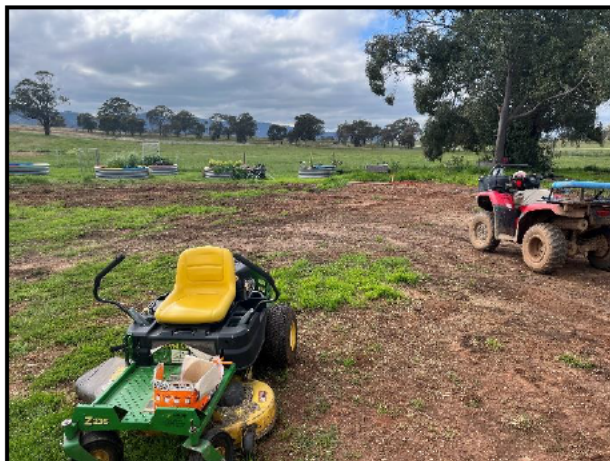
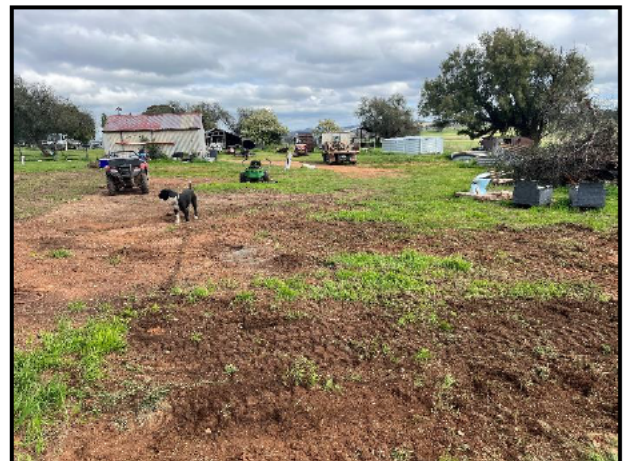
Figure 2 Existing Site

The site was located at Lot 1 in DP577917, 1928 Goolma Road, Two Mile Flat NSW 2852. The investigation area is displayed in Figure 2 below. The site is accessed from Goolma Road to the south.

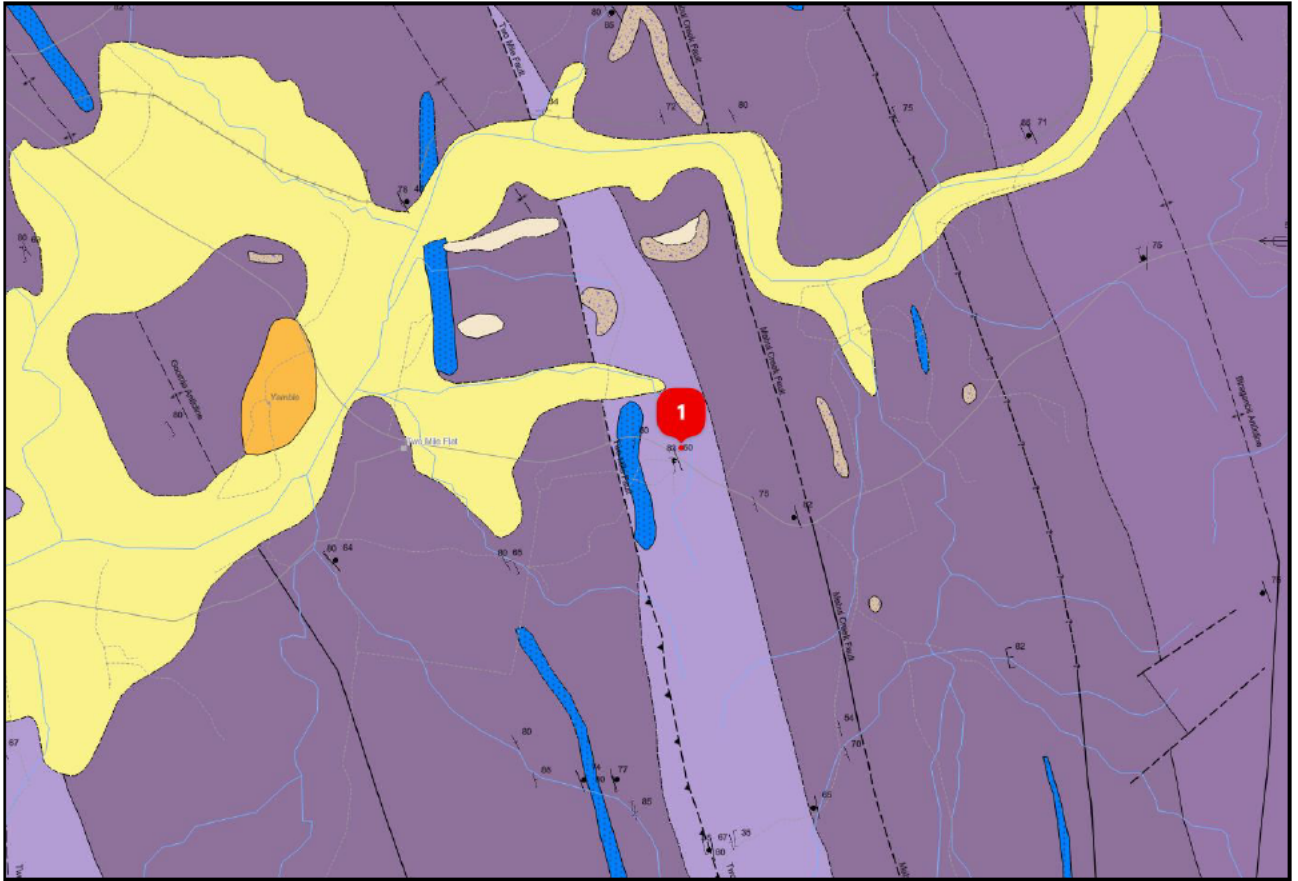
Turondale Formation. Thick bedded, crystal-lithic, rhyolitic to rhyodacitic volcanoclastic sandstone interbedded with lesser thin-bedded, pelagic and volcanoclastic sandstone, siltstone and phyllitic shale. Minor rhyolitic tuff and conglomerate.

Figure 3 Geology Map

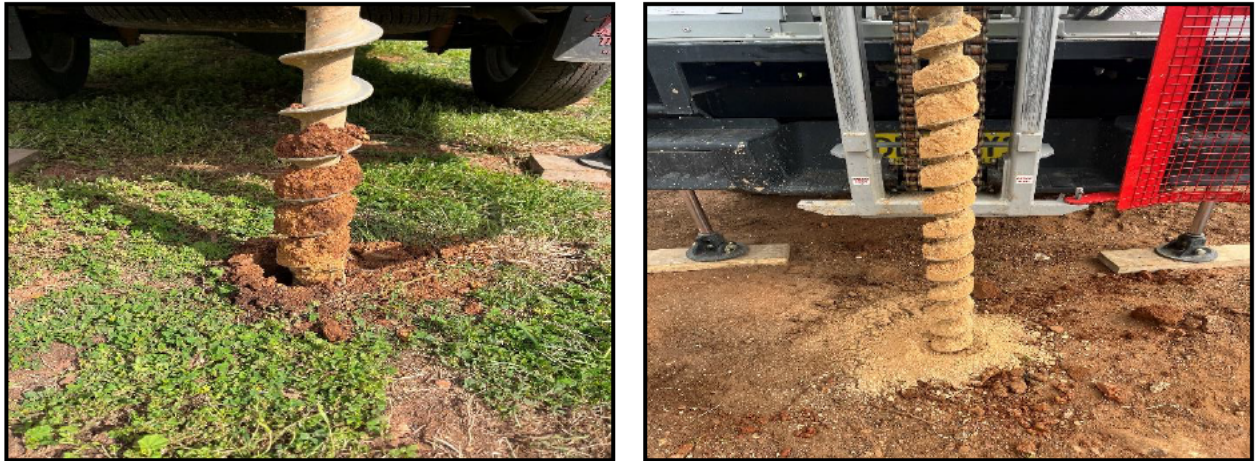
Figure 4 Recovered Borehole Material

Depth (m)	Material Description
0.20 – 1.00	NATURAL: Silty CLAY w sand, low to medium plasticity, red brown and yellow orange, trace fine to medium gravels, fine to medium grained, moisture content < plastic limit (DEEP MARINE)
1.00 – 1.50*	NATURAL: Clayey ROCK (SILTSTONE/SANDSTONE), extremely weathered, orange and grey to pale grey and white, fine to coarse grained, moist (DEEP MARINE-Volcaniclastic)
