Site Classification for 88 Gibsons Lane, Erudgere NSW 2850

Prepared For: Manor Homes

Reference: SGC22-640

Date: 29th November 2022

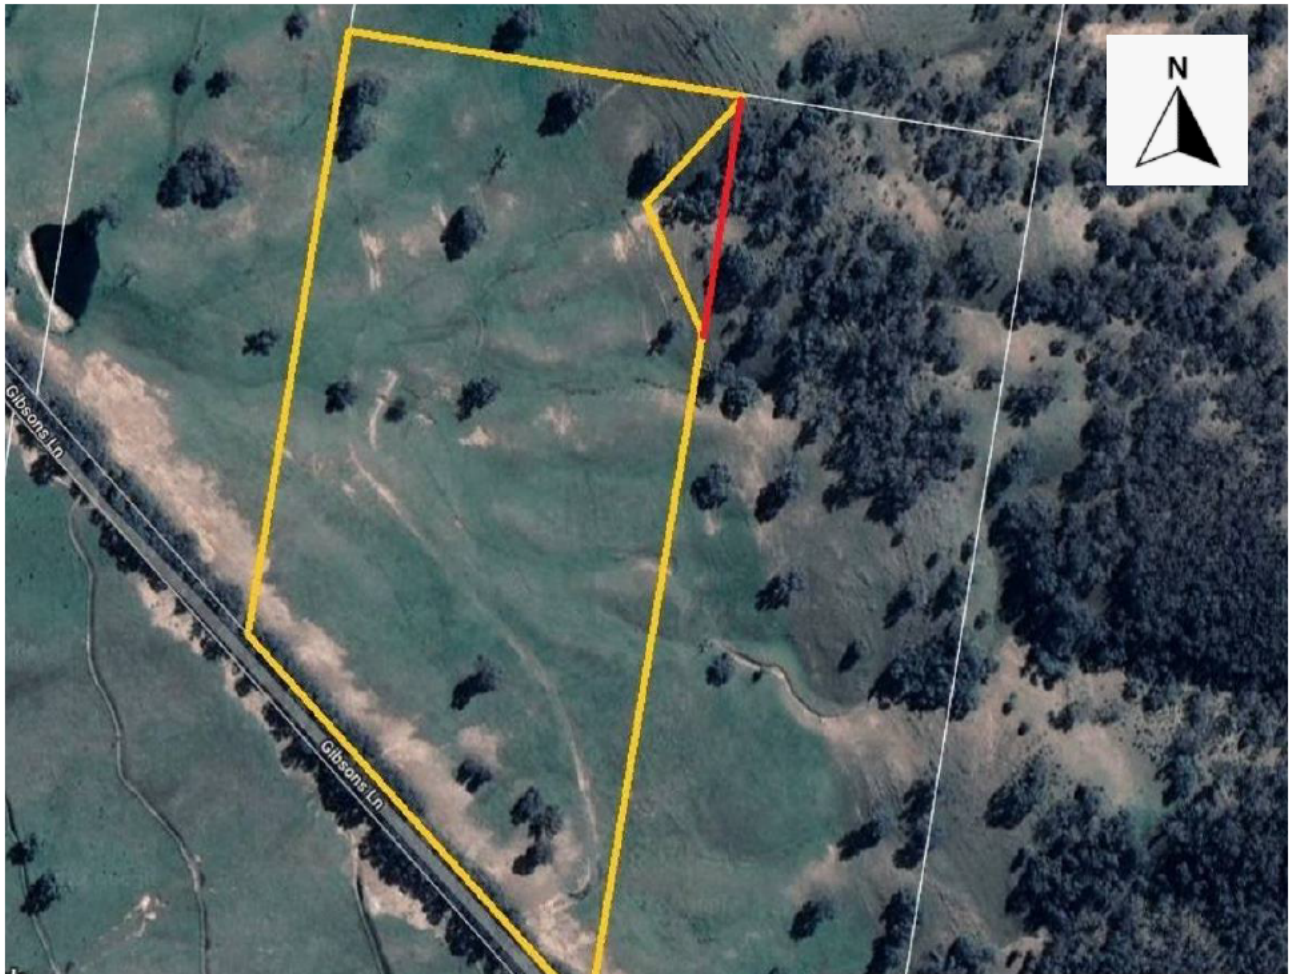
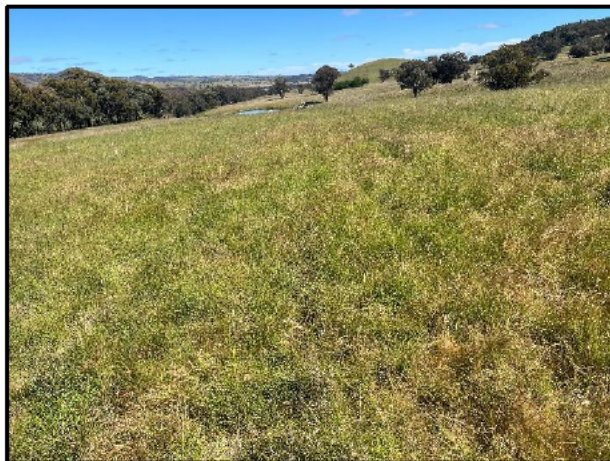
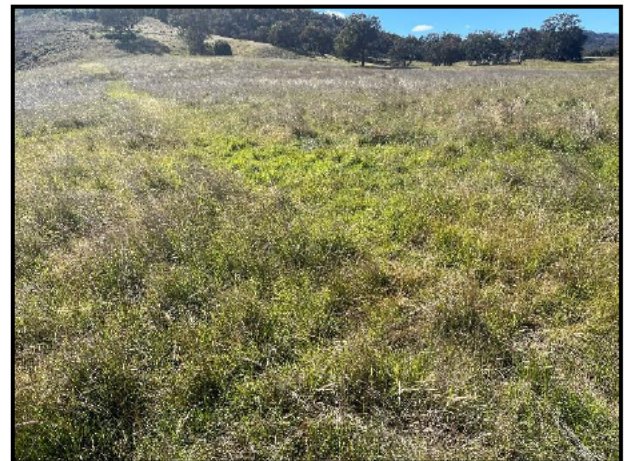
Figure 2 Existing Site (Six Maps and SGC Photographs)

The site was located at 88 Gibsons, Lane Erudgere NSW 2850. The investigation area is displayed in Figure 2 below. The site is a rural property, vacant at the time of inspection displaying an open grassed areas and occasional large mature trees. The site area is approximately 15.2 Ha. The site is accessed via a private dirt access track from Gibsons Lane, which branches off Hill End Road to the south.

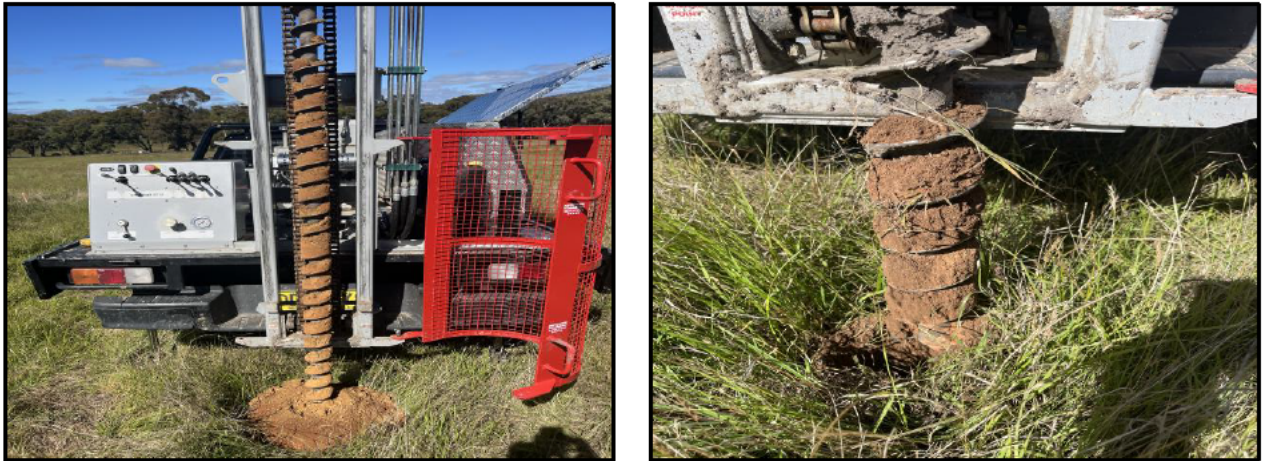
Depth (m)	Material Description
1.00 – 3.00*	NATURAL: Silty Sandy Gravelly CLAY, low to medium plasticity, orange and brown and mottled orange-red-grey below 1.5m, fine to medium sands and gravels, moisture content < plastic limit (MARINE)

Figure 4 Recovered Borehole Material

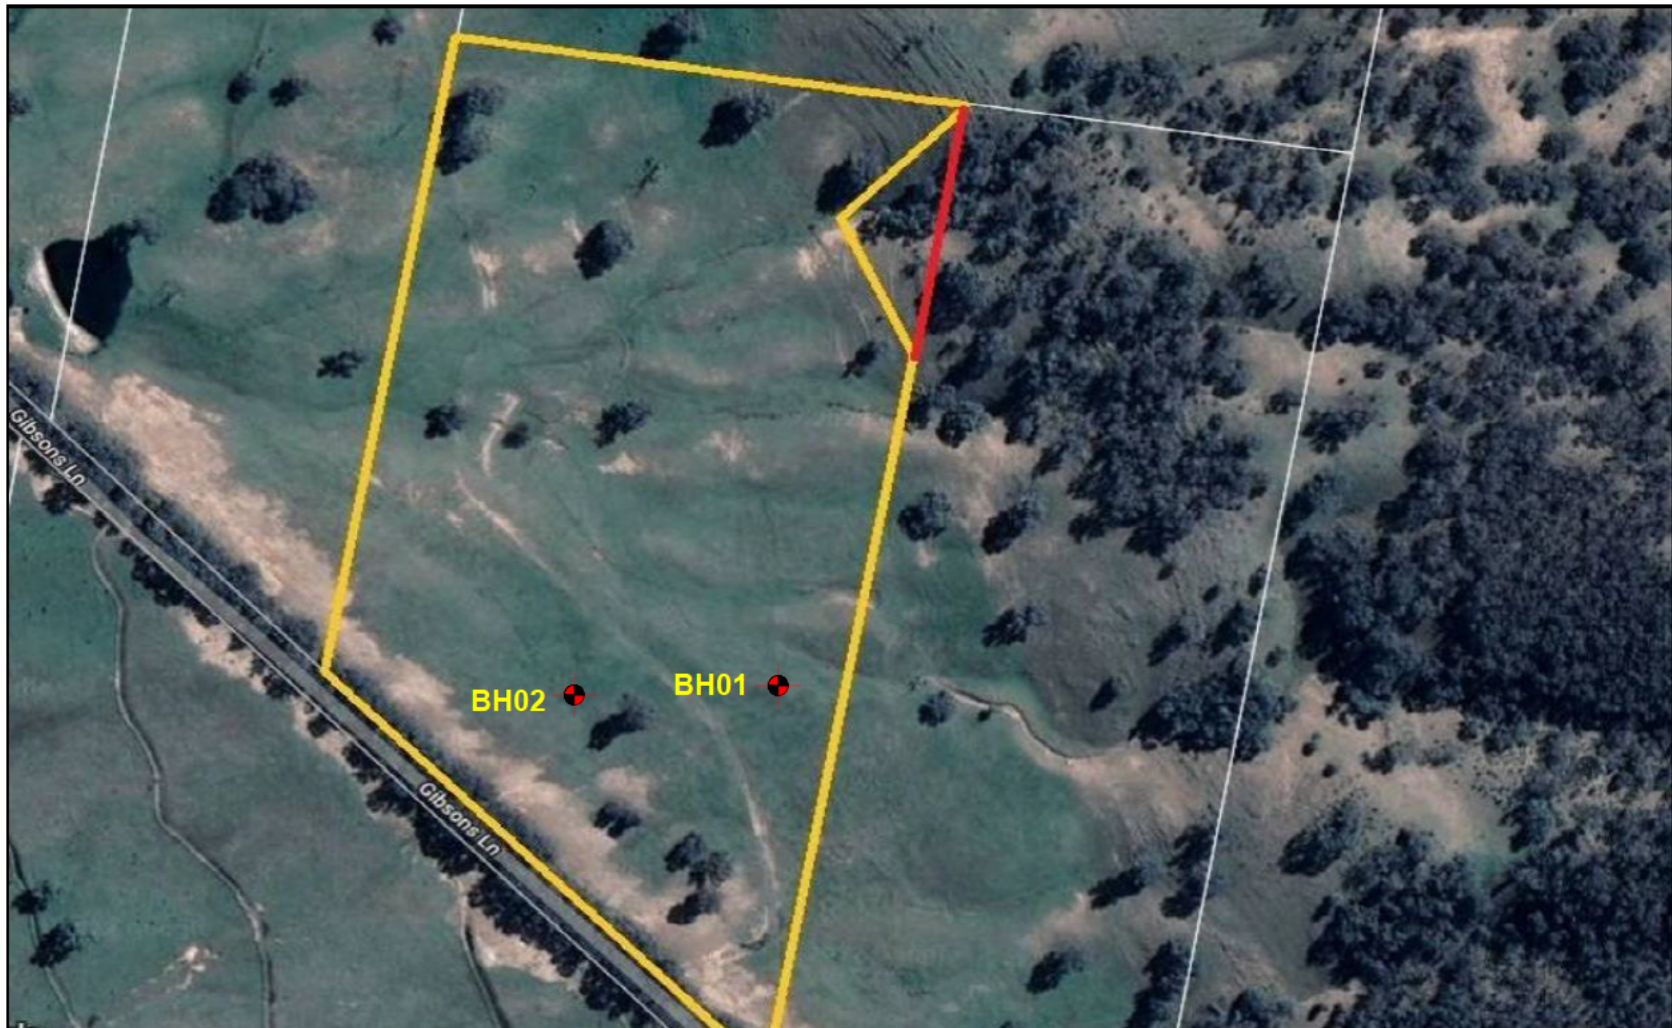
Borehole Location

Note: Borehole locations are approximate. Borehole size is not to scale.

In-situ DCP and PP testing was undertaken at each borehole location. Appendix A displays the location of the excavated borehole.
