## AS2870-2011 SITE CLASSIFICATION

Hibbard Homes Pty Ltd

Lot 17 Saleyards Lane, Mudgee NSW

**AS2870 Site Classification**

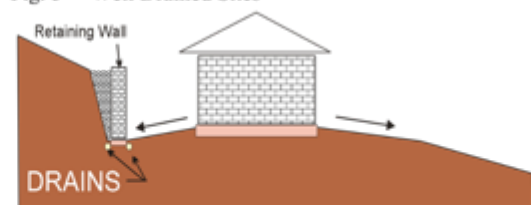
Fig. 5 Well Drained Sites

- Constructing sheds or outdoor roofed areas without connecting the roof drainage to storm water lines.
- Constructing paving around the building without sufficient slope away from the building. (In sandy soils and low and moderate "reactivity" clays, a slope of 1:40 up to 1 metre away from the building is adequate. In highly reactive clays a slope of 1:20 works better. In large paved areas a drain and collection pit may be necessary). (Fig. 5 & 18)

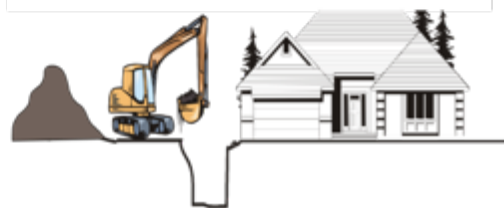
Fig. 11 De-stabilizing house foundations

- Ensuring that excavations are well supported or are dug to avoid collapses. (Fig. 11)
- Constructing well-compacted and retained 'soil aprons' around the building to stop erosion.

- Special considerations if any excavations are to be dug near adjoining structures. (Fig. 11)
- Sloping the soil and paths away from the building by the minimum amount required by the building regulations to prevent water flowing towards the building foundations. (Fig. 10 & 18)

- Running machinery over shallow drain pipes may break them causing leaks and subsequent foundation movements.
- Any excavations close to building footings can cause them to sink by disturbing the foundation material or by drying the foundation clay. (Fig 11)

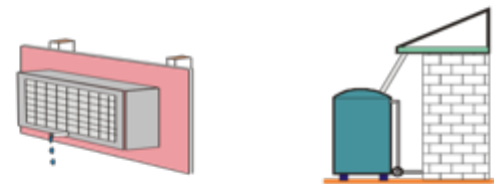
Fig. 16 Air con, up to 35 L/day loss

Fig.17 Leaky pipe:
