Preliminary Geotechnical Investigation

313 Magpie Lane, Galambine NSW 2850

Prepared for: CAM Engineering and Constructions Pty Ltd
EP3229.001 23 February 2024

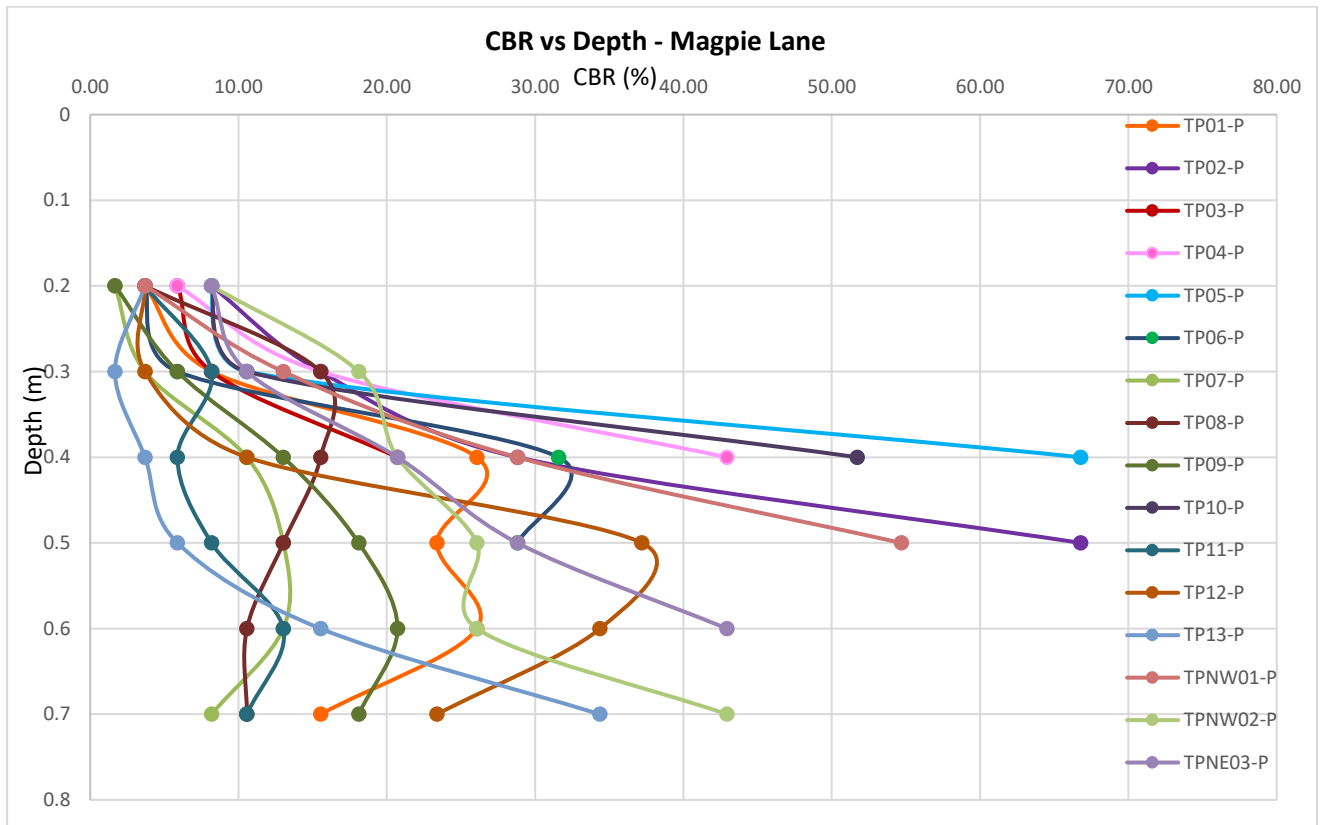
Figure 4. CBR (%) from DCP Tests Versus Depth

The DCP test can be used to provide a correlation with in-situ (field) CBR estimated in accordance with Austroads (2017). The field CBR versus laboratory CBR values are presented in Table 12 and the in-situ CBR values for substrata for the pavement boreholes are presented in the Figure 4.

The CBR at the estimated subgrade level ranges between 2% to 67%. It is noted an unreliable correlation between the in-situ CBR and laboratory values. This could be attributed to the moisture content of the soil in situ being generally drier than the optimum moisture content and granular nature of materials and presence of XW Rock. Pavement Design Parameters

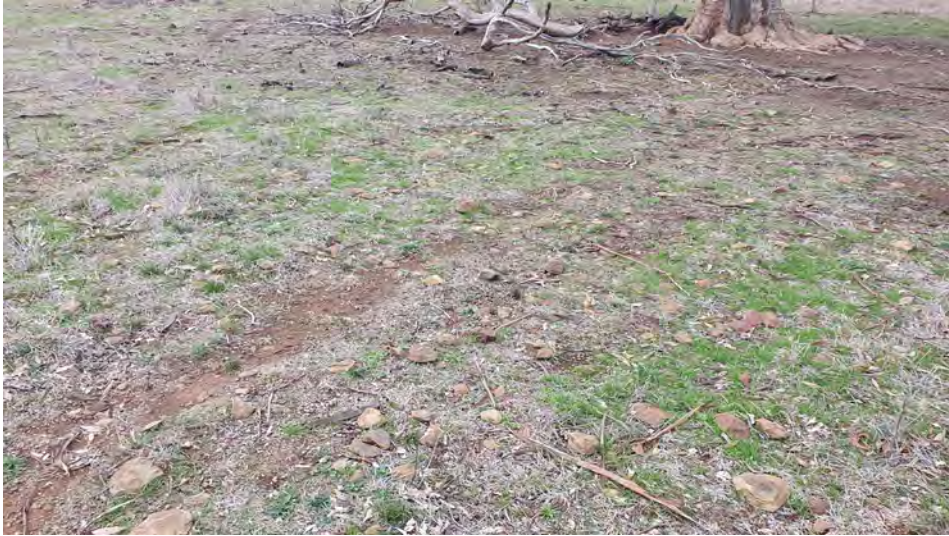
Plate 5

Description:
Rock fragments
in the northern
section of the
site

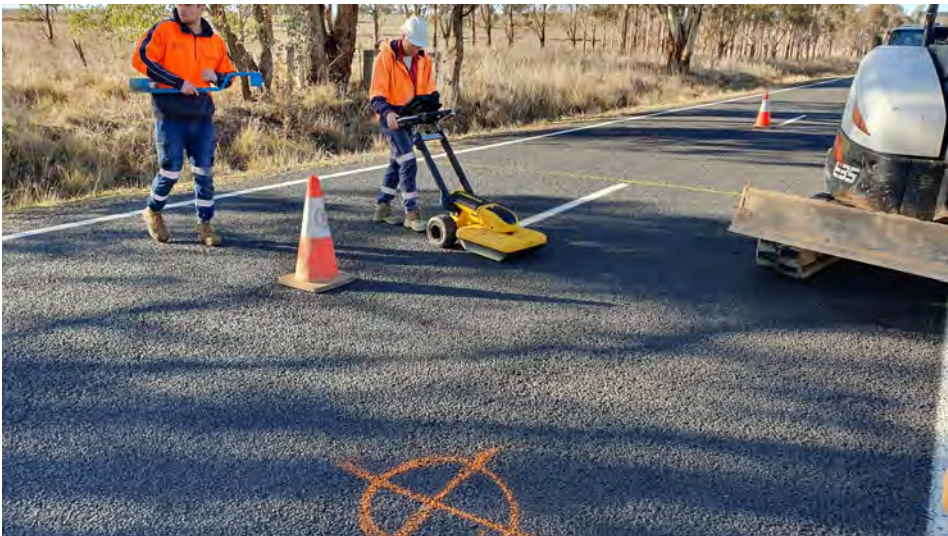
Plate 10

Description:
Ground
Penetration
radar used on
Guntawang
Road

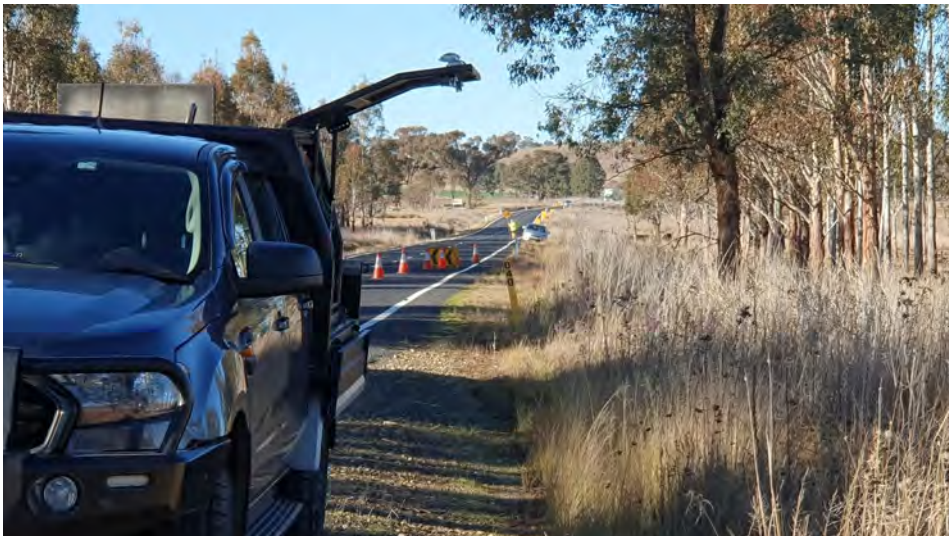
Plate 12

Description:
Setup for
investigation
on Guntawang
Road

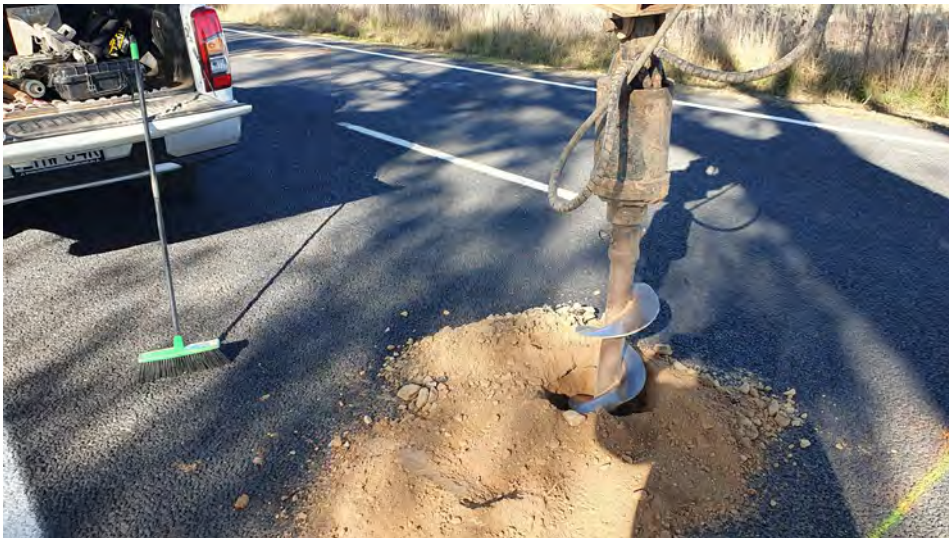
Plate 14

Description:
Rock subgrade
on Guntawang
Road

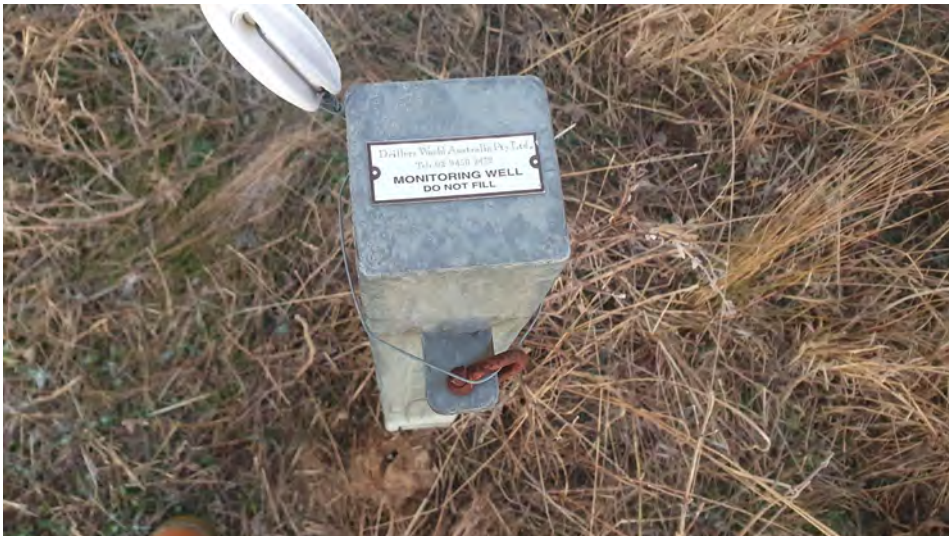
Plate 18

Description:
monitoring well
on site

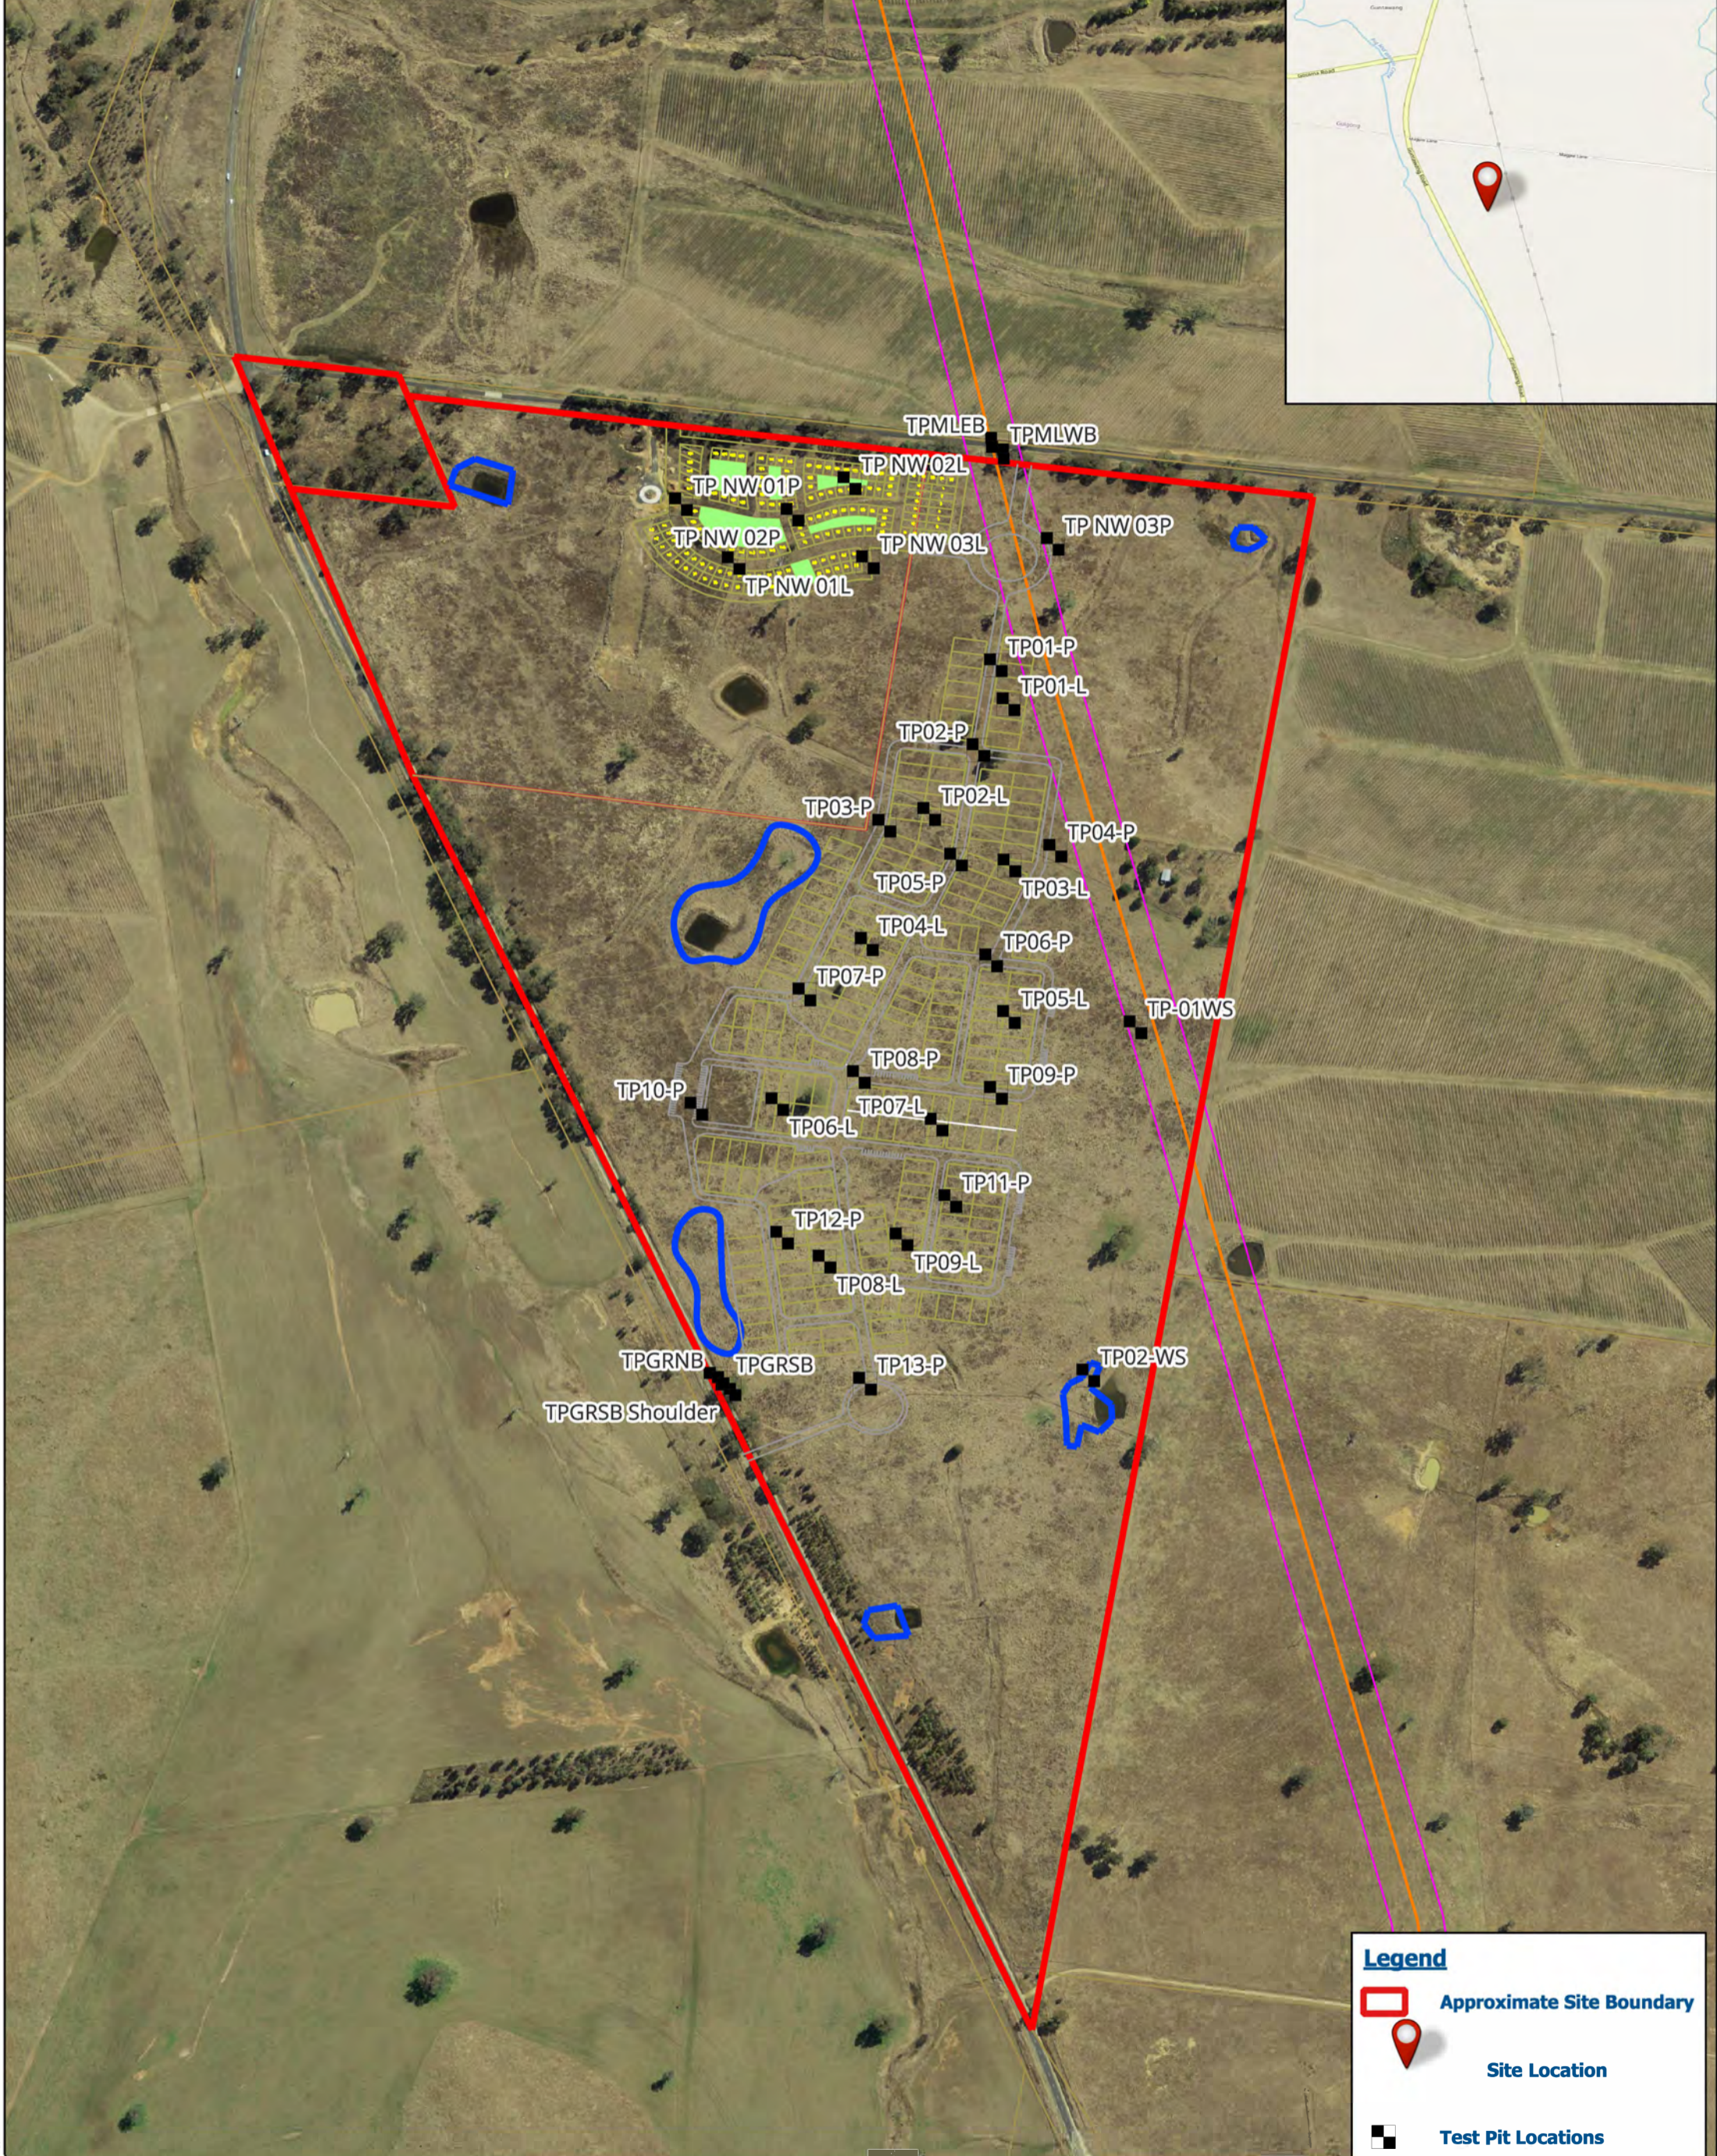
Appendix C - Geotechnical Investigation Locations

Test Pit Locations

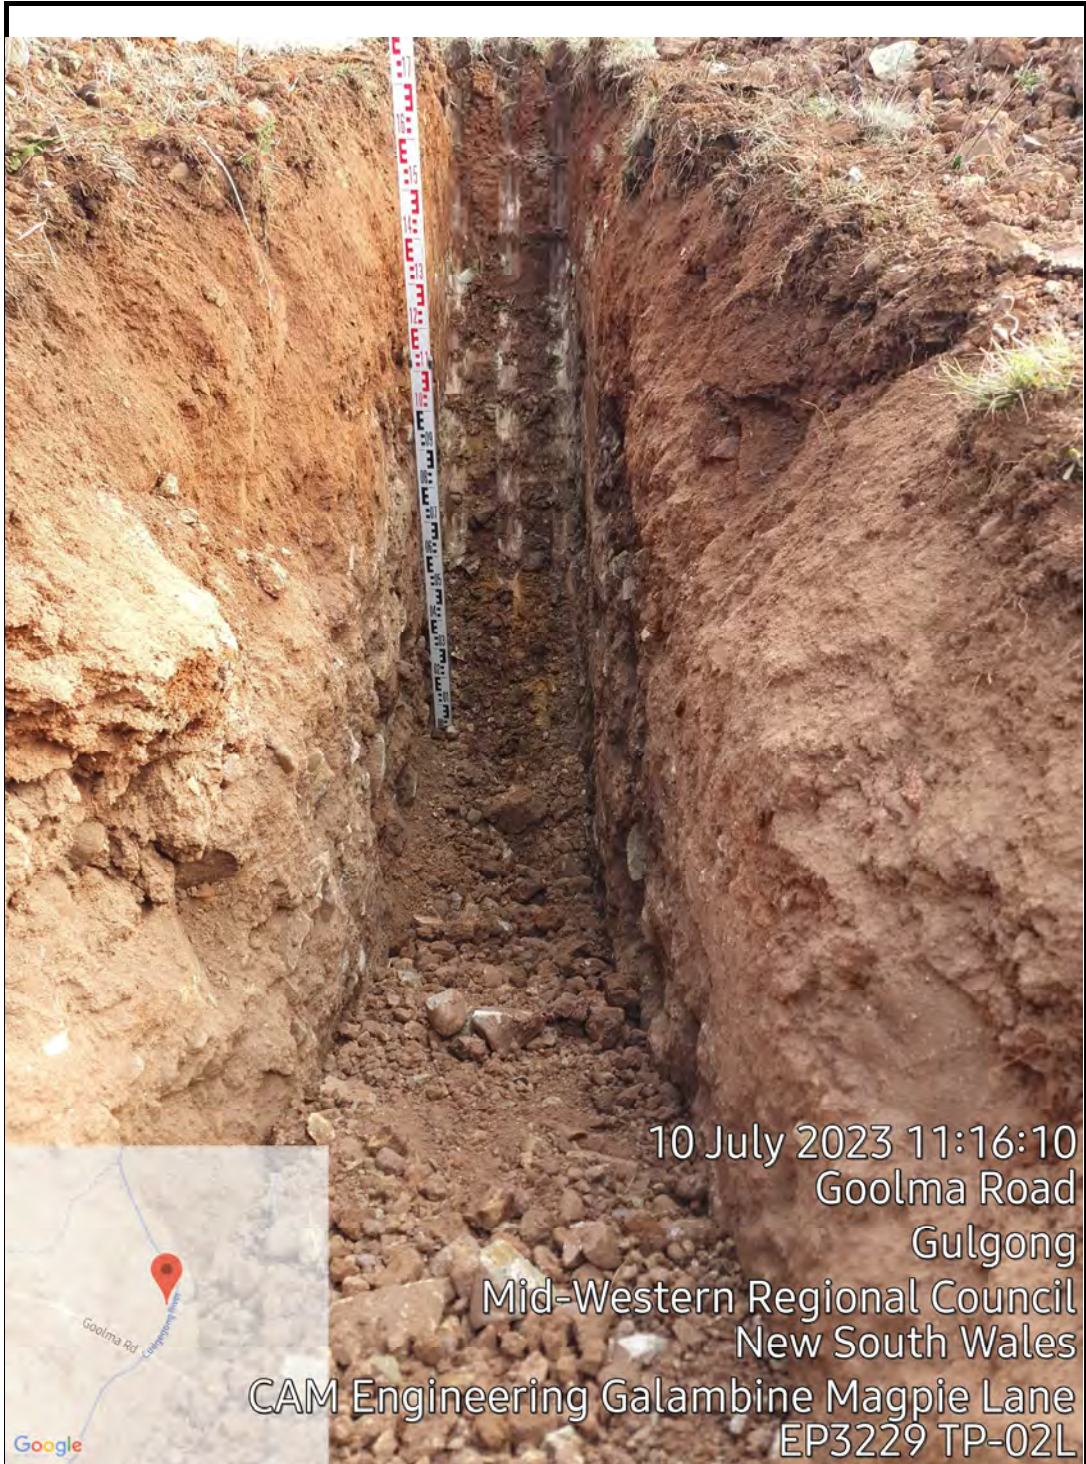
EP3229 TP-02L

EXCAVATION		MATERIAL DESCRIPTION				TESTING, SAMPLING & OTHER INFORMATION										
Method	Water	RL (m)	Depth (m)	Graphic Log	Classification	Description of Soil (soil type: plasticity/grainsize, colour and other components)	Moisture Condition	Consistency	Tests DCP Results (blows/ 100mm)	Samples	Additional Comments (material origin, pocket penetrometer values, investigation observations)					
E	Not Encountered	435	1		SC	TOPSOIL: Clayey SAND: fine to medium grained, brown	D	L	2	B	TOPSOIL					
					CI-CH	Silty CLAY: medium to high plasticity, brown, with cobbles and pebbles	~PL	VSt to H	2		RESIDUAL SOIL					
									8		EXTREMELY WEATHERED ROCK					
									11							
									15							
					15											
					SC	Extremely weathered Sandstone recovered as Clayey SAND, fine to coarse grained, grey, yellow and red	D	D to VD	19							
					14											
					Test Pit TP02-L Terminated at 1.70 m						Refusal on bedrock

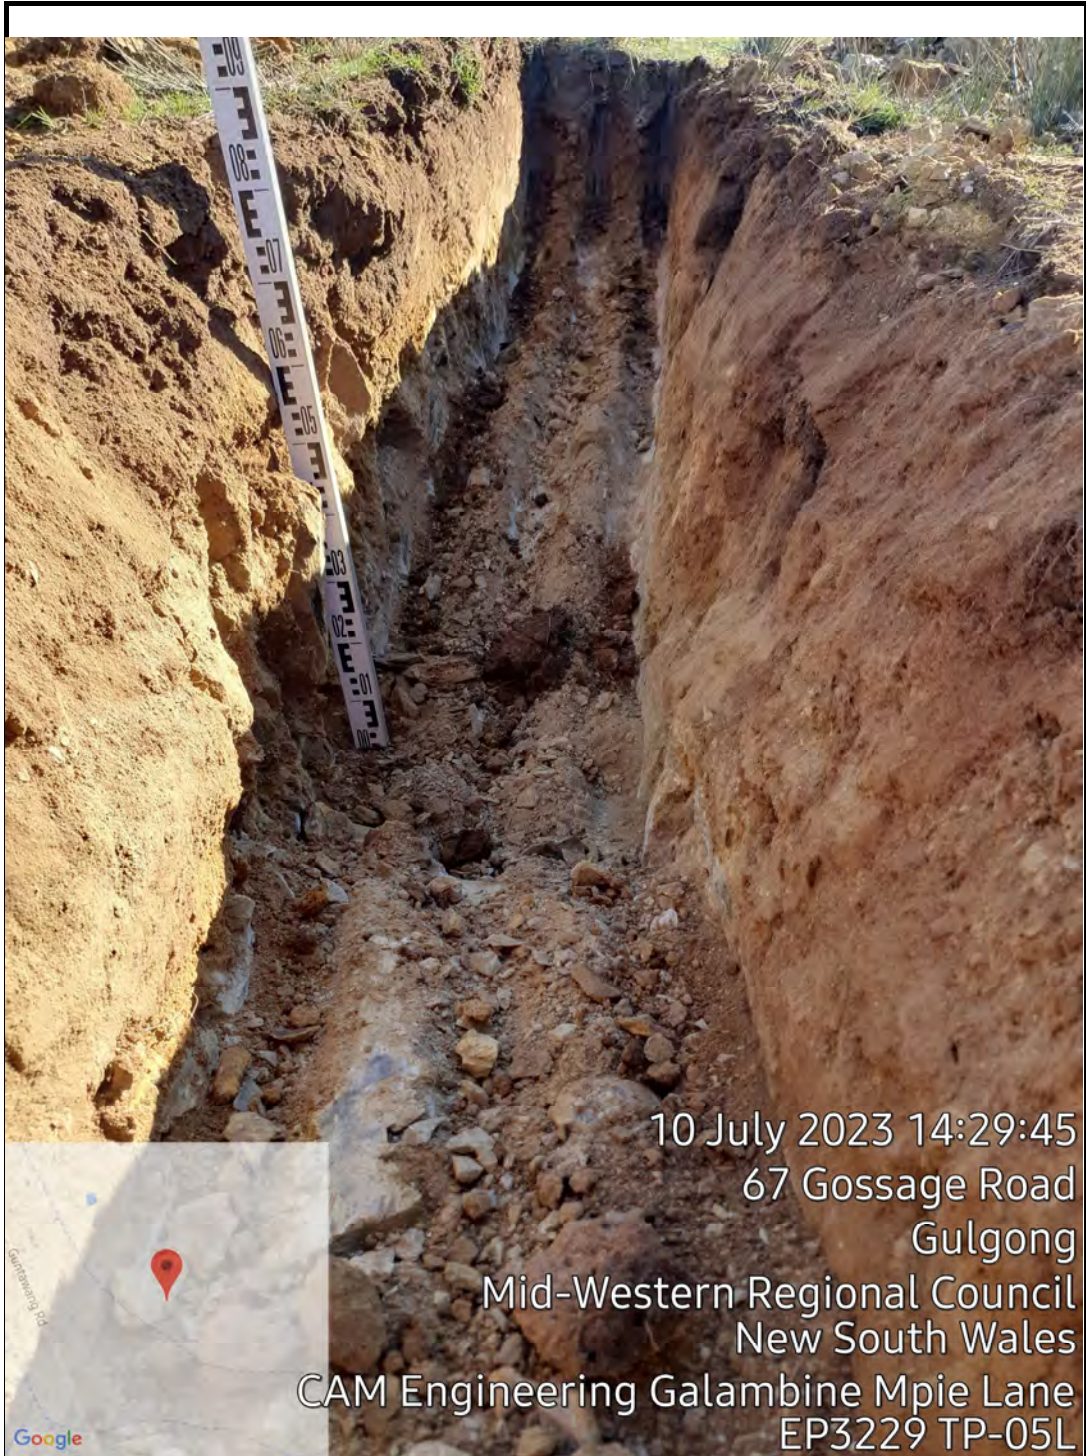
Test Pit TP05-L Terminated at 0.73 m					Refusal on bedrock

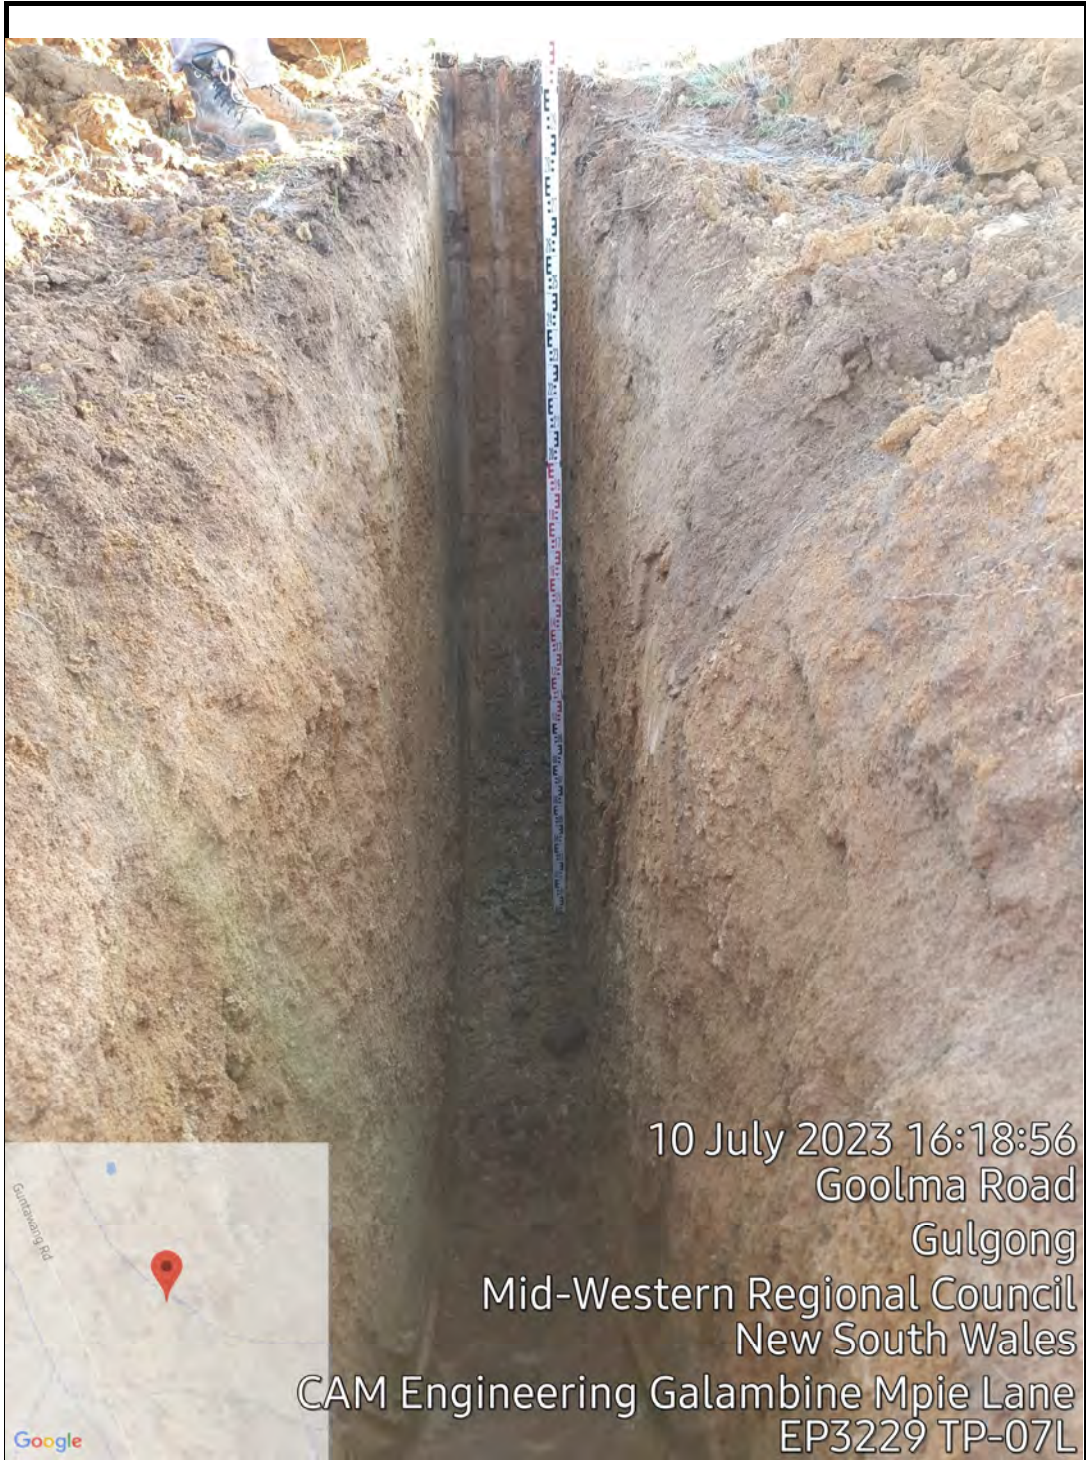
EP3229 TP-07L

436	2		ML	Extremely weathered Shale recovered as Clayey SILT, low plasticity, grey	~PL	VSt to H		D	EXTREMELY WEATHERED ROCK
		435	3			Test Pit TP07-L Terminated at 2.90 m

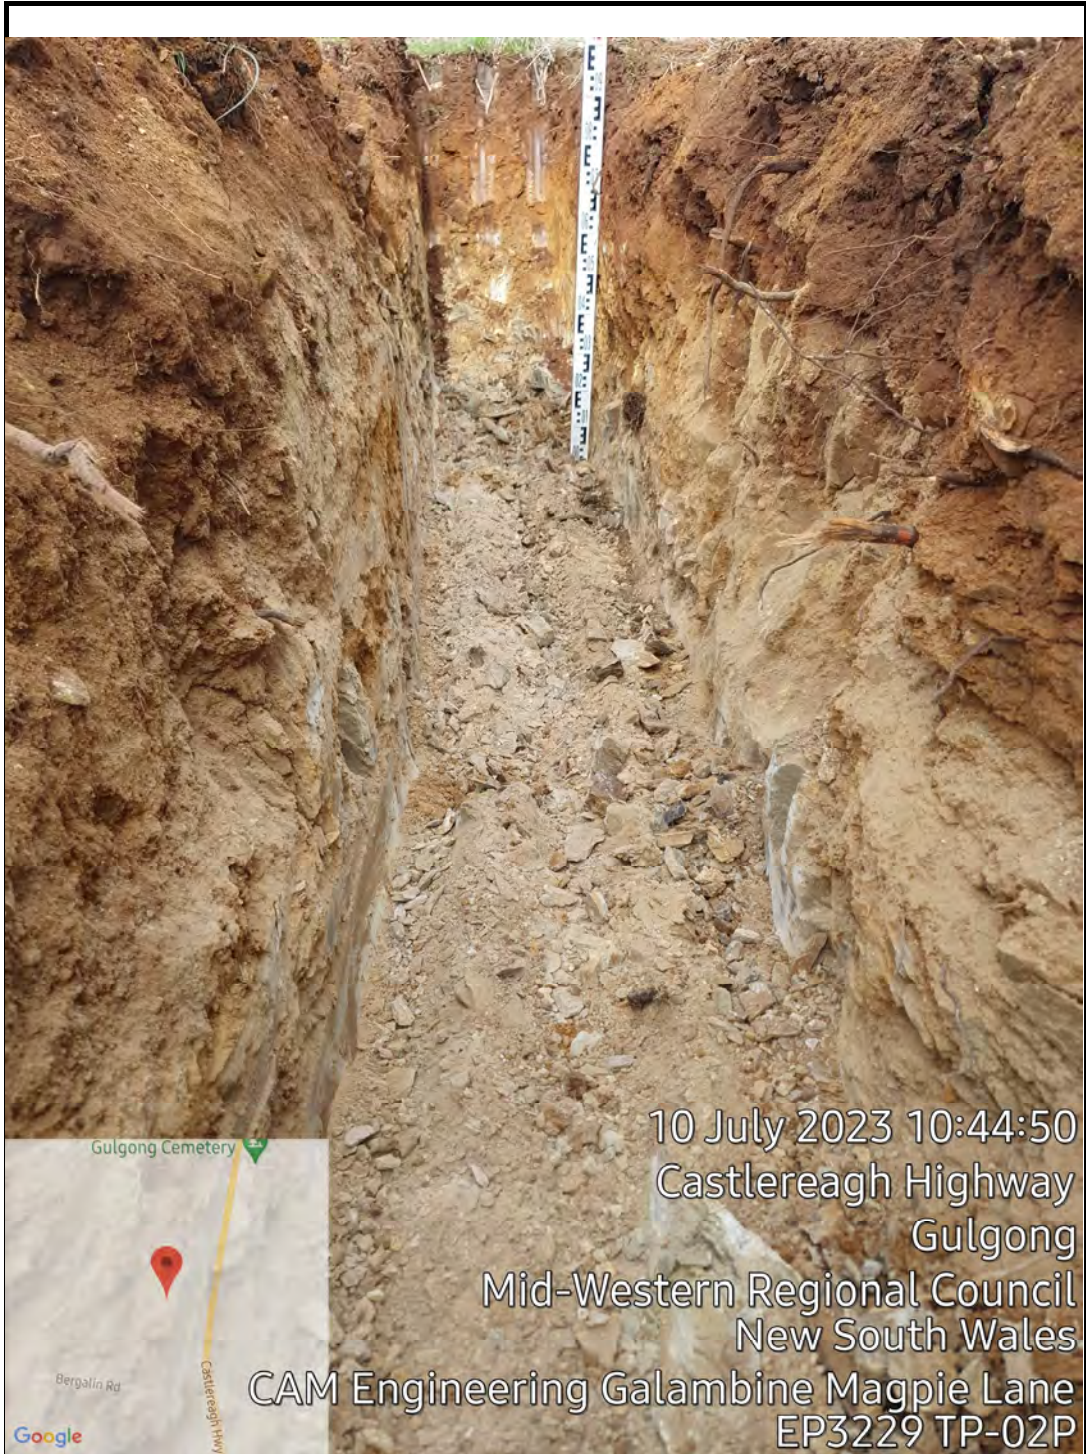
EXCAVATION		MATERIAL DESCRIPTION				TESTING, SAMPLING & OTHER INFORMATION					
Method	Water	RL (m)	Depth (m)	Graphic Log	Classification	Description of Soil (soil type: plasticity/grainsize, colour and other components)	Moisture Condition	Consistency	Tests DCP Results (blows/ 100mm)	Samples	Additional Comments (material origin, pocket penetrometer values, investigation observations)
E	Not Encountered	436	1		CL-CI	TOPSOIL: Sandy CLAY: low to medium plasticity, brown, fine to medium grained sand, with fragments of Sandstone (50mm-100mm)	<PL	St to VSt	3	B	TOPSOIL
					CI-CH	Sandy CLAY: medium to high plasticity, pale brown, fine to medium grained sand			3		RESIDUAL SOIL
									4		
					7						
					12						
25	VSt to H										
					SC	Extremely weathered Sandstone recovered as Clayey SAND, fine to coarse grained, pale brown and grey	D	D to VD			EXTREMELY WEATHERED ROCK
					Test Pit TP02-P Terminated at 1.00 m						Refusal on bedrock

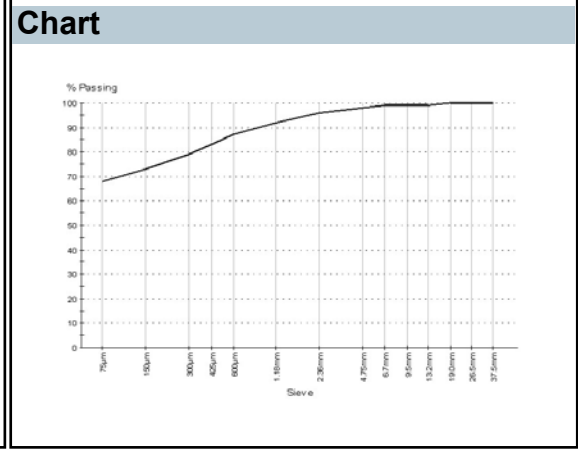
Particle Size Distribution		
Method:	AS 1289.3.6.1	
Drying By:	Oven	
Date Tested:	19/07/2023	
Note:	Sample Washed	
Sieve Size	% Passing	Limits
37.5mm	100	
26.5mm	100	
19.0mm	100	
13.2mm	99	
9.5mm	99	
6.7mm	99	
4.75mm	98	
2.36mm	96	
1.18mm	92	
600µm	87	
425µm	83	
300µm	79	
150µm	73	
75µm	68

Other Test Results			
Description	Method	Result	Limits
Sample History	AS 1289.1.1	Air-Dried	
Preparation	AS 1289.1.1	Dry-Sieved	
Linear Shrinkage (%)	AS 1289.3.4.1	18.0	
Mould Length (mm)		250	
Crumbling		No	
Curling		Yes	
Cracking		No	
Liquid Limit (%)	AS 1289.3.1.1	50	
Method		Four Point	
Plastic Limit (%)	AS 1289.3.2.1	19	
Plasticity Index (%)	AS 1289.3.3.1	31	
Date Tested		20/07/2023
