#### Peppertree Hill Estate Development Geotechnical Investigation Report

**Client:** Parkview Capital c/- Wild Modular

Site Address: Peppertree Hill Estate 85 Rocky Waterhole Road Mudgee, NSW 2850

Our Reference: 46561-GR01\_B

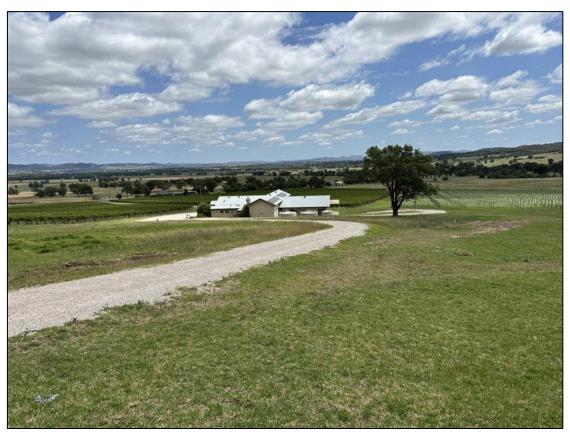
Figure 4: Photograph Looking Northeast Over the Existing Cellar Door

An extension and remodel of the existing onsite Cellar Door is proposed (**Figure 4**). The extension will include a new enclosed area (approximately 405m<sup>2</sup>) as well as a new outdoor covered deck area (220m<sup>2</sup>), extending northeast of the existing building (**Appendix F**). A car parking area for visitors is also proposed as part of the development, south of the existing Cellar Door (**Figure 3**).

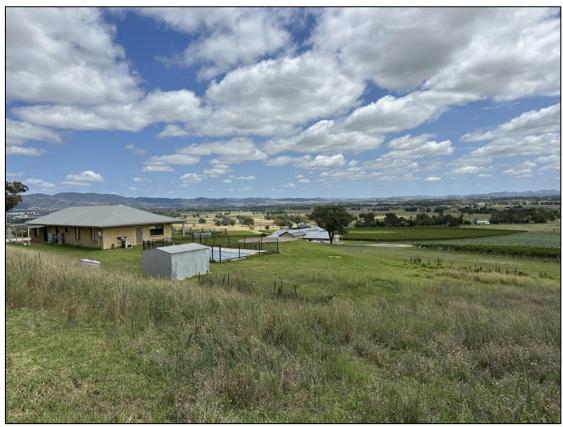
Figure 5: Photograph Looking East Over the Existing Residence and Cellar Door

Demolition of the existing residence is proposed, located 100m southeast and upslope of the existing Cellar Door (**Figure 5**). A proposed Bath House development, including construction of a retaining wall, is proposed to replace the existing residence (**Figure 3**). The proposed Bath House will be available for onsite guests as well as day visitors.

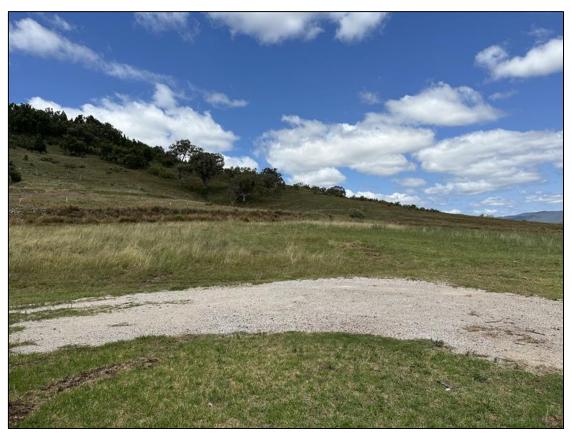
Figure 6: Photograph Looking Southeast Over Proposed Luxury Villa Locations

The construction of the sixteen single and double bedroom luxury villas is proposed for the site. The villas will be located alongside the existing residence as well as approximately 50m further southeast upslope of the existing residence (**Figure 3**). The proposed development area for each luxury villa is currently vacant with grass and weed species covering the areas (**Figure 6**).

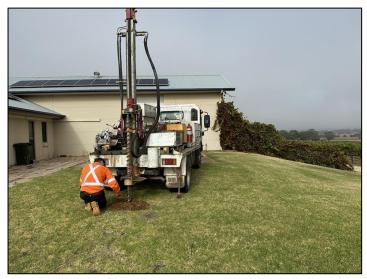
**Figure 13:** Photograph Looking Southwest Over the Proposed Extension Area of the Existing Cellar Door and BH12 Location

The soil profile at the Cellar Door/Restaurant extension, BH12, comprised dark brown sandy silt fill to approximately 0.1m followed by brown gravelly clay fill to approximately 0.4m. The natural subsoil comprised soft to firm gravelly clayey sand, sandy clay and sandy silt to 1.5m, then stiff silty clay and gravelly to silty clay to the target drilling depth of 3.0m. Medium to coarse sized gravel was identified in the stiff natural subsoil from 1.5m. Soil moisture in the borehole profile included less than, equal to and greater than plastic limit. High historical seasonal episodic shallow groundwater was evidenced by brown, red, orange and grey mottled clay at 1.5m depth.

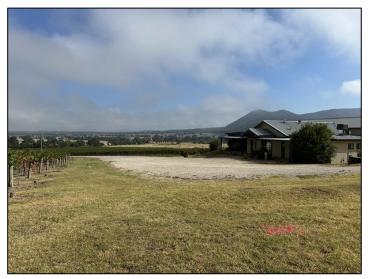
**Figure 14:** Photograph Looking North Over the Proposed Carpark Area and BH13 Location

The soil profile at the proposed carpark location, BH13, comprised sandy silt topsoil to 0.3m, then natural sandy to silty clay to 0.5m and silty clay with gravel to the target drilling depth of 2.0m. Soil moisture throughout the borehole profile less than plastic limit.

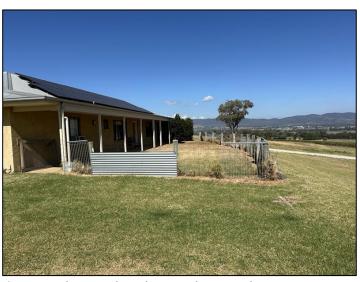
**Figure 16:** Photograph Looking Southwest at the Existing Residence Front Yard Area and BH16 Location

Very stiff drilling on natural sandy silt with weathered rock was encountered from 0.4m in BH14, 1.2m in BH15 and 3.3m in BH16, before drill refusal due to weathered rock in each borehole locations. Evidence of historical seasonal shallow groundwater was identified by mottled clay from 0.2m depth in BH15 and 1.6m depth in BH16. Gravels and weathered rock fragments occurred throughout the profiles. Soil moisture was less than plastic limit throughout BH14 and BH15. Soil moisture in BH16 ranged from less than plastic limit to greater than plastic limit throughout the profile.

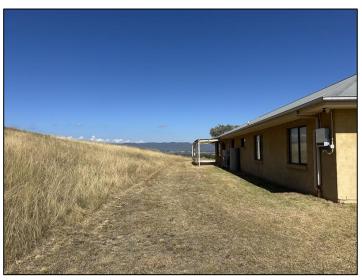
**Figure 18:** Photograph Looking Southwest Over the Rear of the Existing Residence and BH14 Location

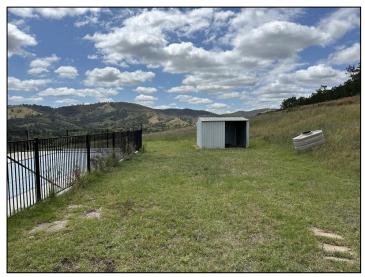
**Figure 19:** Photograph Looking Northeast at Part of the Onsite Swimming Pool, Small Storage Shed and BH15 Location

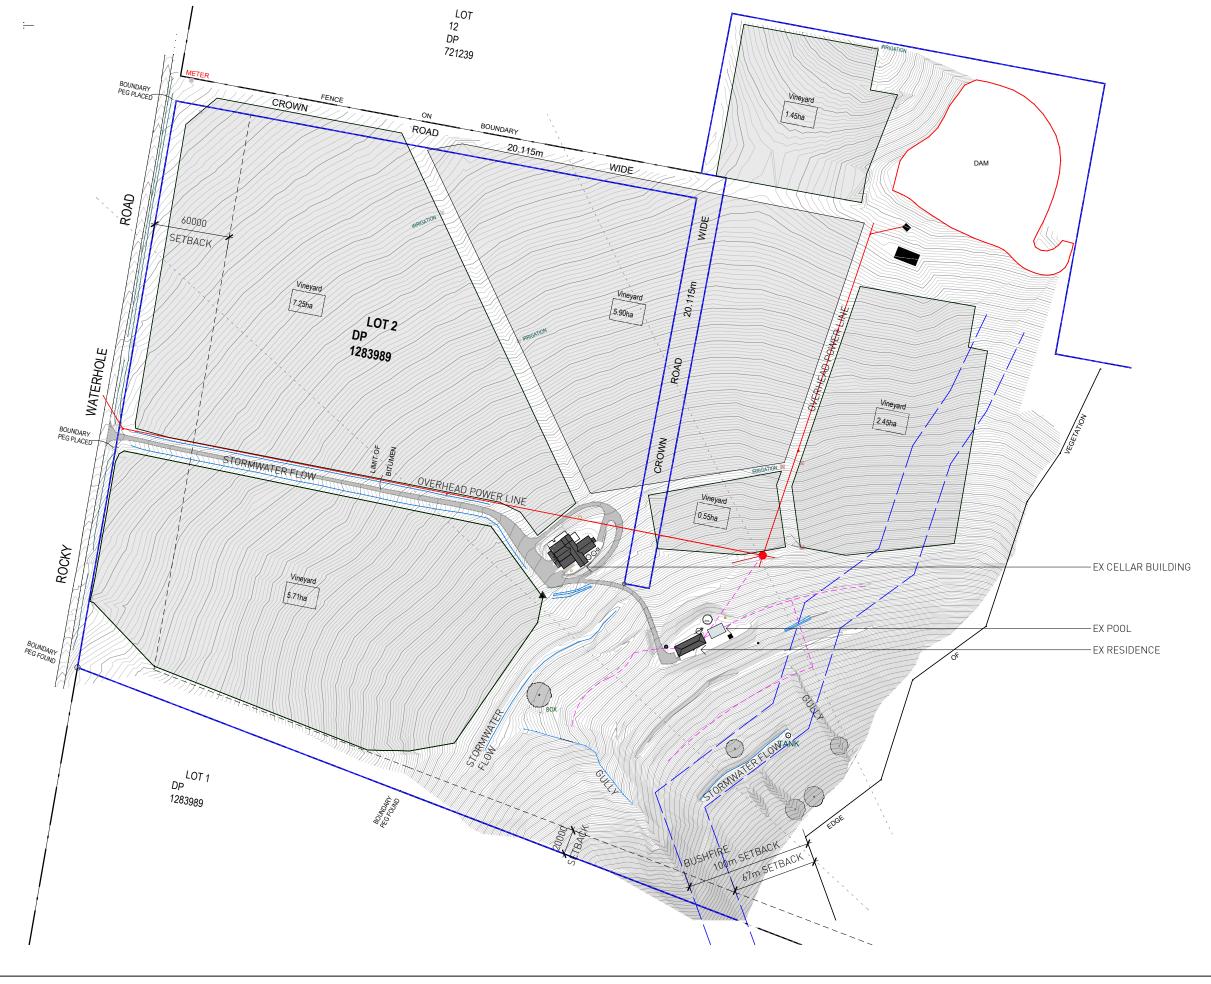
2408 PEPPERTREE HILL ESTATE EX. SITE PLAN DRAWN SENIOR QA APP'D DWG NO DRAFT EX001 В

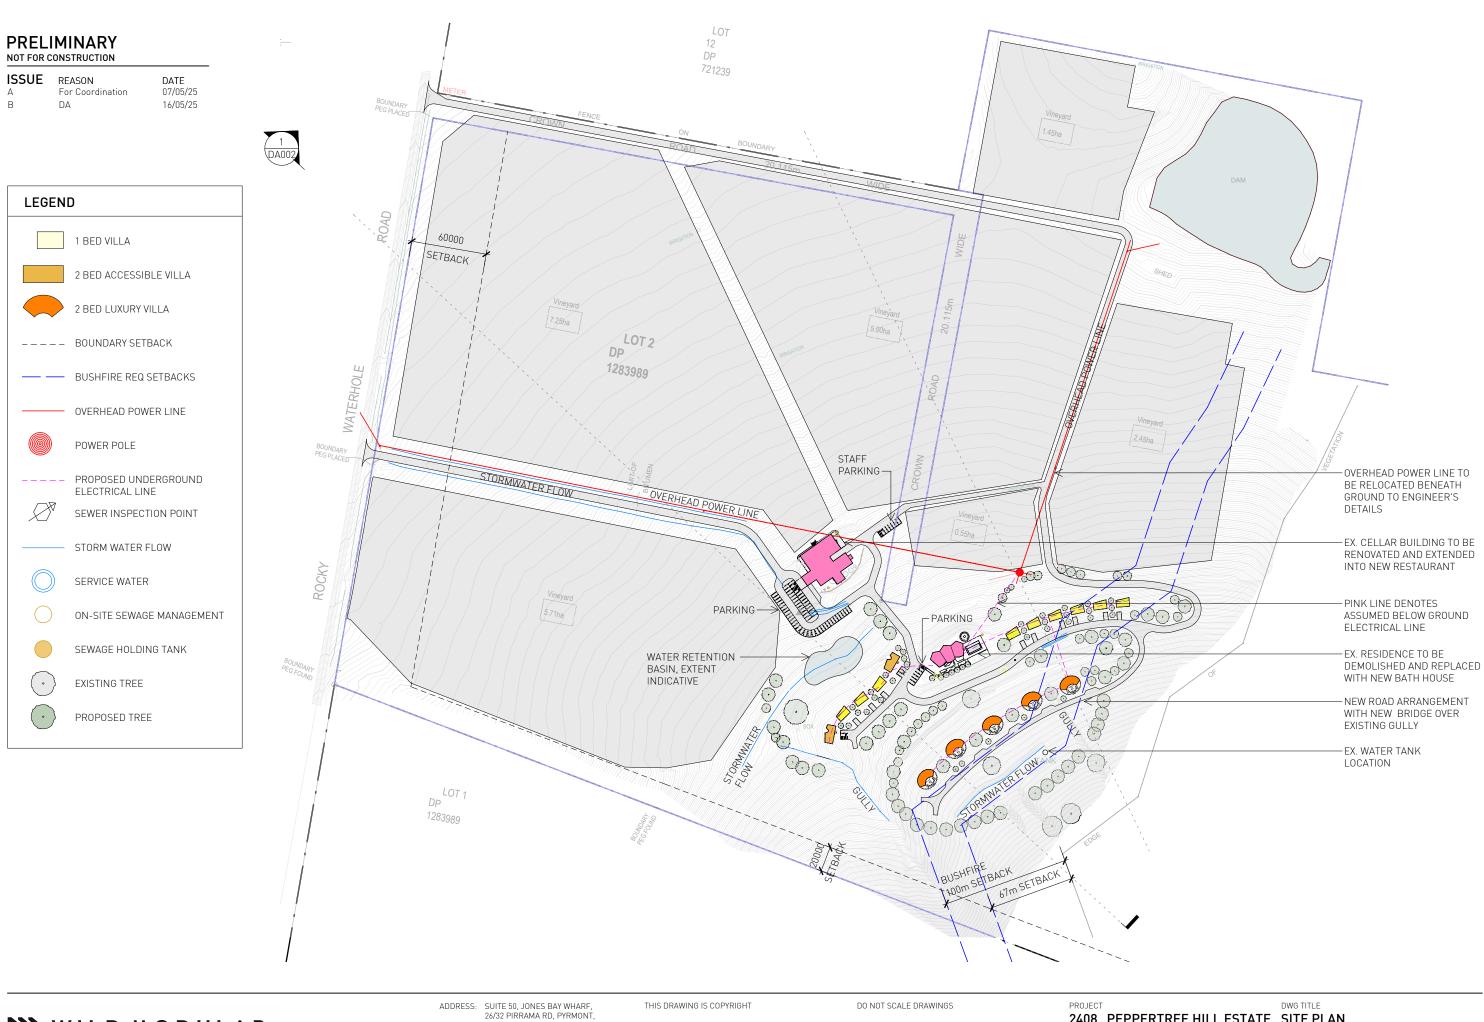
2408 PEPPERTREE HILL ESTATE SITE PLAN DRAWN SENIOR QA APP'D DWG NO DRAFT DA001 В

A development is proposed for Lot 2 DP1283989, 85 Rocky Waterhole Road, Mudgee NSW (Figure 1 and Figure 2). The proposed development will include the extension and remodelling of the existing onsite Cellar Door, including the development of car parking areas on the site. The existing residence will be demolished, replaced by a new Bath House. Sixteen luxury villas will also be constructed on the site as part of the proposed development (Appendix F).

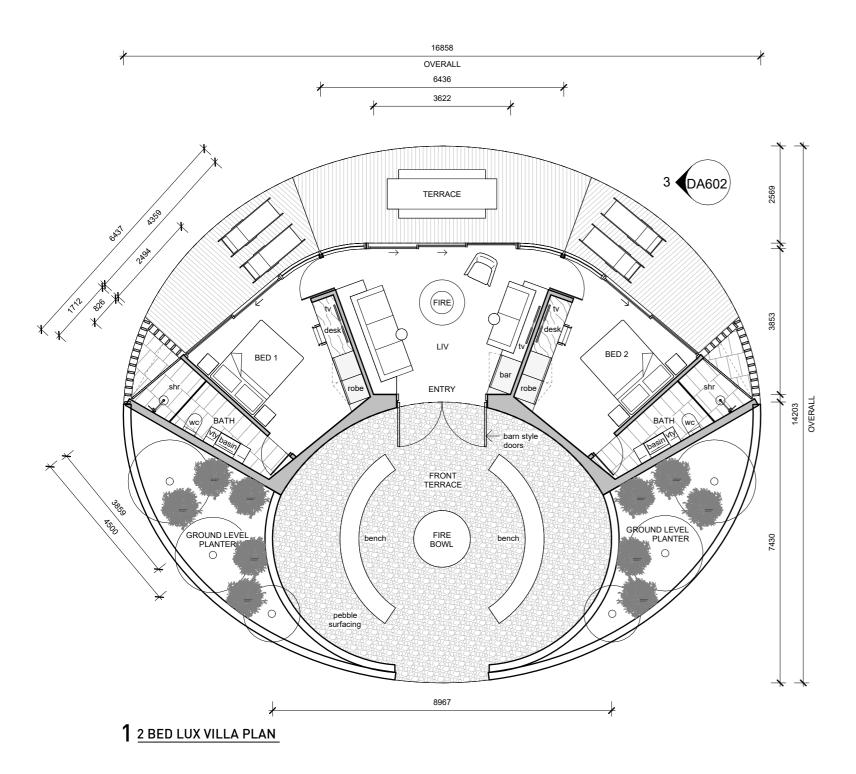
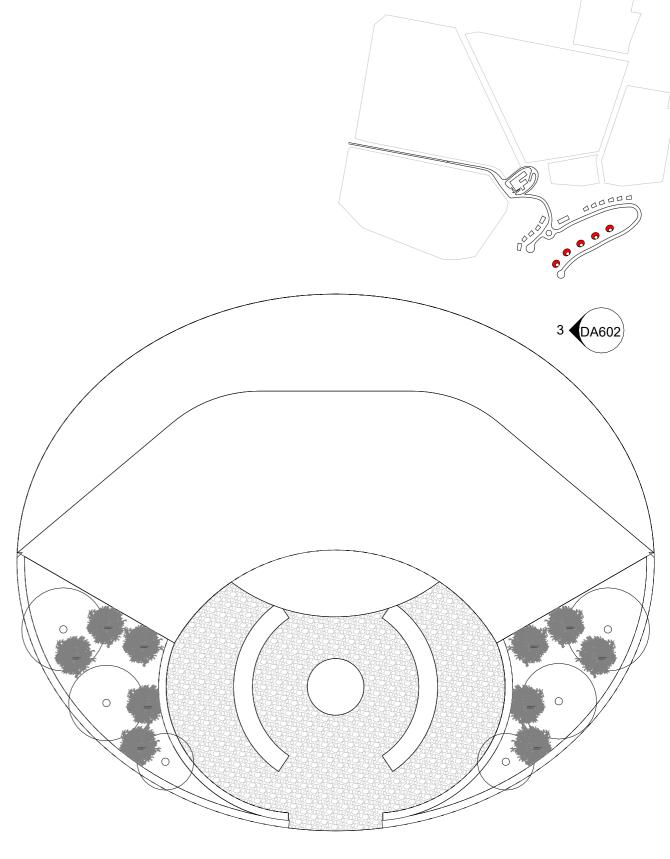
## 2 2 BED LUX VILLA ROOF PLAN

DRAWING NAME 2 BED LUX VILLA TYP. PLANS
