## Site and Soil Assessment for On-site Effluent Management System

Client: Geoff Spice Site Address: 433 Kaludabah Road Piambong, NSW 2850

Our Reference : 41215-ER01\_A

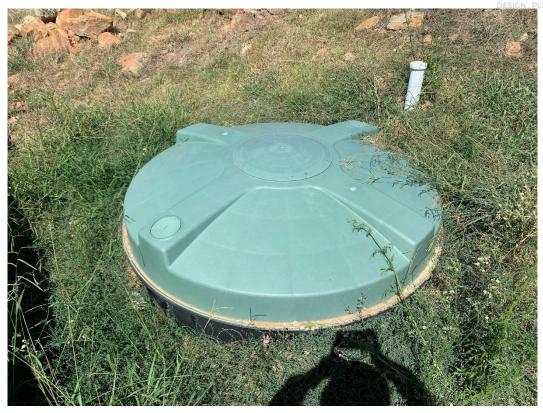
Plate 3 – Existing Plastic Standard Septic Tank

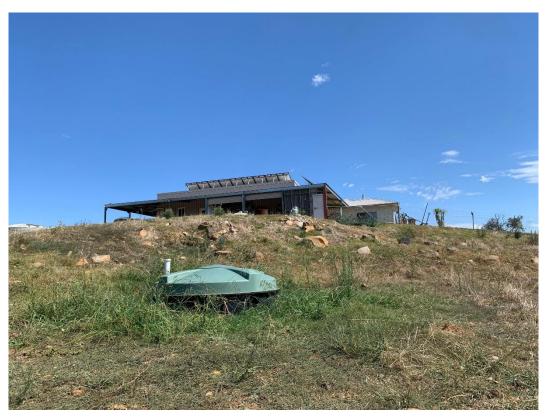
Plate 4 – Existing Plastic Septic Tank Location
