# MUDGEES HERITAGE STUDY

## BUILDING INVENTORY

HUGHES TRUEMAN LUDLOW CONSULTANTS (02)439.2633

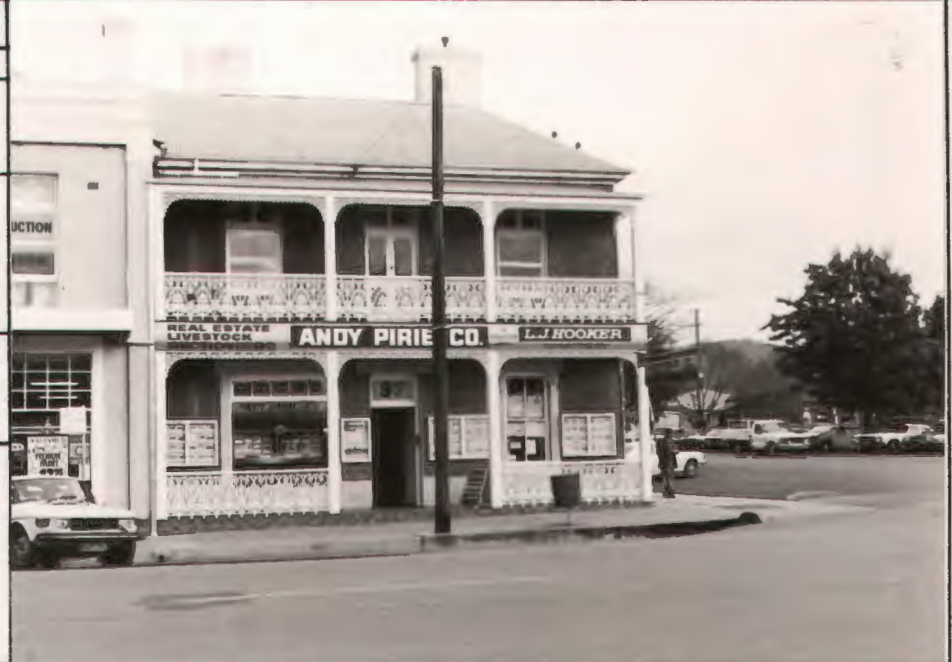
BUILDING ADDRESS **MARKET ST** **MUDGEES**  
CNR. PERRY ST.BUILDING TITLE **ANDY PIRIE & CO**TYPE :- **REAL ESTATE OFFICE**

(APPROX. BY VISUAL INSPECTION UNLESS NOTED OTHERWISE) **C. 1860**

**BROWN/RED BRICK.**  
**ENGLISH BOND.**

**EARLY VICTORIAN HOTEL OF TWO STORIES WITH  
 PROJECTED PARAPETTED FRONT (NOW WALLPAPER). CAST  
 IRON RAILING TO BAL. SOME ORIGINAL UPPER  
 WINDOWS & DOORS REMAIN BUT MANY ALTERED.**

INTEGRITY Good ☐ Nos  
 Fair ☒ Nos  
 Poor ☐ Nos

CONDITION Good ☒ Nos  
 Fair ☐ Nos  
 Poor ☐ Nos..

• **TIMBER POSTS + E.I.**

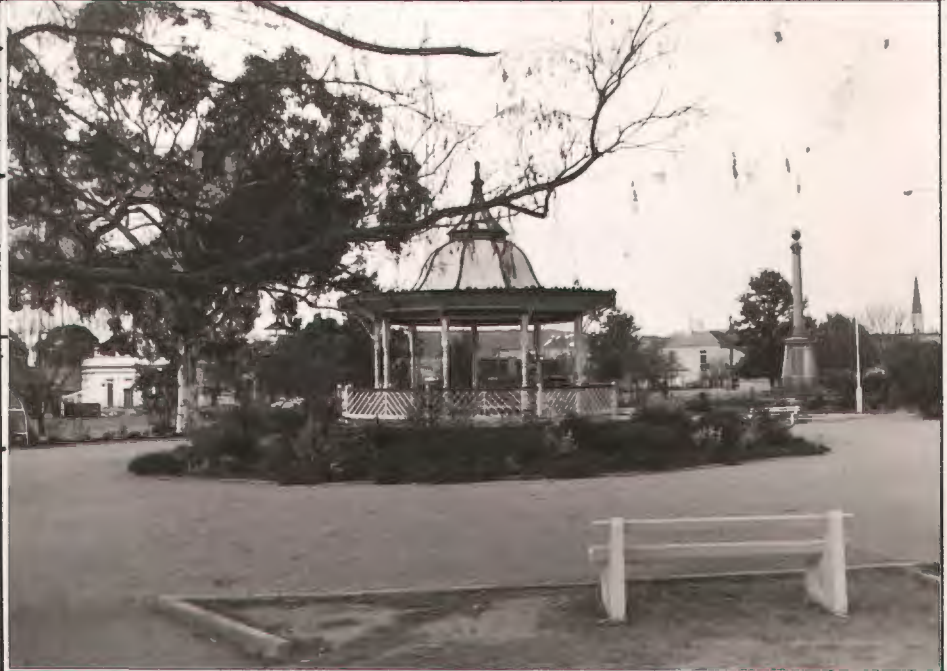
BANDSTAND.

(APPROX. BY VISUAL INSPECTION UNLESS NOTED OTHERWISE) C. 1903.

FINE EDWARDIAN PERIOD BAND ROTUNDA  
IN EXCELLENT CONDITION. THE OCTAGONAL  
FORM HAS A CURVED ROOF OF TURKISH  
CHARACTER SET WITH METAL CRESTINGS ON  
FINE TURNED TIMBER POSTS. THE BALUSTRADE  
IS OF ELABORATE RAKING TIMBER  
STRAPWORK.

FINE EDWARDIAN PARK BANDSTAND.

PLANTING AROUND BANDSTAND NOT  
IN PERIOD STYLE.
SEE ALSO ROBERTSON PARK  
IN LANDSCAPE INVENTORY.
 Abbreviations: BW = Brickwork  
 CI = Cast iron  
 DEC = Decoration  
 FLR = Floor  
 PPT = Parapet  
 TC = Terra cotta  
 VER = Verandah  
 WB = Weather Board

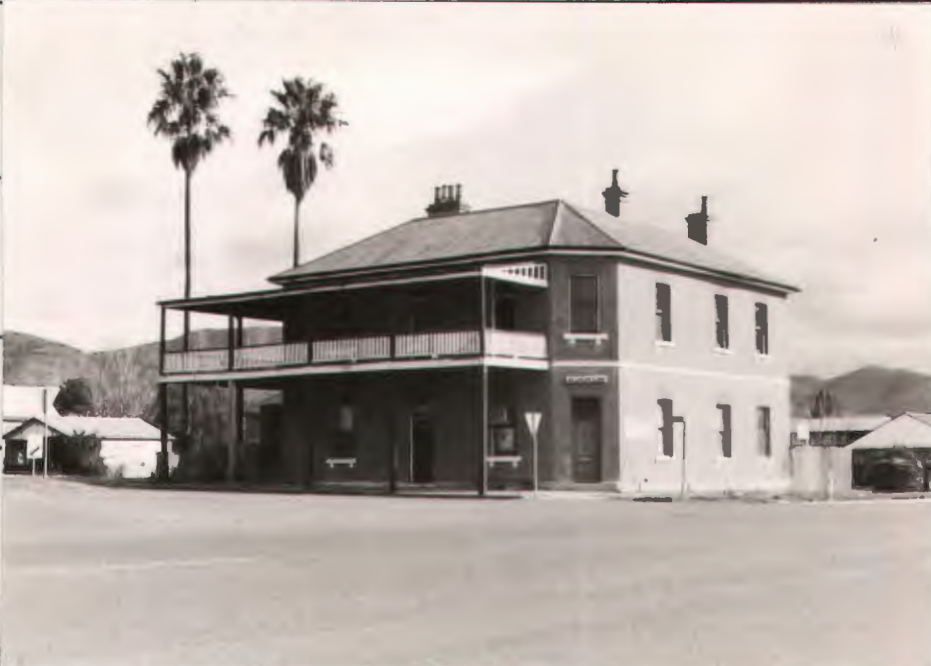
TYPE :- **BEAUTY SALON/ACUPUNCTURIST**  
ORIGINAL USE IF DIFFERENT :- **LESTER'S PHARMACY+RES.**EXISTING LISTING : National Estate ☐ State Heritage ☐ National Trust ☐ OtherSIGNIFICANCE CLASSIFICATION National ☐ State ☐ Local 1. ☒ Local 2. ☐ Local 3. ☐ OtherPhoto file; film-neg: **B.9**Survey date **18.7.85**

(APPROX. BY VISUAL INSPECTION UNLESS NOTED OTHERWISE) **C. 1865**  
**WITH 1920 ALTERATIONS**

**BROWN BRICK****FLEMISH BOND.****SANDSTONE BASE COURSE.**

**FINE TWO STORED COMMERCIAL BUILDING ALBEIT  
SOMEWHAT ALTERED FROM MID-VICTORIAN PERIOD.  
BRICKWORK IN FINE CONDITION WITH RED RUBBED FLAT SOLDIER  
COURSE HEADING OVER OPENINGS. BUILT RIGHT TO ST. ALIGNMENT  
& WITH SPLAYED CORNER ENTRY.  
DOUBLE HUNG SASH WINDOWS (SOME WITH OFFSET MULLIONS)  
ONE ORIG. DOOR REMAINS ON GD. FL. (FOUR PANELLED TIMBER  
WITH RECT. FANLIGHT OVER).**

**1920'S VERANDAH HAS SOLID WOODEN POSTS, BATTEN  
BALUSTRADE AND SKILLION ROOF.**

**COMMERCIAL BUILDING FROM  
POST GOLD RUSH EXPANSION PERIOD.**

• REP. DOOR STAINED.  
 • TOO SMALL.  
 • AIR CONDIT.  
 • SIGNAGE.

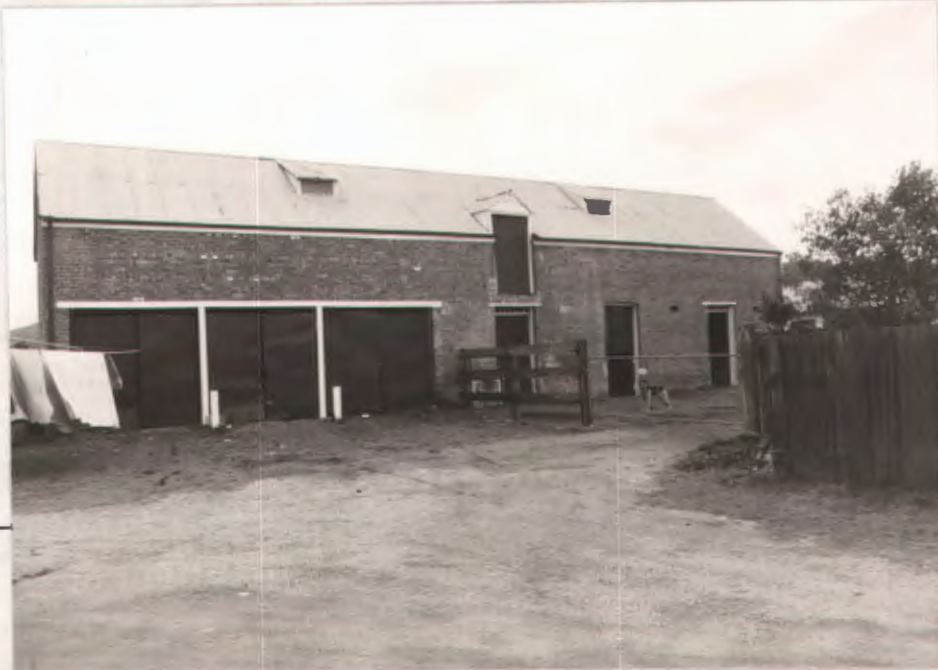
↑  
STABLES  
CUM GARAGE.

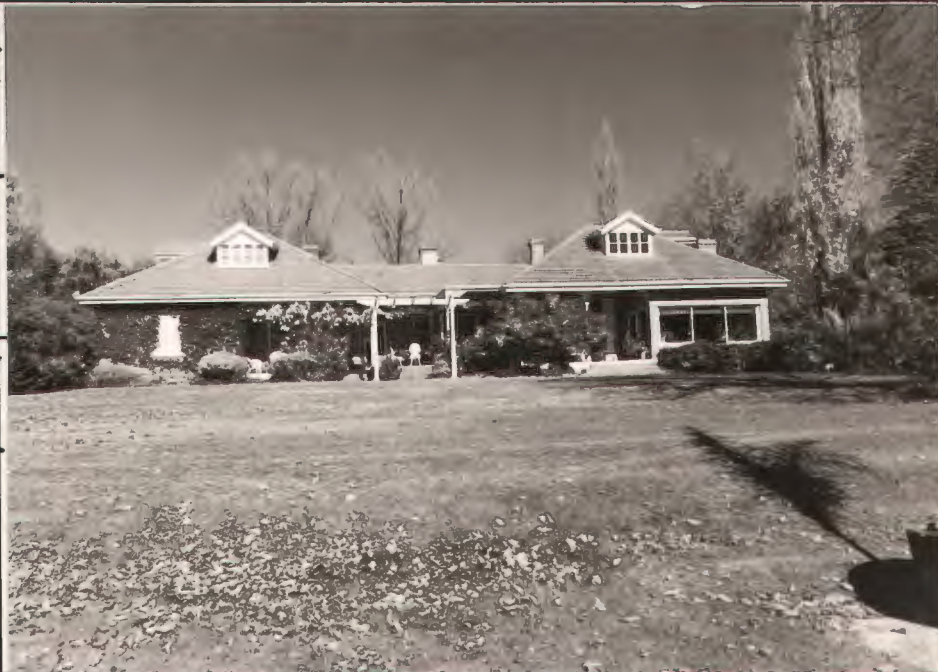
**BROWN BRICK.**

**LARGE FEDERATION HOUSE ALTERED SUBSTANTIALLY IN 1950'S (POSSIBLY BY KENETH McCONNEL, ARCHITECT). THE PAVILLIONED ROOFS WITH LINKED VERANDAS FACES NORTH TO THE RIVER RESULTING IN AN ELEVATION OF REPOSE AND DEEP SHADE. THE HOUSE FORMS THE CENTRE PIECE OF AN ESTATE WITH ORNAMENTAL BUILDINGS & GATEWAYS INTRODUCED INTO A PARK LANDSCAPE OF CLUMPED TREES (MOSTLY DECIDUOUS), LAWNS, CURVED DRIVEWAYS, & RUSTIC STONE BRIDGE. A THE LANDSCAPE POSSIBLY THE WORK OF E. SORENSON LANDSC. DESIGNER. HOUSE AND ESTATE OF LONERAGANS, PROSPEROUS LOCAL MERCHANT FAMILY FROM POST GOLD RUSH EXPANSION PERIOD**

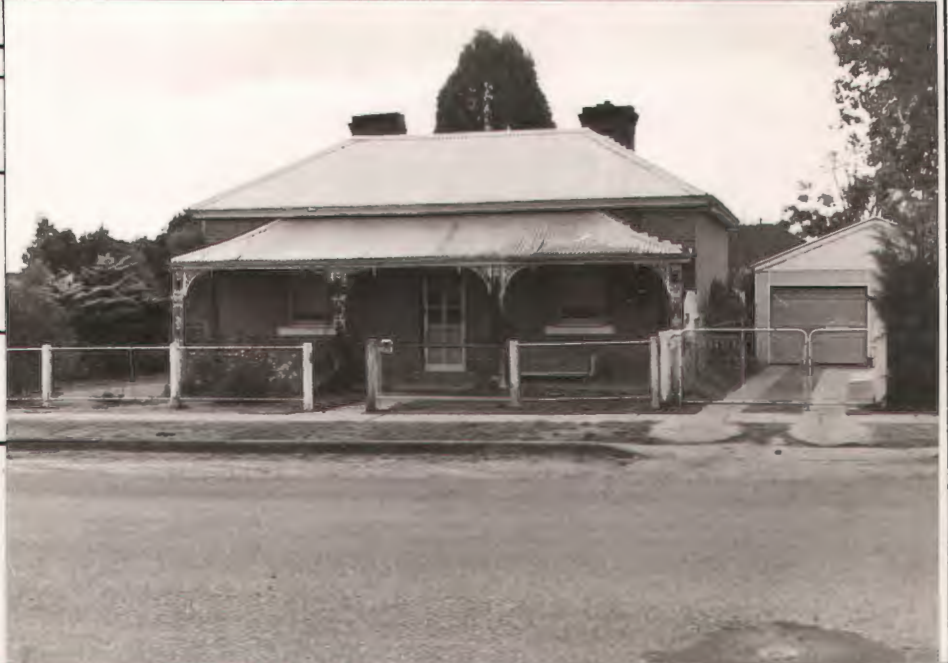
BROWN BRICK  
FLEMISH BOND.

CONDITION Good ☒ Nos ☐  
 Fair ☐ Nos ☐  
 Poor ☐ Nos ☐ RISING DAMP.

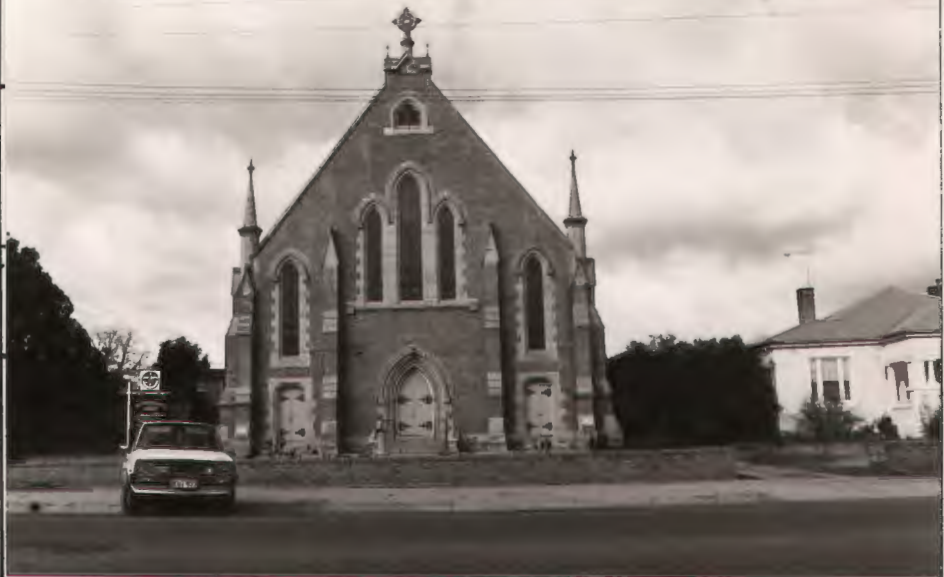
CONSTRUCTION DATE **FOUND. STONE 1863**  
(APPROX. BY VISUAL INSPECTION UNLESS LAID BY NOTED OTHERWISE) **W. HARDWICK.**

MATERIALS (WHERE NOT APPARENT)  
**BROWN BRICK (FLEMISH BAND)**  
**SANDSTONE DRESSINGS.**

**STRONGLY WROUGHT GOTHIC ELEVATION TO STREET  
RISING THROUGH MULTIPLE POINTED OPENINGS TO  
PINNACLES. BRICK BUTTRESSING IS PROMINENT ON ALL  
ELEVATIONS. THE NARROW LANCET WINDOWS (OF THE  
EARLY ENGLISH GOTHIC STYLE AS IS THE DEEPLY MOULDED  
STONE DOORWAY IN THE CENTRE. THE LEAD LIGHT WINDOWS  
ARE IN SIMPLE GEOMETRIC STYLE WITH LITTLE STAINED  
GLASS THOUGH THE SIDE WINDOWS ARE MORE ELABORATE.**

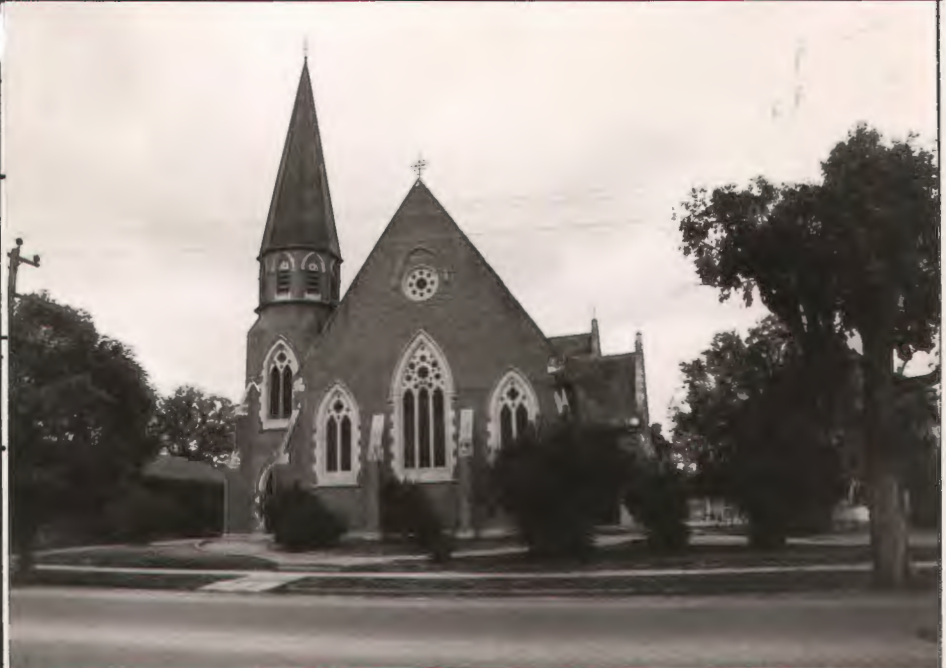
BROWN BRICK (ENGLISH)  
 STONE DRESSINGS. BOND  
 ASBESTOS DIAMOND PATTERN  
 SHINGLE ROOF.

A FINE BRICK GOTHIC CHURCH WITH POWERFUL, SQUAT, ASYMMETRICAL FORM DESIGNED BY THOMAS ROWE. POINTED STONE GOTHIC WINDOWS WITH STAINED GLASS & SMALL ROSE WINDOW ON NORTH STREET FACADE WITH THE POINTED ARCHED DOORWAYS. E. BROAD SPIRE ARE THE MAIN FACADE ELEMENTS. WITHIN THE CHURCH RETAINS THE NON-CONFORMIST MEETING HALL PLAN. THE QUALITY OF THE BRICK WORK IS NOTABLE.

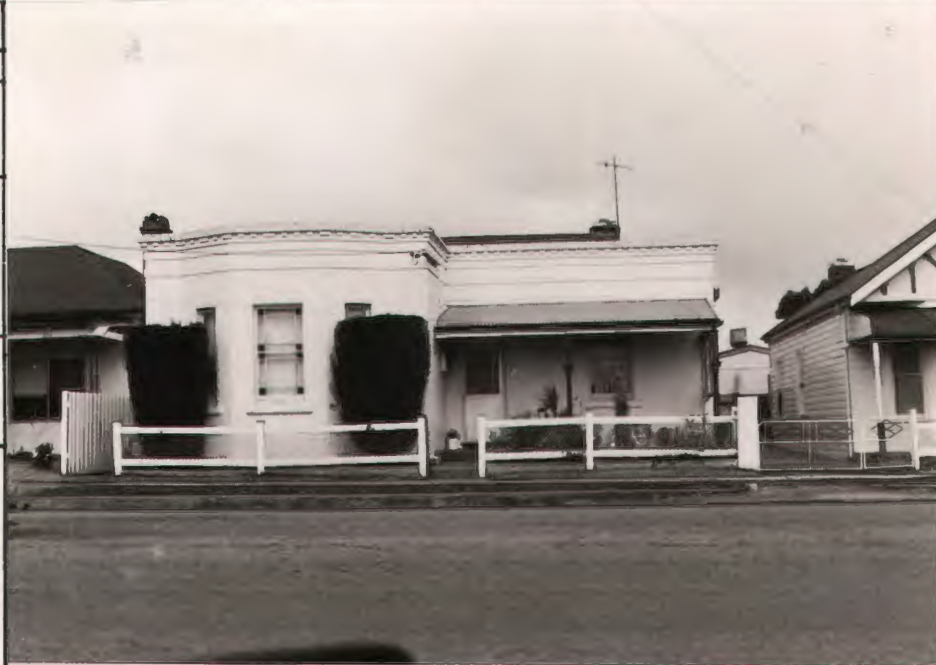
**BRICK.  
(PAINTED.)**

**LATE VICTORIAN FRONT ADDITION TO EARLIER VICT. HOUSE. UNUSUAL PARAPET DESIGN WITH LARGE OCTAG. BAY ON EAST FRONT & ABUTTING VER. WITH SLOPING ROOF (PROB. NOT ORIG) ON CORINTHIAN TYPE CAST IRON COLUMNS (DEC. MISSING).**

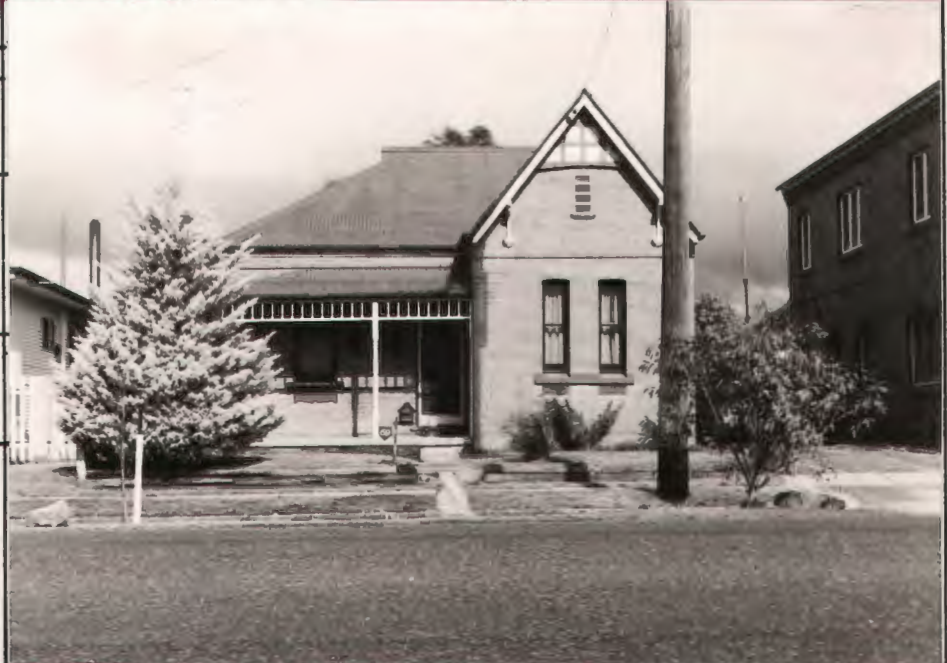
**BROWN BRICK**  
**TUCK POINTED**  
**FLEMISH BOND.**  
**RED RUBBED BRICK WINDOW**  
**HEADS.**

SIGNIFICANCE **ASYMMETRICAL**
**EDWARDIAN PERIOD HOUSE WITH GABLE FRONT END & ABUTTING FRONT VER. DOUBLE CURVED IRON VER. ROOF SUPPORTED ON TURNED TIMBER POSTS & DEC. WITH TIMBER VALANCE AND TURNED SPINDLES. NARROW DOUBLE HUNG SASH (SINGLE PANE) WINDOWS WITH SCRIBBED RENDERED SILL MOULDING. PROB. ORIGINAL GLAZED TIMBER PANELLED DOOR (OBS. GLASS PROB. NOT ORIG.) SIMPLE BARGE BOARDS SUPPORTED ON FRETWORK TIMBER BRACKETS. ROUGH CAST & RENDERED STRAPWORK TO PART GABLE END.**
**GOOD EDWARDIAN HOUSE USING THE VERNACULAR BRICK.**

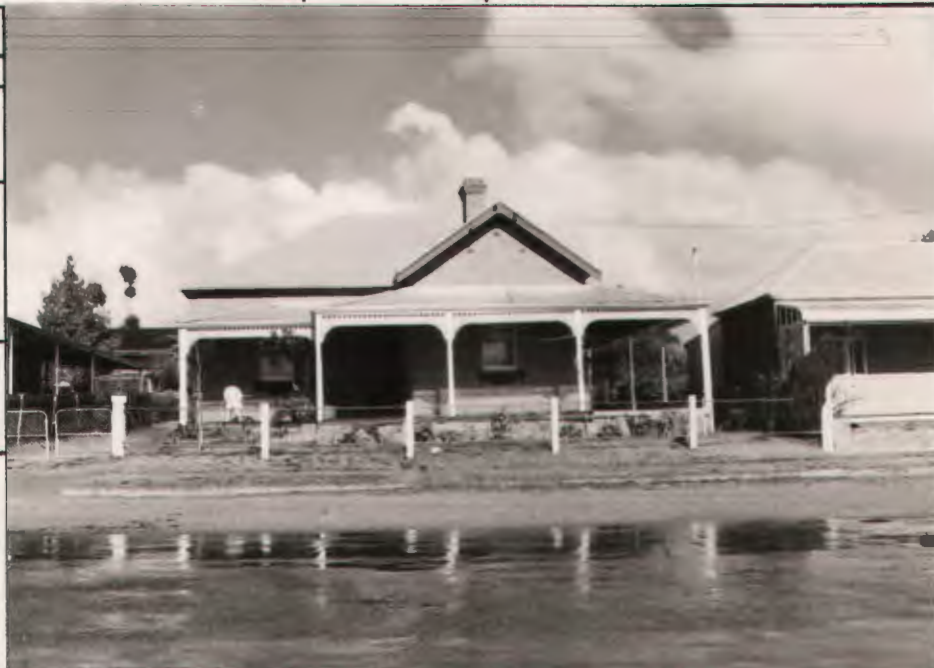
**BROWN BRICK.**
**(MAINLY FLEMISH BOND)**

**VER. WALL IS IN DELAPIDATED CONDITION.**

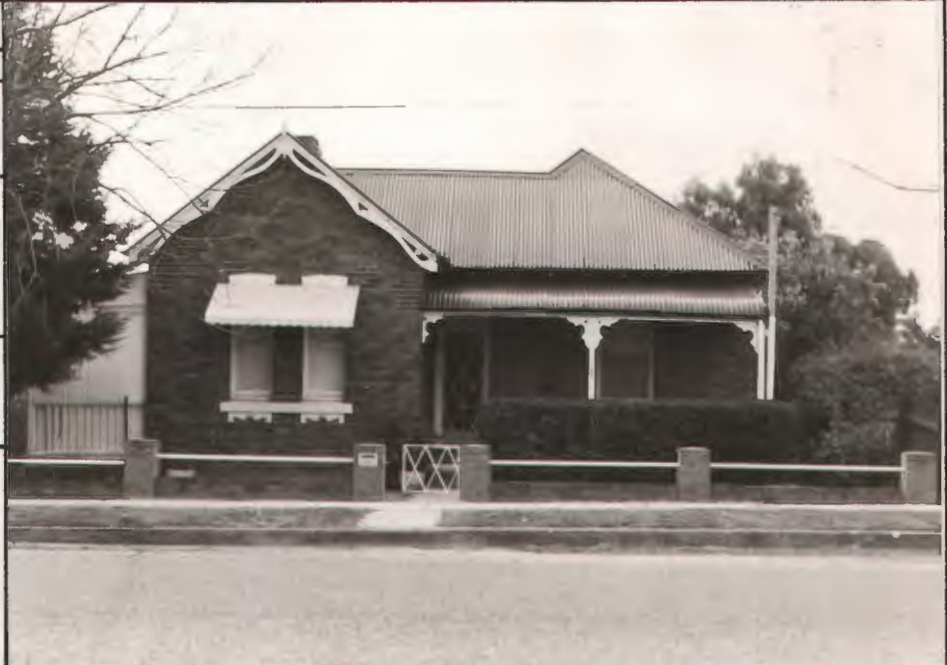
**BROWN BRICK**  
**(STRETCHER BOND)**

• BROKEN FINIAL  
 • MOD. AWNING
